ENGINE BEARING:

FAILURE ANALYSIS AND CORRECTION

Technical information

OEB-2-1114

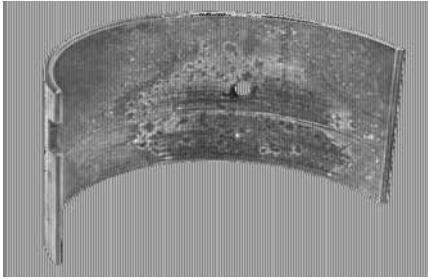
5 Foreign particles in lining

Foreign particles are embedded in the lining of the bearing. Scratch marks may also be visible on the bearing surface.

The high-spot may be large enough to make contact with the journal causing a rubbing action that can lead to the eventual breakdown and rupture of the bearing lining. Foreign particles may embed only partially and the protruding portion may come in contact with the journal and cause a grinding wheel action.

1. Improper cleaning of the engine and parts prior to assembly.
2. Road dirt and sand entering the engine through the air-intake manifold or faulty air filtration.
3. Wear of other engine parts, resulting in small fragments of these parts entering the engine's oil supply.
4. Neglected oil filter and/or air filter replacement.

1. Install new bearings, being careful to follow proper cleaning procedures.
2. Grind journal surfaces if necessary.
3. Recommend that the operator have the oil, air filter, oil filter and crankcase breather-filter replaced as recommended by the manufacturer.

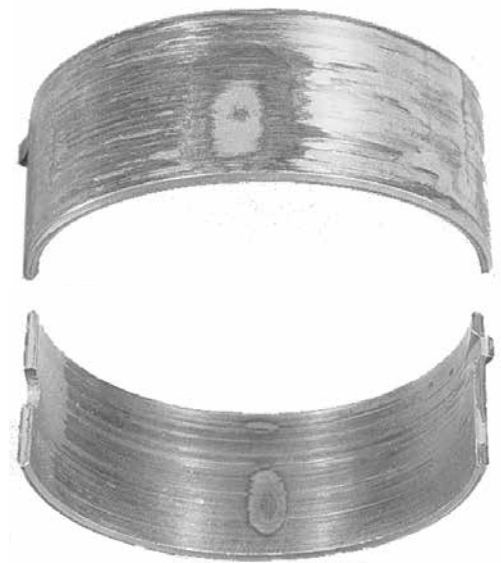
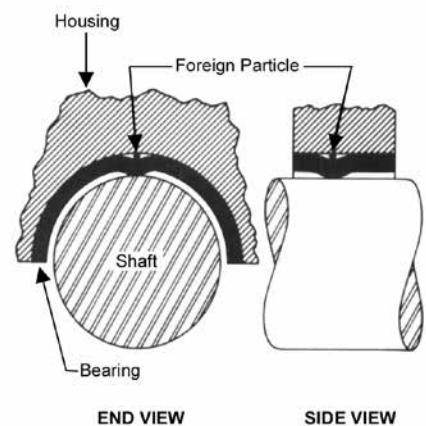
6 Foreign particles on bearing back

A localized area of wear can be seen on the bearing surface. Also, evidence of foreign particle(s) may be visible on the bearing back or bearing housing directly behind the area of surface wear.

Also, an uneven distribution of the load causes an abnormally high pressure area on the bearing surface, increasing localized wear on this material.

1. Install new bearings following proper cleaning and burr removal procedures for all surfaces.
2. Check journal surfaces and if excessive wear is discovered, regrind.

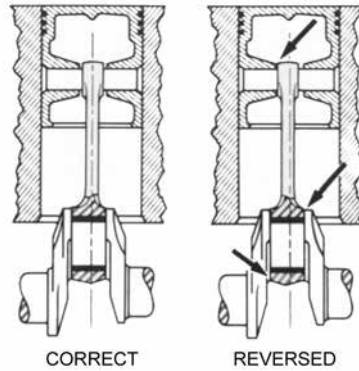
Position of offset connecting rod reversed

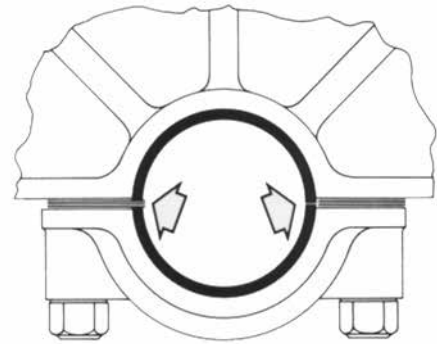
Shims improperly installed

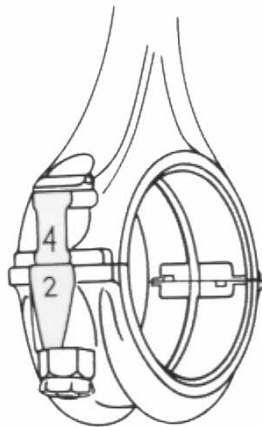
Bearing caps in wrong or reversed position

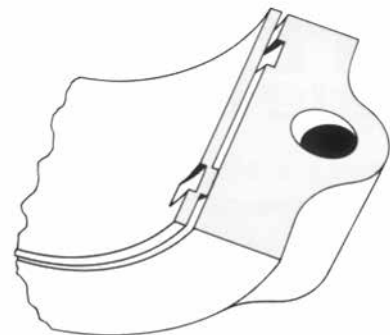
Locating lug not nested

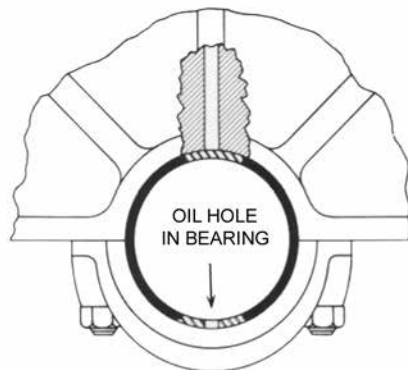
Bearing halves reversed

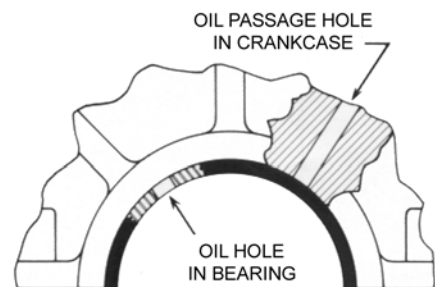
Bearing oil hole not aligned with oil passage hole

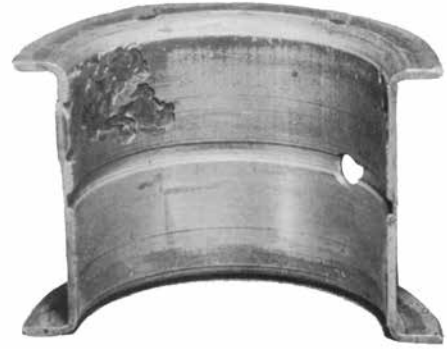
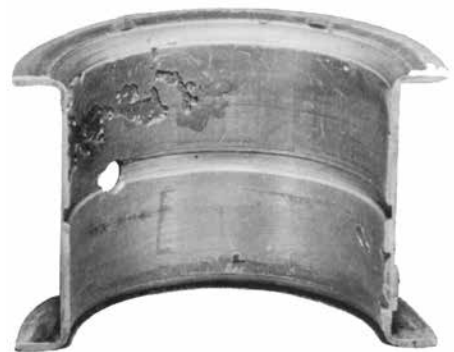
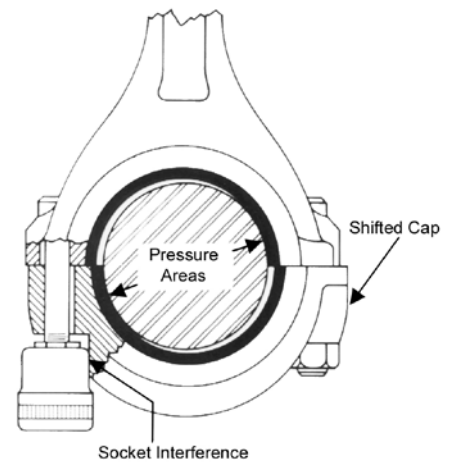
8 Shifted bearing cap

Excessive wear areas can be seen near the parting lines on opposite sides of the upper and lower bearing shells.

The resulting metal-to-metal contact and excessive pressure cause deterioration of the bearing surface and above normal wear areas.

1. Using too large a socket to tighten the bearing cap. In this case, the socket crowds against the cap causing it to shift.
2. Reversing the position of the bearing cap.
3. Inadequate dowel pins between bearing cap and housing (if used), allowing the cap to break away and shift.
4. Improper torquing of cap bolts resulting in a "loose" cap that can shift positions during engine operation.
5. Enlarged cap bolt holes or stretched cap bolts, permitting greater than normal play in the bolt holes.

1. Check journal surfaces for excessive wear and regrind if necessary.
2. Install the new bearing being careful to use the correct size socket to tighten the cap and the correct size dowel pins (if required).
3. Alternate torquing from side to side as to assure proper seating of the cap.
4. Check the bearing cap and make sure it's in its proper position.
5. Use new bolts to assure against overplay within the bolt holes.

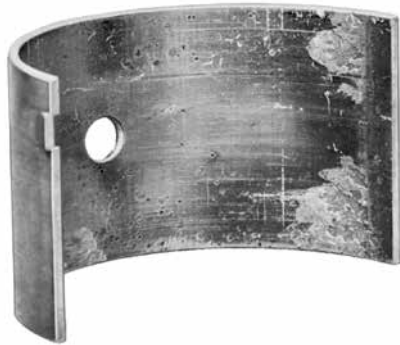
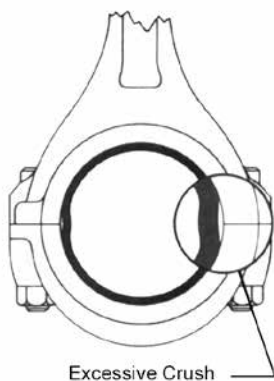
9 Excessive crush

Extreme wear areas visible along the bearing surface adjacent to one or both of the parting line.

When there is too much crush, however, the additional compressive force created by the surplus crush that still remains after the bearing is fully seated causes the bearing to bulge inward at the parting faces. This bearing distortion is called “side pinch.”

1. The bearing caps were filed down in an attempt to reduce oil clearance.
2. The bearing caps were assembled too tightly due to excessive torquing.
3. Not enough shims were utilized (if shims were specified).

1. Rework the bearing housing of the engine block if it has been filed down.
2. Replace the connecting rod if its bearing cap has been filed down.
3. Check journal surfaces and regrind if necessary.
4. Install the new bearing and follow proper installation procedures by never filing down bearing caps and using the recommended torque wrench setting.
5. Correct the shim thickness (if applicable).
6. Check for out-of-roundness of the inside diameter of the assembled bearing by means of an out-of-roundness gauge, inside micrometer, calipers or prussian blue to assure that any out-of-roundness is within safe limits. The maximum assembled bearing I.D. should always be across the split line.

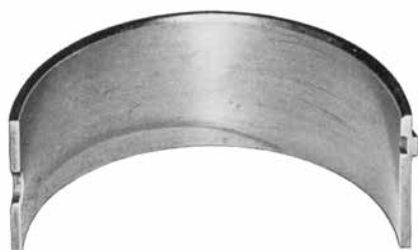
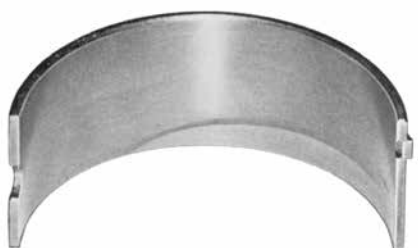
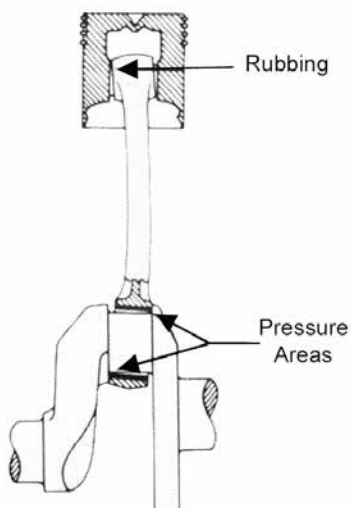
11 Bent or twisted connecting rod

Excessive wear areas can be seen on opposite ends of the upper and lower connecting rod bearing shells. The wear is localized on one portion of the bearing surface with little or no wear on the remainder.

A bent or twisted connecting rod results in misalignment of the bore, causing the bearing to be cocked so the bearing edge makes metal-to-metal contact with the journal. These metal-to-metal contact areas cause excessive wear on the bearing surface.

1. Extreme operating conditions such as "hot rodding" and "lugging."
2. Improper reconditioning.
3. Dropping or abusing the connecting rod prior to assembly.

1. Inspect connecting rod and recondition or replace if bent or twisted.
2. Check journal surfaces for excessive wear and regrind if necessary.
3. Install bearing.
4. Avoid dropping or abusing the connecting rod prior to assembly.
5. Use proper installation techniques.
6. Check related upper cylinder parts and replace if necessary.

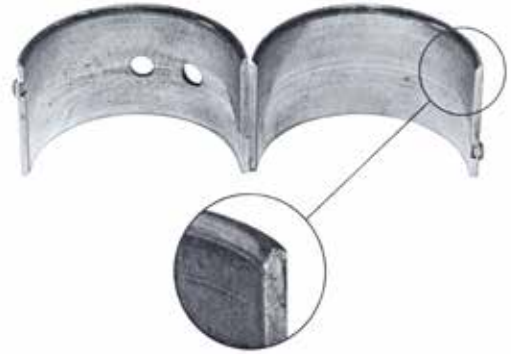
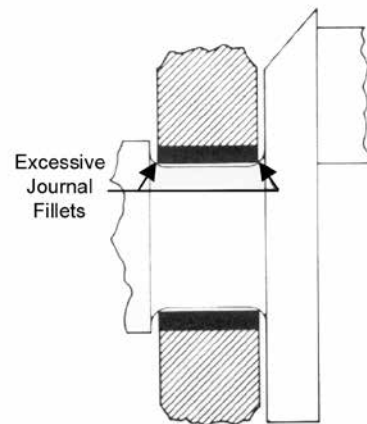
12 Fillet ride

When fillet ride has caused a bearing to fail, areas of excessive wear are visible on the extreme edges of the bearing surface.

This metal-to-metal contact between the bearing and fillet causes excessive wear, leading to premature bearing fatigue.

1. Regrind the crankshaft paying particular attention to allowable fillet radii.
NOTE: Be careful not to reduce fillet radius too much, since this can weaken the crankshaft at its most critical point.
2. Install new bearings with enlarged chamfers that allow proper fillet clearance.

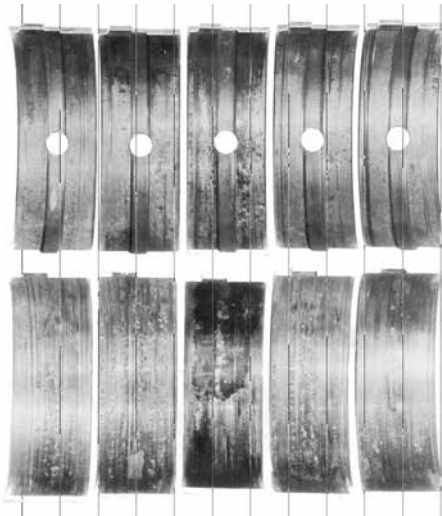
13 Distorted crankcase

A wear pattern is visible on the upper or lower halves of the complete set of main bearings. The degree of wear varies from bearing to bearing depending upon the nature of the distortion. The center bearing usually shows the greatest wear.

A distorted crankcase imposes excessive loads on the bearings, with the point of greatest load being at the point of greatest distortion. These excessive bearing loads cause excessive bearing wear. Also, oil clearance is reduced and metal-to-metal contact is possible at the point of greatest distortion.

Alternating periods of engine heating and cooling during operation is a prime cause of crankcase distortion. As the engine heats the crankcase expands, and as it cools, the crankcase contracts. This repetitive expanding and contracting causes the crankcase to distort over time in some situations.

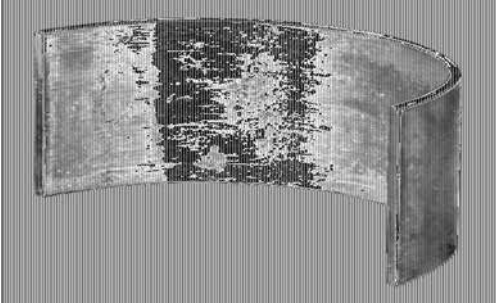
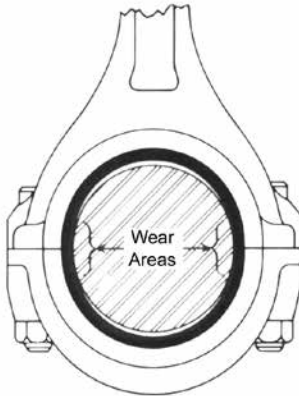
15 Out-of-round bore

Localized excessive wear areas are visible near the parting line on both top and bottom shells.

Oil clearance near the parting line is decreased to such an extent that metal-to-metal contact between bearing and journal takes place, resulting in areas of above-normal wear.

Also, improper seating between the bearing back and the housing bore may be present which hinders proper heat transfer causing localized heating of the bearing surface and thus reducing fatigue endurance.

Alternating loading and flexing of the connecting rod can cause the bearing housing to become elongated. And because replacement bearing shells, when installed, tend to conform to the shape of the bearing housing, this can result in an out-of-round bearing surface.

1. Check the roundness of bearing housings before installing the new bearings. If they are found to be out-of-round, recondition the bearing housings (or replace connecting rod).
2. Check the journal surfaces for excessive wear and regrind if necessary.
3. Install new bearings.

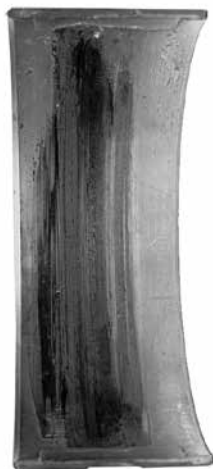
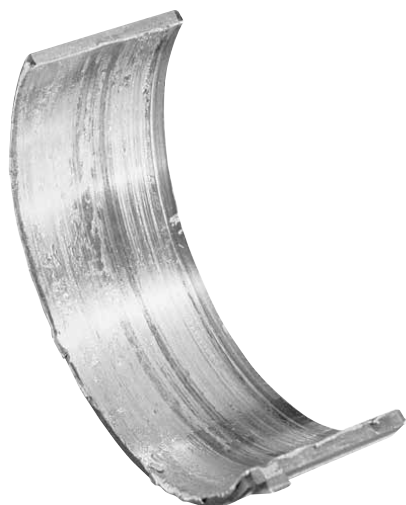
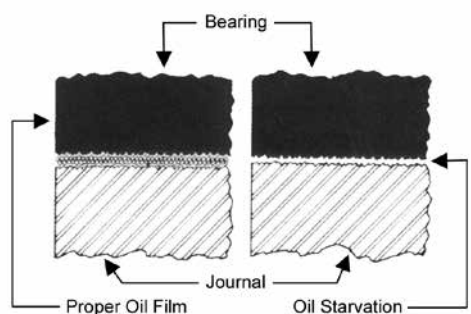
17 Oil starvation

When a bearing has failed due to oil starvation, its surface is usually very shiny. In addition, there may be excessive wear of the bearing surface due to the wiping action of the journal. In the most severe cases the bearing surface will be smeared or scratched and torn. The bearing will begin to turn dark blue to black in color.

The absence of a sufficient oil film between the bearing and the journal permits metal-to-metal contact. The resulting wiping action causes premature bearing fatigue.

1. Insufficient oil clearance – usually the result of utilizing a replacement bearing that has too great a wall thickness. In some cases, the journal may be oversized.
2. Broken or plugged oil passages, prohibiting proper oil flow.
3. A blocked oil suction screen or oil filter.
4. A malfunctioning oil pump or pressure relief valve.
5. Misassembling main bearings metering off an oil hole.
6. Lubrication system not primed before start up.

1. Double-check all measurements taken during the bearing selection procedure to catch any errors in calculation. (During assembly check oil clearance with Plastigage®.)
2. Check to be sure that the replacement bearing you are about to install is the correct one for the application.
3. Check the journals for damage and regrind if necessary.
4. Check engine for possible blockage of oil passages, oil suction screen and oil filter.
5. Check the operation of the oil pump and pressure relief valve.
6. Be sure that the oil holes are properly indexed when installing the replacement bearings.
7. Advise the operator about the results of engine lugging.
8. Always prime the lubrication system before the engine is started the first time.

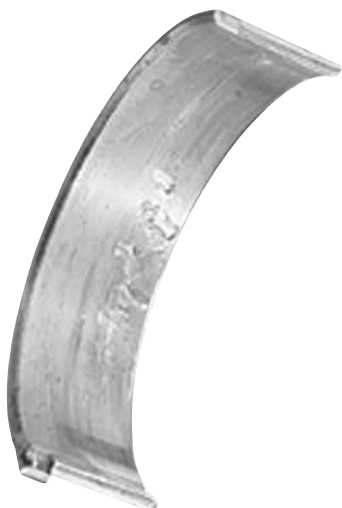
19 Surface fatigue

Bearing surface cracked, small irregular areas of surface material missing from the bearing lining.

Heavy pulsating loads imposed upon the bearing by reciprocating motion within the engine cause the bearing surface to crack due to metal fatigue.

Fatigue cracks widen and deepen perpendicular to the bond line. Close to the bond line, fatigue cracks turn and run parallel to the bond line, eventually joining and causing pieces of the surface to flake out.

1. Overloading (lugging, detonation, or overfueling).
2. Uneven loading (see sections on misalignment).
3. Bearing material of inadequate fatigue strength for application.
4. Bearing failure due to surface fatigue can be the result of the normal life span of the bearing being exceeded.

1. If the service life for the old bearing was adequate, replace with the same type of bearing to obtain a similar service life.
2. If the service life of the old bearing was too short, replace with a heavier duty bearing to obtain a longer life.
3. Replace all other bearings (main connecting rod and camshaft) as their remaining service life may be short.
5. Check for misassembly. Use proper installation techniques.

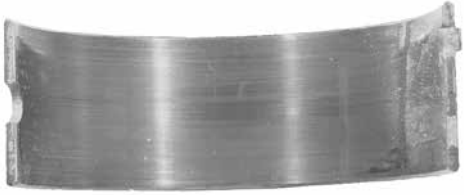
21 Accelerated wear

Wall thickness reduced from original dimension. Bearing surface worn and polished but not smeared, torn or scored. No evidence of heat, no embedded foreign particles.

Grinding and polishing the crankshaft journals produce burrs that are so small that we can't see or feel them. Not only is it important that the surface finish meet recommended average Ra or better, but it is also important to always grind opposite to rotation and polish in the direction of rotation. Otherwise it is possible for these microscopic burrs to disrupt the oil film and abrade away the bearing surface.

1. Poor journal surface finish.
2. Wear in the presence of adequate lubrication to prevent heat build-up and wiping is caused by peaks in the journal surface finish profile which penetrate the oil film and abrade the bearing.
