Absolute Excellence

Engine Valve Service Bulletin.

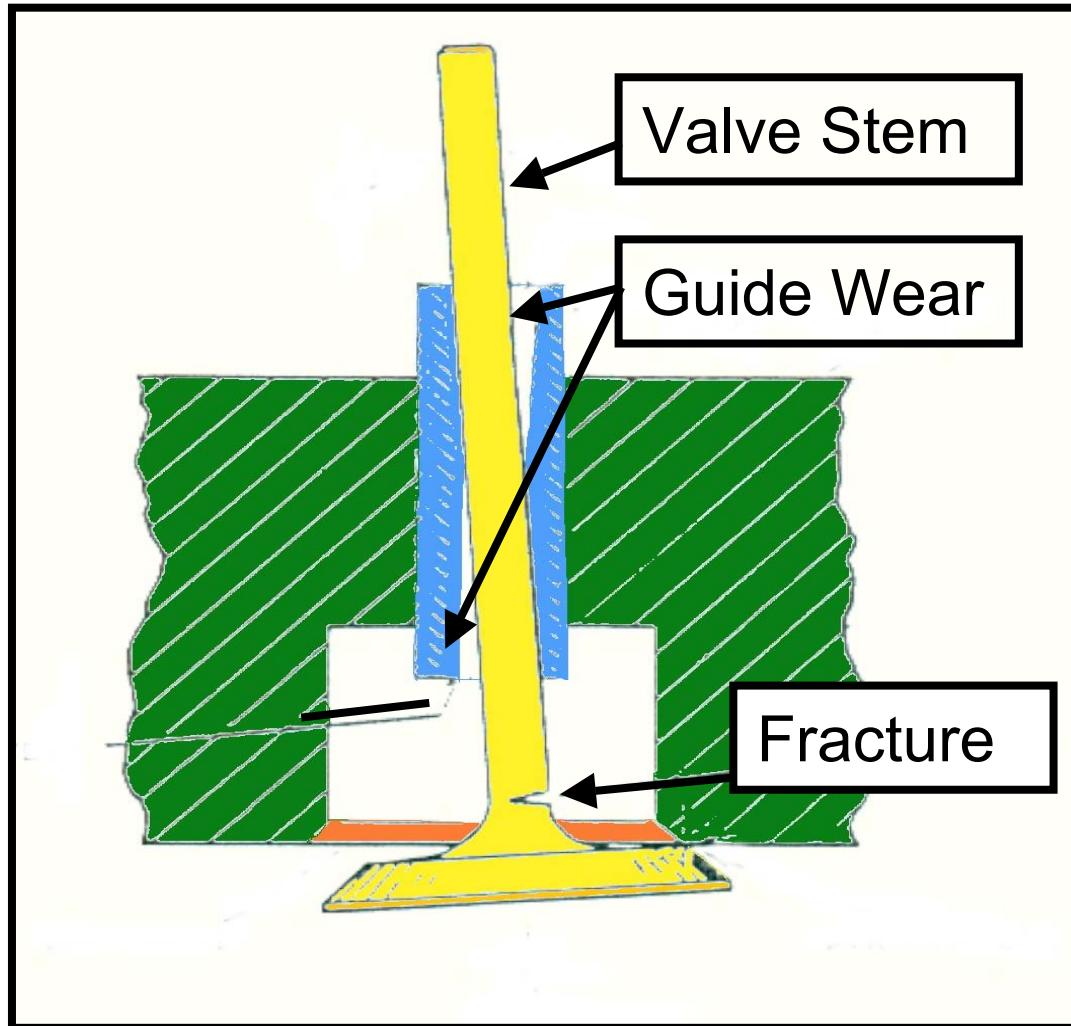
Valve Stem Breakage

Typical causes:

Excessively worn valve guide that fails to assist the valve to close squarely on the seat.

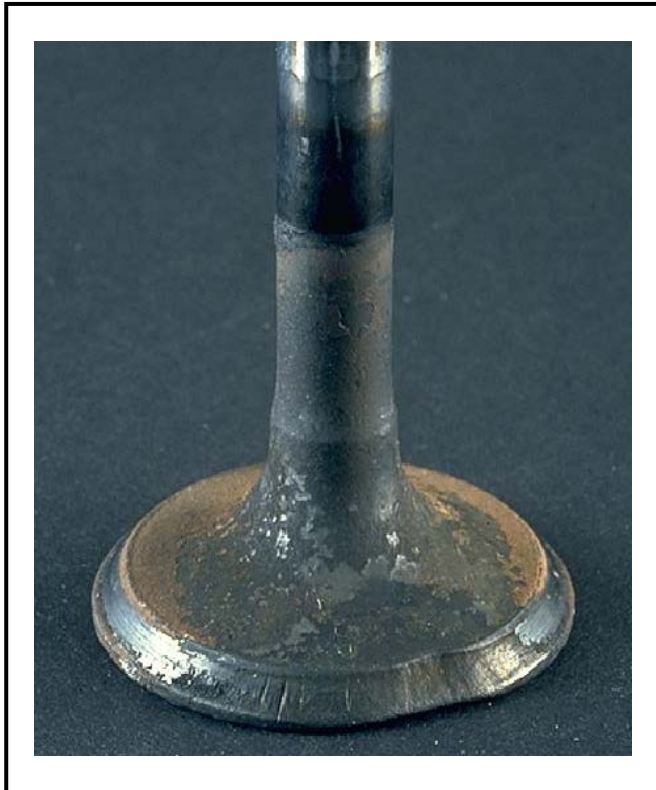
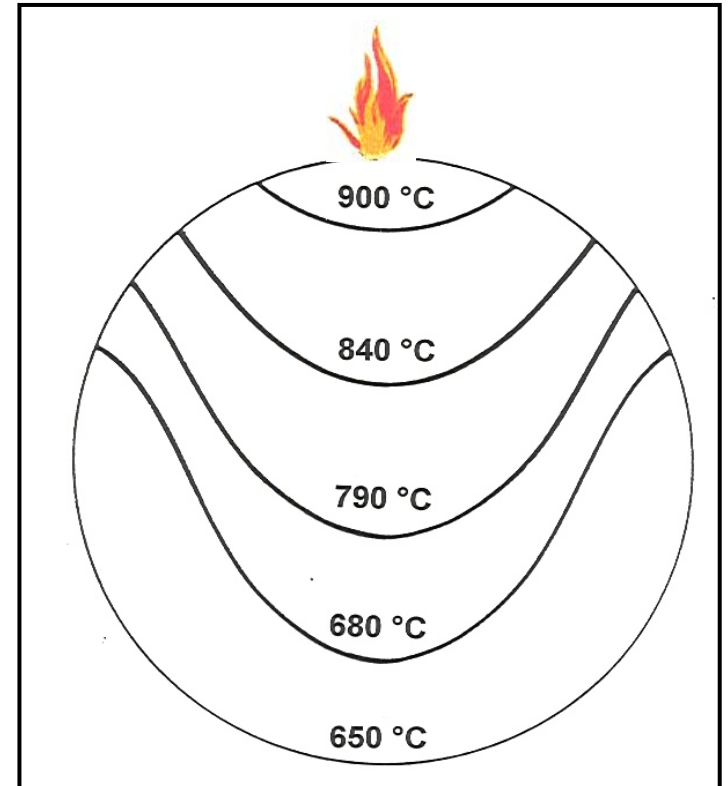
Burnt Valve Seat:

- Incorrect valve clearance.
- Damage/deposits on valve seat.
- No valve rotation.

Temperatures on valve head due to combustion gas leakage.

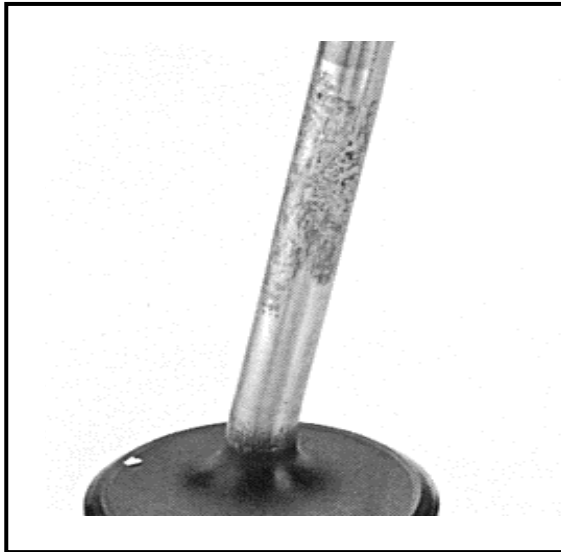
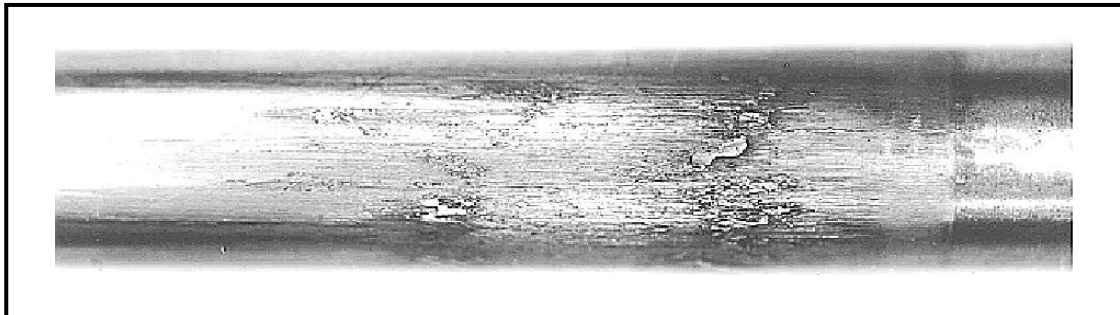
Valve Stem to Valve Guide Seizure:

- Insufficient clearance, resulting from failure to check diameter of valve guide bore after replacement.
- Contaminated oil.
- Overheating.
- Insufficient lubrication.
- Bent valve stem.

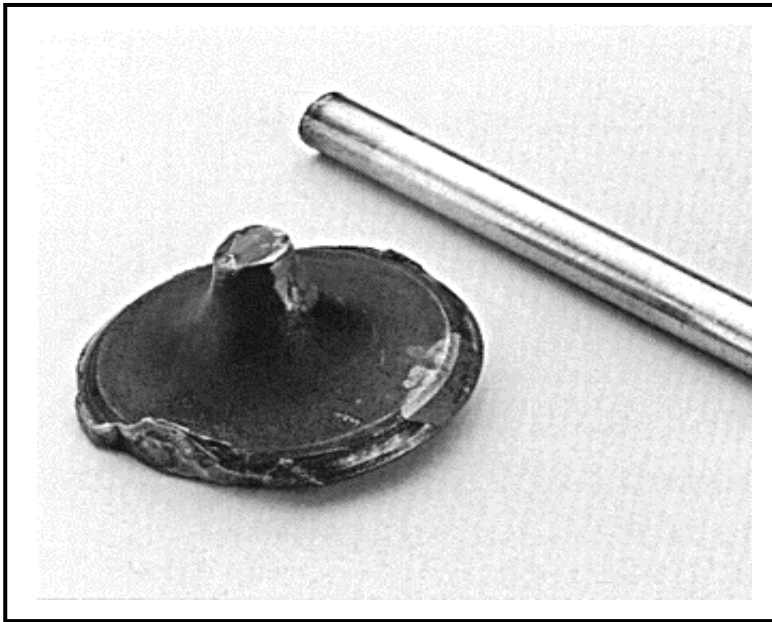
Mechanical Damage:

- Impact with piston "foreign" component.
- Excessive valve spring pressure.
- Excessive valve guide wear.

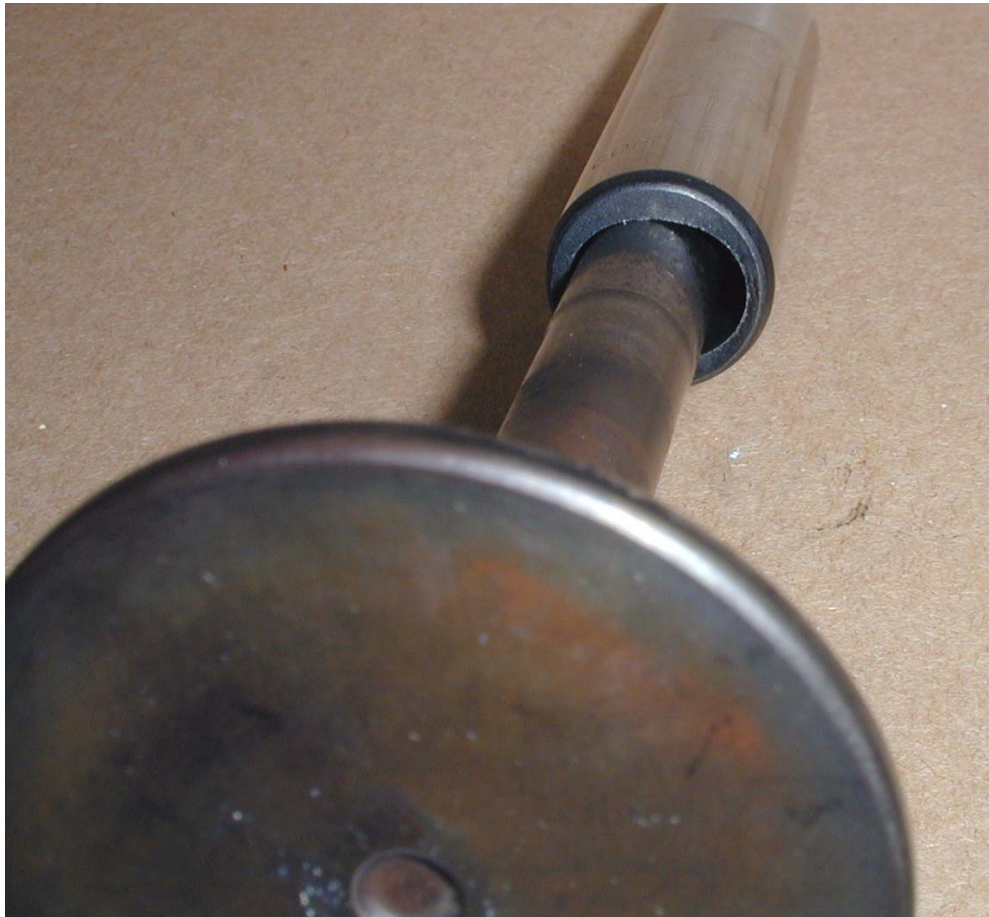
Excessive Valve Stem & Valve Guide Wear:

- (a) Incorrect stem to guide clearances, usually fitted with too much clearance, resulting in bell-mouthing of the guide.
- (b) Excessive carbon packing of the port end of the guide, leading to stem scuffing.

- (c) Scoring and scuffing of the stem due to lack of oil or breakdown of the oil film.
- (d) Abrasive wear from foreign bodies trapped between stem and guide, for example residual carborundum particles after overhaul.

- (e) Temporary lack of coverage by the engine lubrication supply when starting a cold engine in sub-zero temperatures.
- (f) Misalignment of valve guide to valve seat, resulting in high side loading.

- (g) On rocker operated valves, excessive side thrust due to incorrect valve height after overhaul - i.e. valve heavily recessed due to too much metal removal from valve seat and face. Incorrect fitting of special high lift cams which affects the rocker geometry.

- (h) A bent valve stem.
- (i) A badly worn valve tip - this increases side loading.

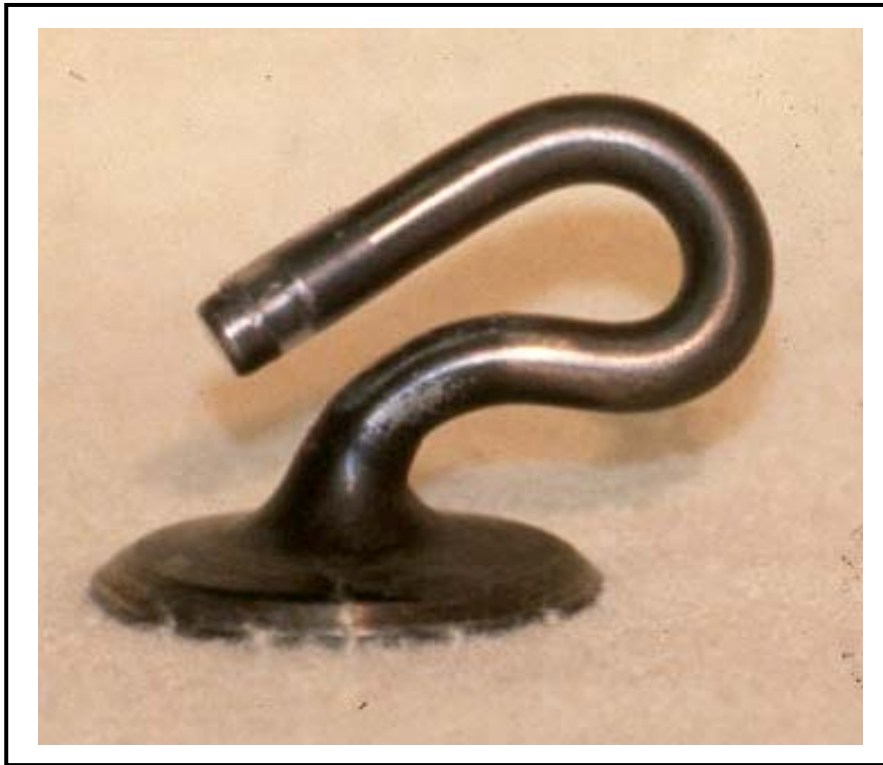
Bent valve:

- Incorrect valve clearance.
- Incorrect piston protrusion value.
- Foreign object in combustion chamber.

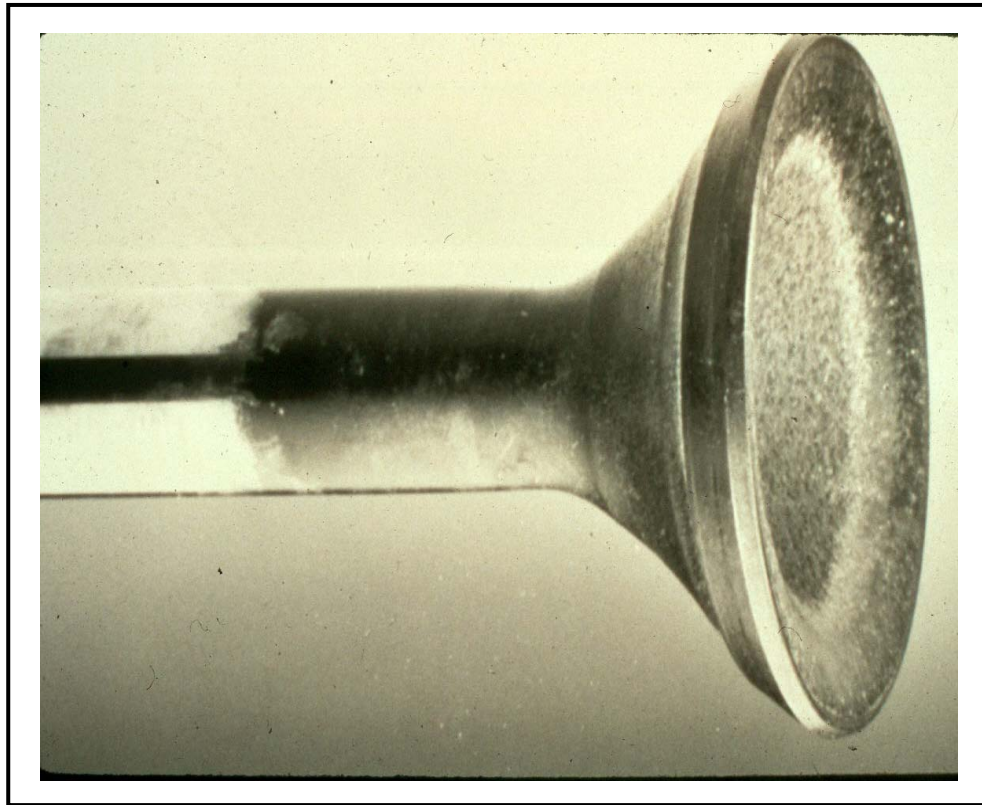
Cupping:

Abnormal operating temperature conditions, combined with excessive valve spring pressure/high velocity impact seating.

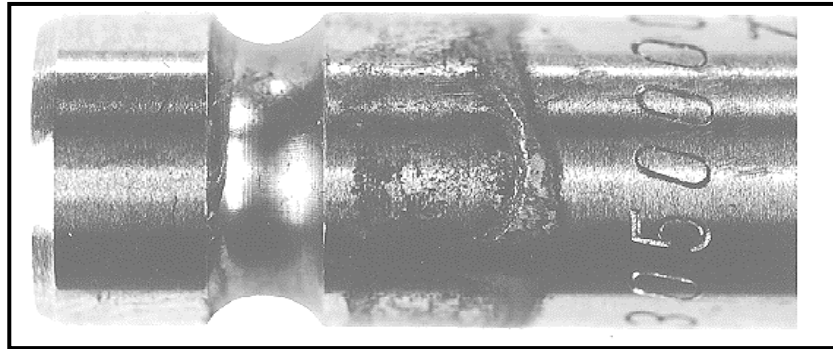
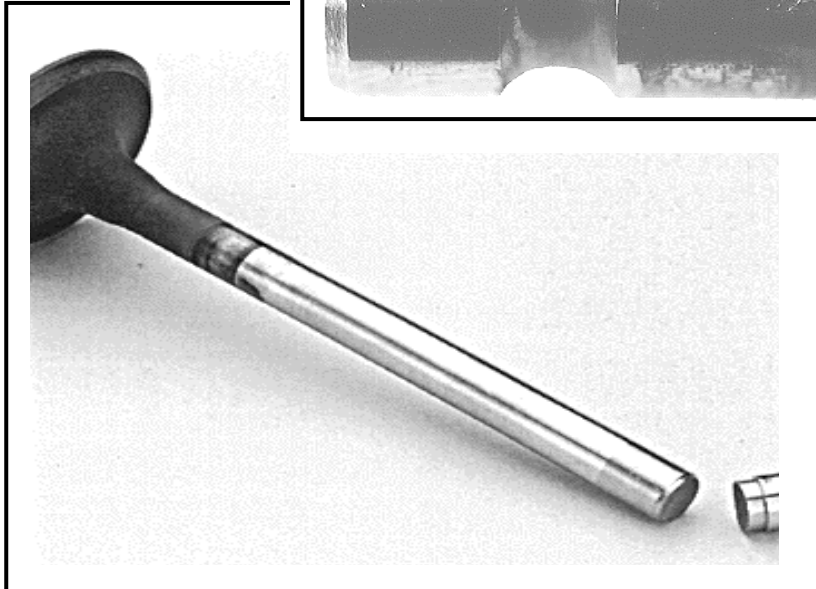
Valve Tip Breakage:

- Poor valve train alignment due to re-use of worn cotters and associated valve train components.

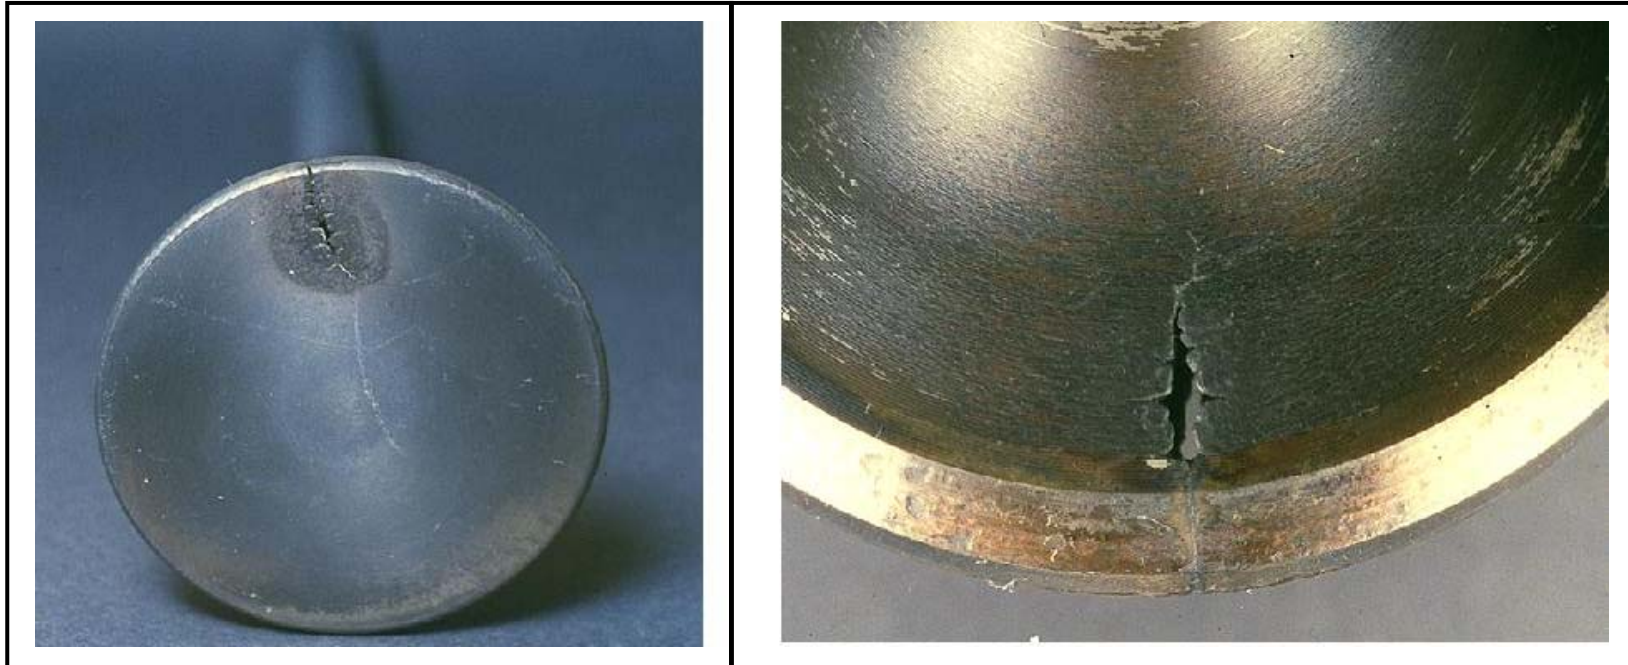
Radial Cracking of Valve Head:

Typical causes: extreme thermal cycles (continual sudden changing from full power to shutdown), damage on valve seat/seat insert producing stress raisers or mechanical overload due to valve bounce.

Symptom: Rough running, loss of compression & poor starting.

Remedy: Check all valves for cracking and replace where necessary, check engine settings, valve springs, guides and followers.

Do not overpeed the engine.

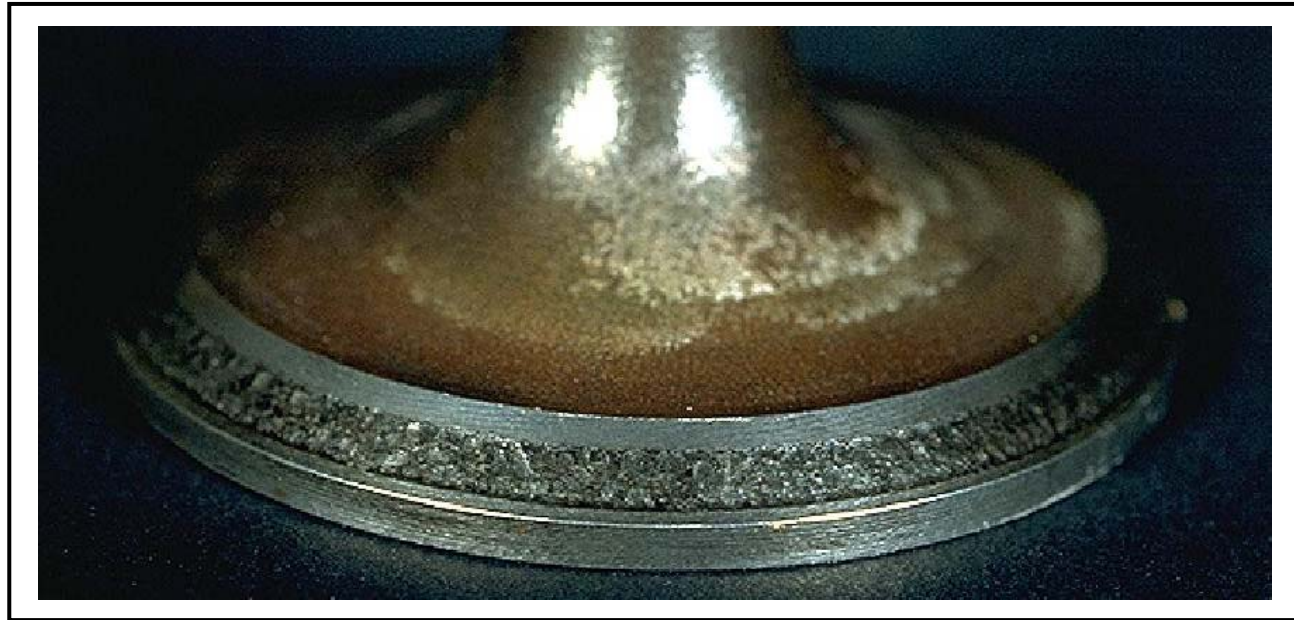
Valve Seat Erosion.

Typical causes: solid particles (often carbon deposits) trapped between the valve and seat.

Symptom: rough running, loss of compression & poor starting.

Remedy: check all valves and replace where necessary, identify the cause (usually combustion related) and rectify.

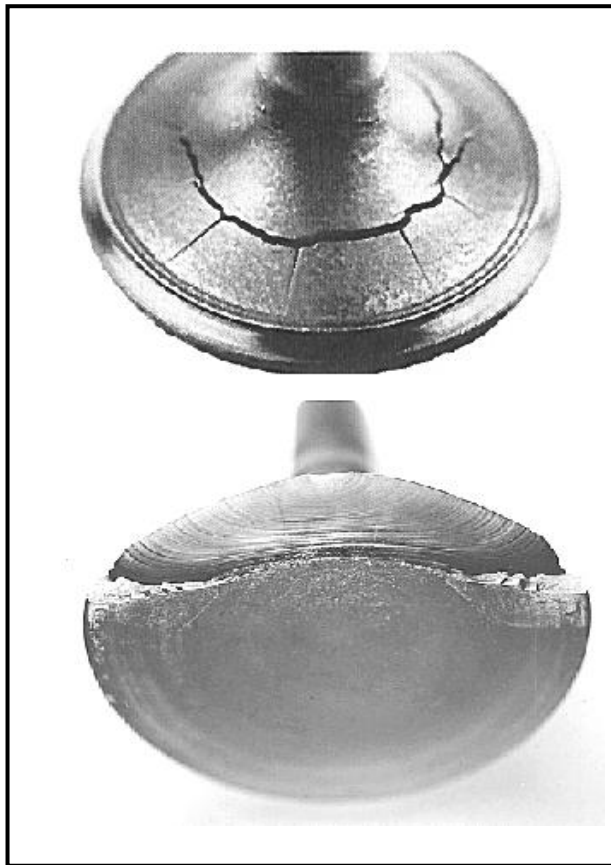
Overload on Valve Head:

$\sigma_{v,max} = 104 \text{ N/mm}^2$

Stress Peak
Fracture Zone

Typical causes: Abnormal operating temperature conditions, combined with excessive valve spring pressure/high velocity impact seating.

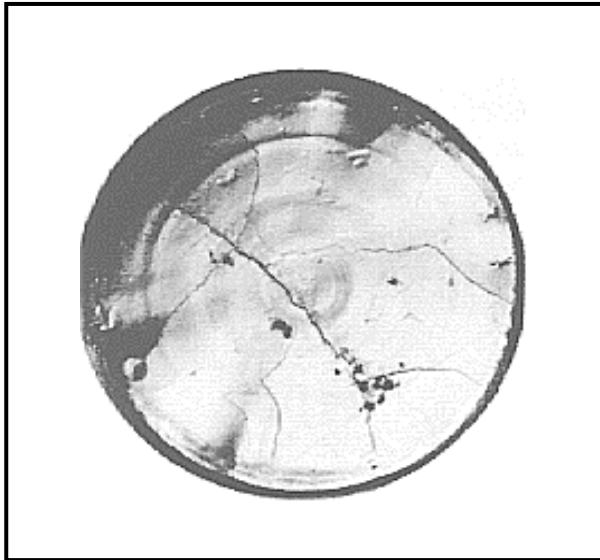
Valve clearance too large:

Cracked stem tip

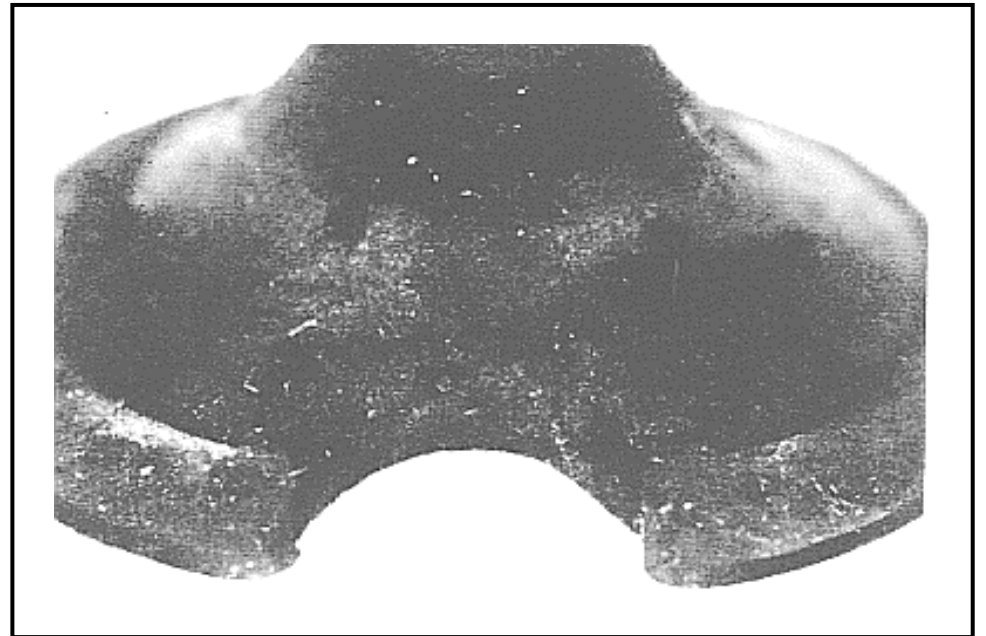
Valve clearance too small:

Burnt valve seat

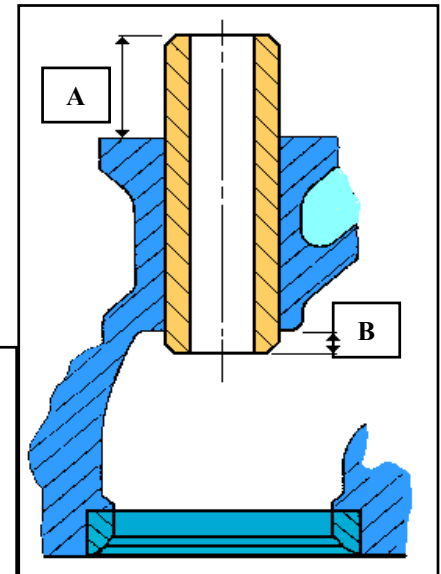
- Measure valve guide protrusion in the direction of the valve spring (**A**) and also into the port (**B**) before removing 'old' guides. Install replacement guides in the same position.
- Excessive valve guide protrusion in the direction of the valve spring (**A**) may result in the spring retainer/collets fouling the valve guide. Conversely, excessive protrusion into the port (**B**) can affect gas flow and temperature transfer characteristics of the valve/guide..
