Eaton® Fuller® Clutches

Failure Analysis Guide
All Clutch Models

Troubleshooting Guide CLTS-1271 June 2003

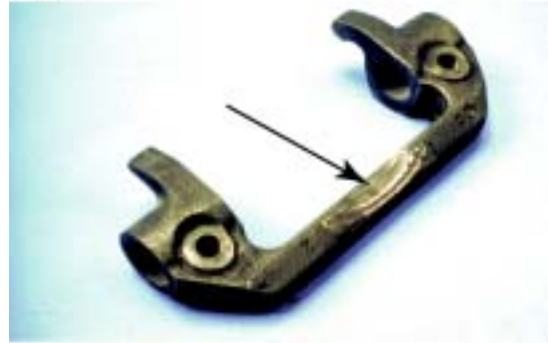
Fig 1

The arrows in Figures 1 and 2 show the areas of contact between the release yoke bridge and the clutch cover. Overstroking of the yoke, in an attempt to obtain the required 1/2" - 1" clutch brake squeeze, is a typical cause of this failure.

- Worn clutch brake
- Broken or missing clutch brake
- Worn or incorrect transmission bearing retainer cap (refer to Figure 3)
- Excessive wear on release bearing wearing pads and/or the fingers of the yoke (refer to Figure 1)
- Improper set up of the linkage system. Consult your OEM service manual
- Incorrect yoke installed

Note: The clutch cover can be reused if the above items are corrected, a new yoke is installed, and there are no broken or cracked parts on the cover. The above failure is typically preceded by a noise complaint and/or vibrating clutch pedal at the point where the clutch pedal is fully depressed. Depending upon the amount of wear (at the bearing cap and/or yoke fingers/wear pads), it may be possible to adjust the linkage to eliminate the noise complaint.

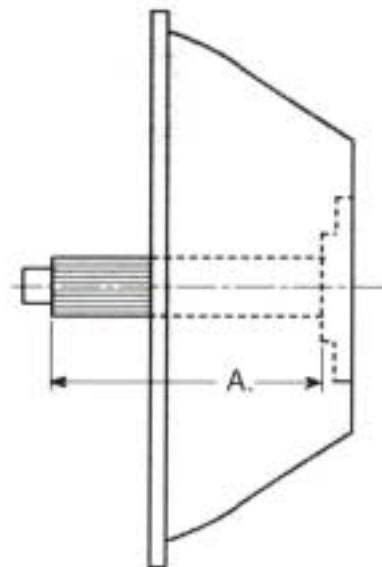
Figure 3

Dimension A, based on SAE standards, is 8.657" (219.9 mm) nominal, and should not be greater than 8.71" (221.5 mm) Ref. 1990 S.A.E. handbook 4:36.106

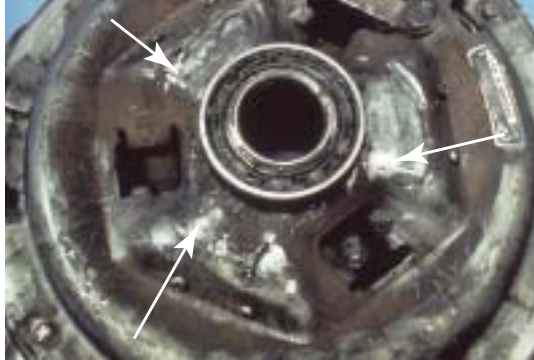
Fig 4

Figures 4 - 5 show the damage that results when the release yoke contacts the clutch cover. More specifically, the fingers have become pinched between the clutch cover and release bearing, resulting in one or more of the following:

- A broken /cracked release bearing housing (not shown)
- Damage to the clutch cover (see arrows, Figure 4)
- Wear to the backside of the yoke fingers (see arrows in Figure 5, top yoke)
- Broken yoke finger(s) (see arrow in Figure 5 bottom yoke)

- Linkage system broke, allowing the loose yoke to contact cover
- Linkage system was improperly reinstalled (example: forgetting to reinstall the cotter key, allowing the clevis pin to come out)
- Adjusting the clutch with the linkage instead of internally using the adjusting ring
- Rotating the ring the wrong direction (counterclockwise instead of clockwise) when adjusting for clutch wear

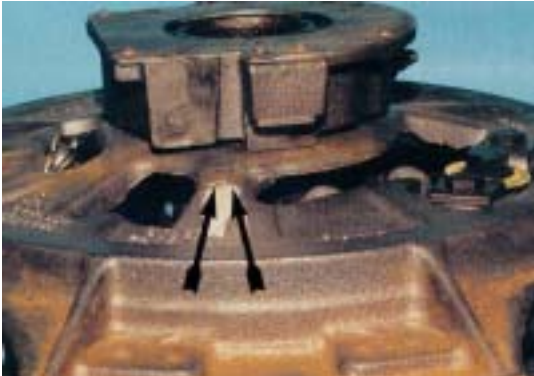
Fig 6

Referring to the arrow in Figure 6, this brand new clutch (Easy-Pedal 1402 S.D.) was damaged during transmission installation. More specifically, the release yoke "fingers" were elevated to the "straight out position" and were allowed to jam into the clutch cover. Subsequent damage might be a broken finger(s)(Figure 5) or bent release yoke / cross shafts. As a result, it is important that these parts be inspected for damage (and replaced if damaged) before installing a new clutch.

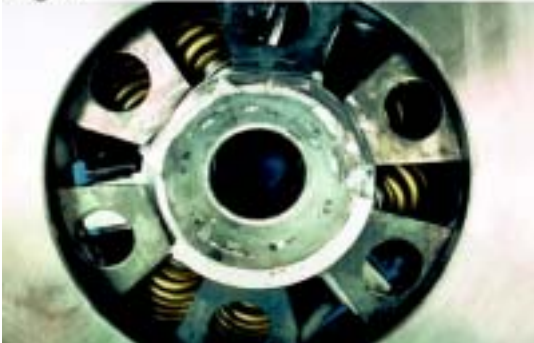
Fig 7

Figure 7 shows what can happen when the levers break through the retainer's nose. The primary cause of this failure is allowing the transmission to hang unsupported in the driven disc during transmission installation.

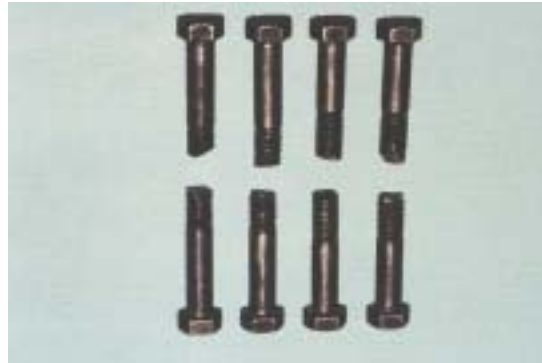
Fig 8

The broken mounting bolts, show in Figure 8, are the direct result of insufficient torquing of these (8) bolts to the flywheel. More specifically, these bolts were loose enough to allow the clutch cover to hammer back and forth against each bolt until they broke. Also, the (8) mounting bolt holes in the clutch cover were "egg-shaped" as a result of the constant hammering.

Another potential cause of the above failure would be the over-torquing of the mounting bolts. Doing so can cause the bolts to fracture and eventually separate from the flywheel. Combining this scenario with low grade mounting bolts will increase the chances of failure.

Note: Refer to the Eaton Installation Instructions (packaged with each clutch) to determine the proper mounting bolt torque, minimum grade of bolt, etc., for the specific Eaton Fuller Clutch model you are installing.

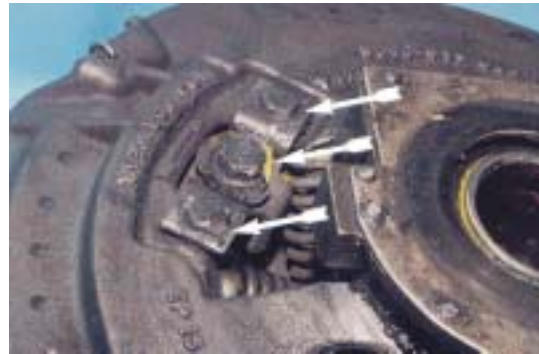
Fig 9

Additional damage occurred to both the clutch cover and the release yoke as a result of their interference with each other (refer to the arrows in Figures 9 and 10). It is worth noting that this service clutch had accumulated 50,000+ miles before it failed.

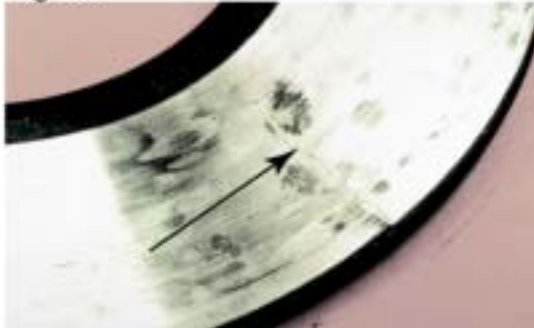
Fig 13

Figures 13 - 16 depict damaged clutch plates which resulted from an abnormal amount of clutch slippage/heat. Some causes of this abnormal slippage/excess heat can be one or more of the following:

Figure 13 is an example of a cracked pressure plate. The heat flow was so great that the metal could not dissipate it quickly enough.

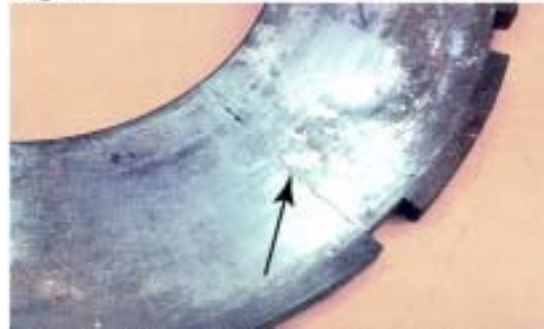
Fig 14

Figure 14 shows a broken intermediate plate. As in the previous example, the heat flow was so intense that the metal could not disperse the heat quickly enough.

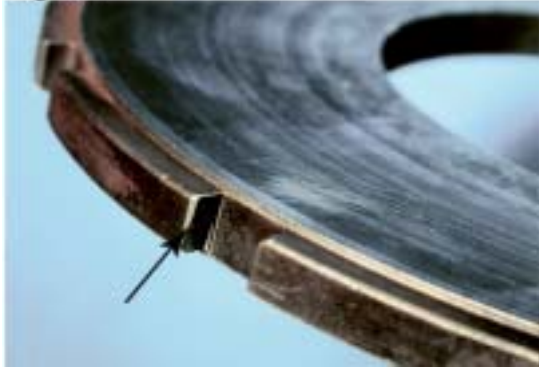
Fig 18

The groove worn in the face of the drive pin slots are on the upper section of the face on one side of the slot (see arrow in Figure 18) and on the lower section on the opposite side of the slot. This indicates that the drive pins were cocked and causing the intermediate plate to hang-up. This will cause release problems and therefore hard shifting. Do not file the slots of the intermediate plate to correct the problem. Instead, you must reset the drive pin(s) until they are square to the flywheel.

Note: Always install new Eaton drive pins when installing a new Eaton Fuller 14" Heavy Duty Clutch. This is important because worn drive pins (against the new intermediate plate slots) can prevent the clutch from releasing cleanly. Also, ensure that the drive pins are set squarely to the flywheel's friction surface (refer to the Eaton Installation Instructions packaged with each Eaton Fuller Clutch). Failure to set each drive pin squarely is the most prevalent reason for a "poor release complaint" on a recently installed clutch (Angle Spring and Easy-Pedal Plus 1402).

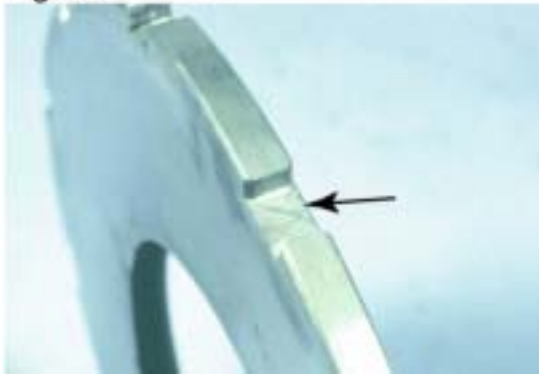
Fig 19

As indicated by the shiny areas on the drive slots, (see arrow Figure 19) the slots of this intermediate plate were hand filed. Eaton does not recommend this practice since it can cause unequal loading on the drive pins in the flywheel. Instead, Eaton recommends that the drive pins be checked for squareness to the flywheel friction surface and reset if necessary (see Eaton Installation Instructions).

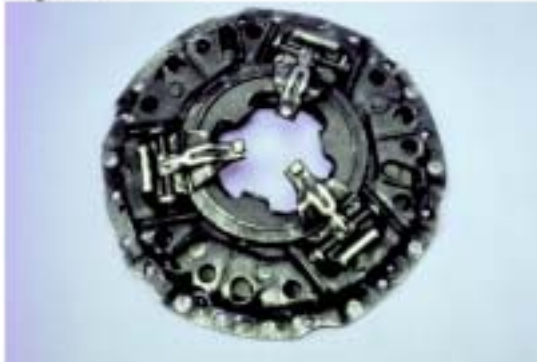
Fig 30

A leaking transmission or a leaky rear main engine seal can coat the clutch cover with oil, as indicated in Figure 30. Figure 41 shows the disc which was run with this cover.

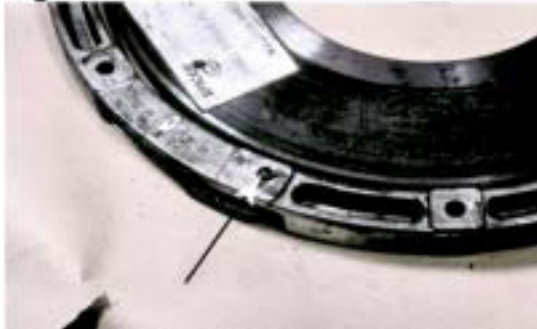
Fig 31

The separator pin shown in Figure 31 became damaged (bent) when it was dropped during clutch installation. To prevent this from occurring, Eaton recommends the use of two (2) guide studs when mounting the intermediate plate and clutch cover to the flywheel (refer to the Eaton Installation Instructions).

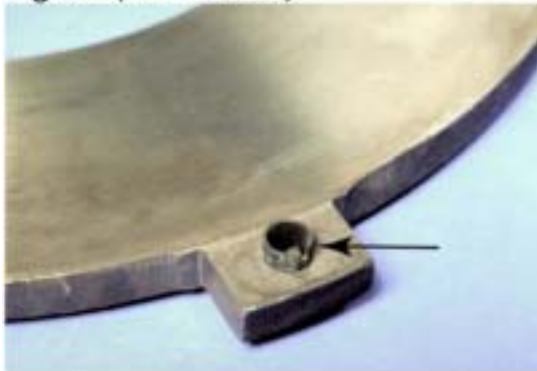
Fig 32 (EPP 15.5")

The damage done to the separator pins in Figures 32 and 33 (see arrows) is the result of using the wrong tool combined with excessive force. All four pins (on each intermediate plate) were damaged. When "setting" the four (4) roll pins, the proper tool would be a 1/4" flat nose punch used in conjunction with a small hammer (to help ensure light taps).

A damaged pin(s) can prevent the intermediate plate from retracting evenly when the clutch is disengaged, leading to a "poor release" complaint from the driver. The same complaint can also occur if the mechanic forgets to "set" the four (4) positive separator pins upon installation of the clutch. In you forgot to set the separator pins before installing the transmission, you can still set them through the inspection opening of the transmission.

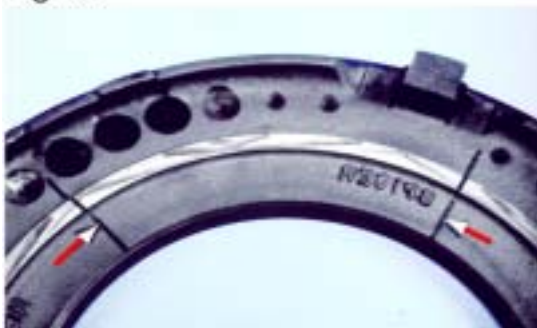
Fig 39

Figure 39 shows the back of the pressure plate. This clutch has been properly adjusted (internally, using the adjusting ring) because each of the 6 levers has more than one witness mark (or lever fulcrum point).

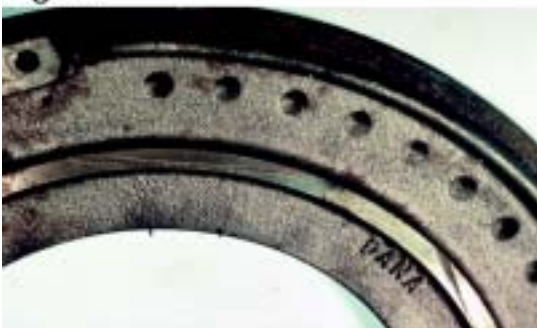
Fig 40

Figure 40 depicts a clutch that has not been adjusted properly. As shown, there is only one witness mark per lever indicating that the clutch was improperly adjusted using the linkage.

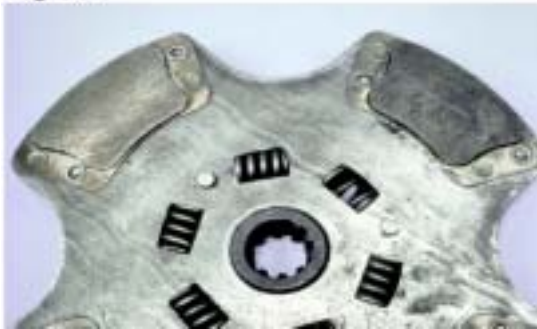
Fig 43

Figure 43 shows a disc with grease on its buttons, flywheel side. When this disc was removed from the truck, all four buttons had a heavy layer of grease on them. The left button has been cleaned to show the contrast with the grease-covered button on the right. Failing to remove the grease (rust preventative) from the flywheel (new or resurfaced) can cause this problem.

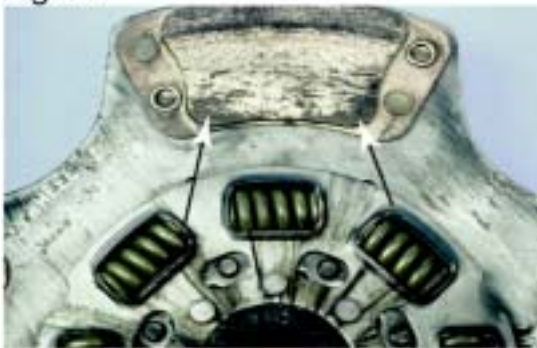
Fig 44

Greasing the splined areas of either the input shaft or disc hub(s) is not recommended because the grease can be spun onto the facing material of the driven disc(s) (refer to both arrows in Figure 44). The circled area in Figure 45 reveals the numerous paths which the grease took as it moved toward the buttons (facing material) of this ceramic driven disc. The photographs in Figures 44-45 are of the same driven disc.

Note: Eaton does not recommend the reinstallation of driven discs which have become contaminated with grease or oil.

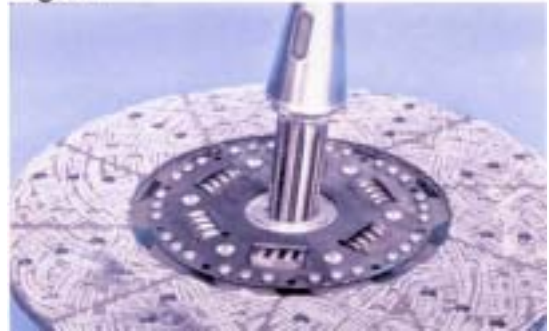
Fig 47

Shown in Figure 47 is a brand new driven disc which was warped during transmission installation (as indicated by the dummy input shaft which is not perpendicular to the disc's hub). More specifically, the transmission was allowed to hang unsupported in the driven disc hub. A driven disc which has become bent due to improper installation techniques should not be reused because of the potential for a "poor release" complaint.

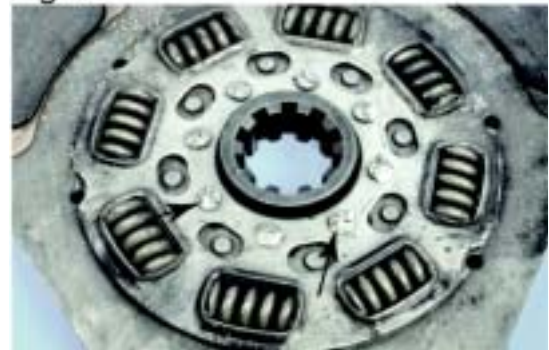
Fig 48

- The rivets of the disc (Figure 48) have been contacting the flywheel's mounting bolts. Some potential causes of this particular interference are as follows:
 - a. Loose flywheel mounting bolt(s) due to inadequate torquing.
 - b. Forgetting to tighten one or more of the mounting bolts when reinstalling the flywheel.
 - c. Installing an extra washer under the flywheel mounting bolt.
 - d. A flywheel which has been resurfaced too many times.
- The damper springs (see arrows, Figure 49 and 50) have been contacting the flywheel mounting bolts because the front driven disc was installed backwards. The driven disc (in Figure 49) had been wearing for a period of time before the interference occurred (as indicated by the full wear pattern on the ceramic buttons) while the one in Figure 50 was run for a very short period.

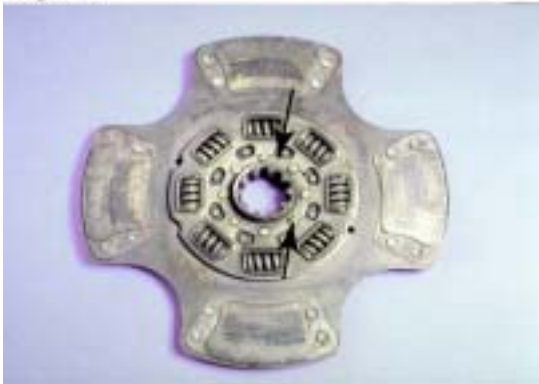
Fig 51

- A disintegrating pilot bearing which is interfering with both the hub and rivets of the driven disc (Figure 51).

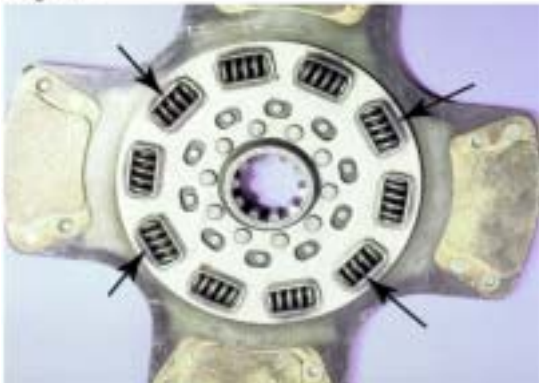
Fig 52

- Installation of the wrong clutch. Figure 52 (see arrows) shows the points of interference that resulted when a 10-spring driven disc was installed where an 8-spring was previously being run. In other words, the recessed area of the flywheel (mounting bolt cavity) was too small for the 10-spring driven disc. Before you mount the new clutch, consult the Eaton Installation Instructions (packaged with each Eaton Fuller Clutch) concerning "potential damper interference". A driver complaint, resulting from the above failure, can be:
 - a. The clutch does not release
 - b. The clutch is noisy during operation

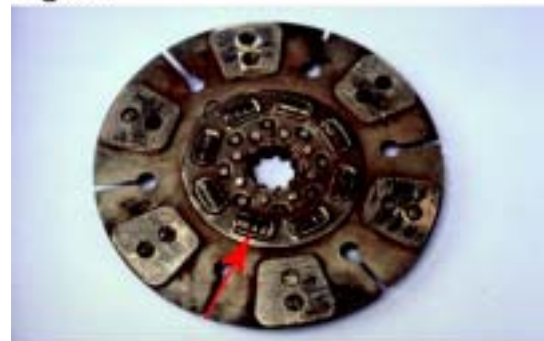
Fig 63

Figure 63 is the disc of a non-Eaton rebuilt clutch. It is an old disc that was rebuilt, as indicated by the presence of dampener springs encased in rubber (see arrow). Consequently, the rubber covered springs can make the disc act as a rigid disc, thus increasing wear to the input shaft and the disc itself. As shown by an arrow in Figure 64, parts of this disc have broken. Also, the springs are wrapped in rubber to prevent any worn ones from falling out after the disc is put into service. Contrast this with the Eaton Fuller Reman Clutches in which only new discs are used.

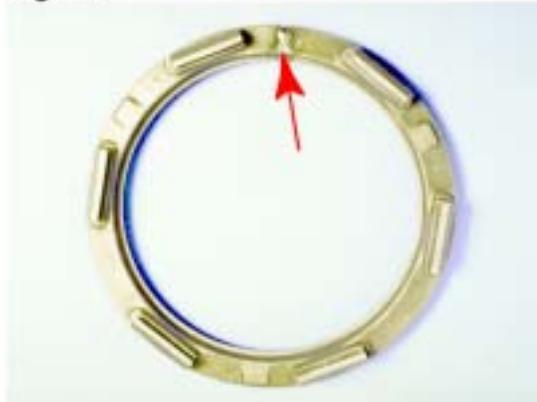
Fig 65

Note also the adjusting ring pictured in Figure 65. It was removed from a non-Eaton rebuilt clutch. This ring was cut open on one side, spread apart, and then welded (see arrow) at a larger diameter to prevent the adjusting ring from becoming loose once it was reinstalled. (Eaton Clutch does not weld adjusting rings, but rather discards any rings that are too loose.)

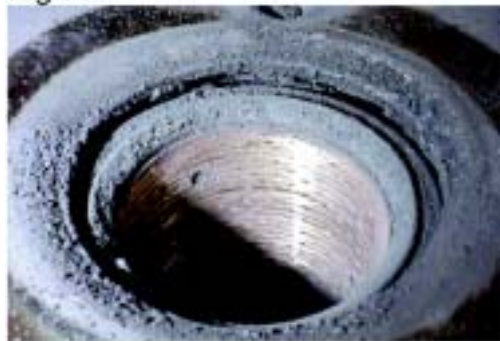
Fig 77

As shown in Figures 77 and 78, incorrect lube or not enough lube can cause a failure. External contamination will also cause wear to the bushing. The transmission input shaft may be rough and require replacement. Use approved/compatible lube. (High quality N.L.G.I #2 or #3 lithium soap grease with E.P. additives 325 degree operating temperature). Apply ample lube and let it flow out of the opening from the bearing housing. Apply additional lube onto the transmission shaft to ensure the bushing will have proper lube. Apply lube to the tips of the release yoke.
