KMP BRAND TECHNICAL BULLETIN

Valve Failures

KB-15004

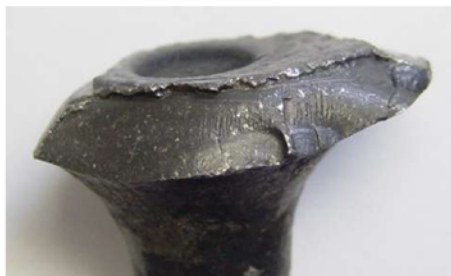
Head breakage can result when the valve head temperature rises above 650°C as this can allow cracks to develop in the areas of stress concentration

These cracks are referred to as chordal fractures and they originate in the lower portion of the underhead radius where they gradually progress through the valve head until a piece/pieces of the head become detached as a result of fatigue which is characterised by the presence of beachmarks across the fracture face. Some possible causes of the high temperatures are, abnormal combustion, inlet air restrictions, high inlet air temperatures or exhaust restrictions. A chordal fracture can also result from misalignment or from impact damage.

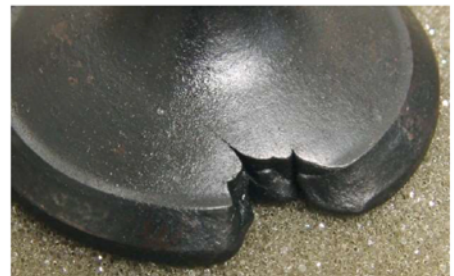
Valve face burning

This type of damage can be referred to as channeling, guttering or torching and results from the leakage of burning combustion gases passing between the valve face and valve seat.

The leakage results in elevated temperatures which exceed the melting point of the valve and seat and erosion of the material takes place.

The poor seating of the valve can result from a number of causes, carbon buildup, misaligned or worn valve guide, cracked valve seat or valve, incorrect lash setting, or insufficient stem to guide clearance.

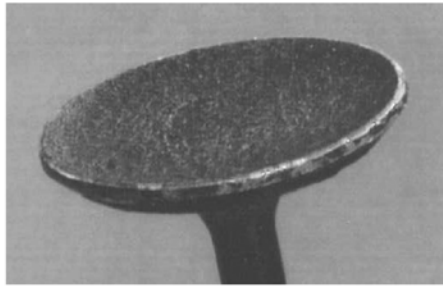
Distortion

The valve head is distorted in a manner referred to as cupping or tuliping and results from very high combustion temperatures and pressures.

Some of the possible causes for this type of failure are, a combustion irregularity, excessive valve spring pressure or a cooling system malfunction.

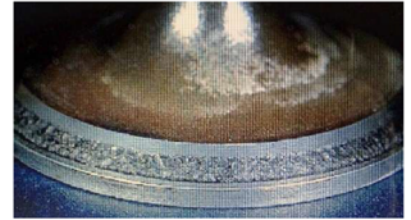
Erosion

Valve face wear as the result of erosion can normally be attributed to carbon particles which are trapped between the seating faces of the valve and seat; the carbon accumulation could have originated from worn or broken piston rings, worn valve guides or damaged/missing valve stem seals.

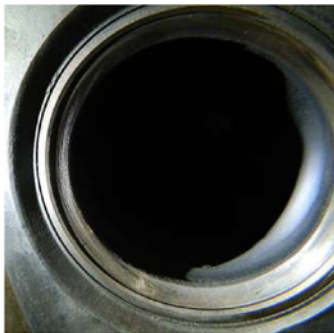
Seat recession

Valve seat recession is another form of wear because when the valve is closing there is a combination of impact and sliding and these result in valve seat wear. As the wear progresses the valve recedes deeper into the insert and this results in the loss of the lash setting and incorrect valve seating.

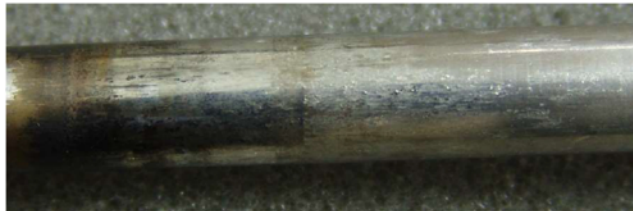
Valve stem seizure

Seizure or scuffing occurs when there is insufficient lubrication which could have originated because there was a lack of clearance between the stem and guide, overheating had resulted in thermal expansion, carbon buildup on the underhead and valve neck, abrasive contamination bridging the oil film or a bent valve stem.

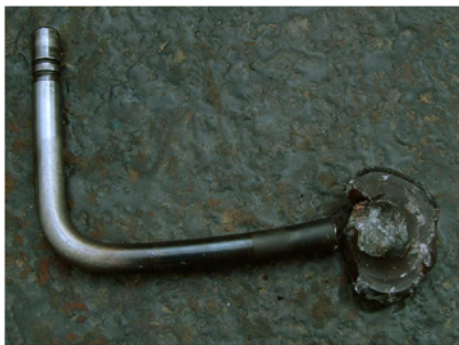
Failure 1

The customer removed and returned the complete cylinder head because it had "dropped" a valve. Initial inspection indicated abnormal wear on the tip of the valve stem and in the cotter grooves and it was concluded that valve geometry was the primary cause of the failure because it had resulted in the valve stem thrusting against the bore of the valve guide causing the seizure that was evidenced on the stem. Piston crown and valve head contact would explain the damage to the cotter grooves and also the eventual separation of the valve head from the stem.

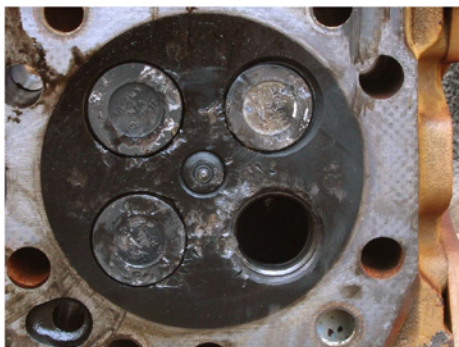
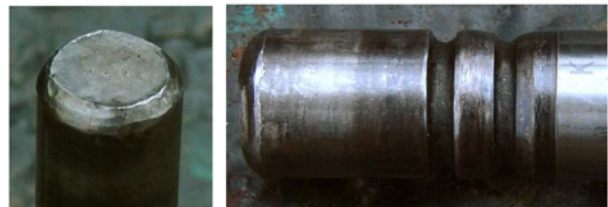
After the initial report, and rejection of the claim, an opportunity arose to inspect **all** the components of the engine. This inspection confirmed the reason for the failure, *the failure was directly attributed to the abnormalities that were present with the valve operating mechanism.*

The valve had definitely contacted the piston crown as arrowed in the photograph.

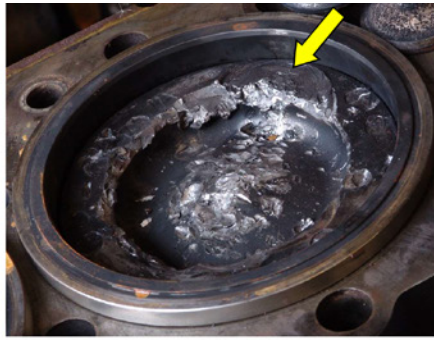
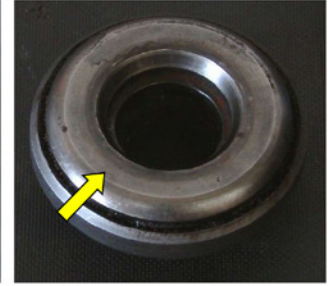
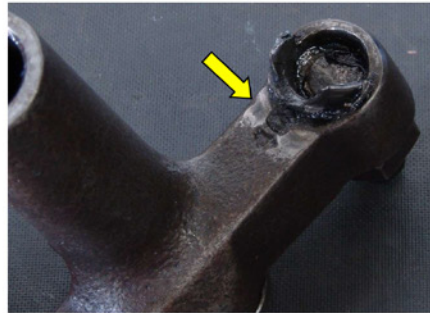
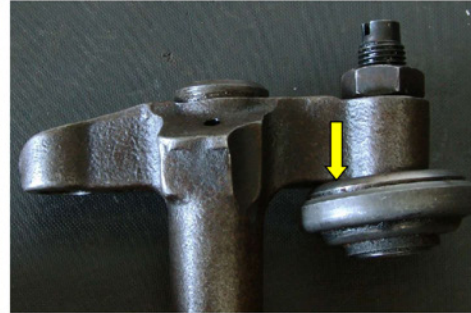
The valve bridge had a cotter lodged into the recess, the arrow indicates an abnormal contact pattern on the rotator, the underside of the bridge has a corresponding contact pattern.

When the wear patterns were aligned the valve operating mechanism abnormalities were confirmed.

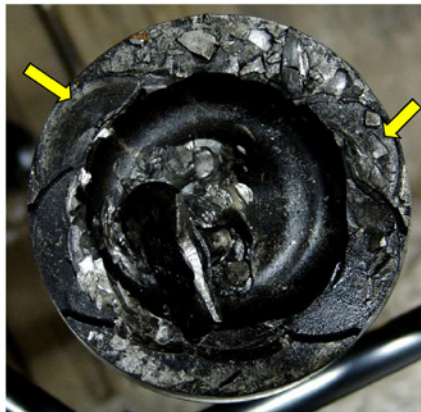
Failure 2

The customer complained of an inlet valve failure, the head of the valve was embedded into the piston crown.

The two yellow arrows indicate where the valve heads were making contact with the piston crown prior to the failure.

It was evident from these two indentations that the piston had been installed 180° out of position, which meant that the valve pockets in the piston crown were not aligned with the valve heads.

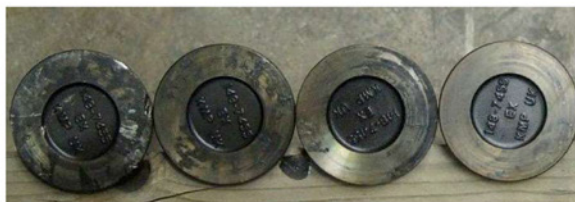
From the appearance of the remaining seven valves it was evident that the crowns of the other three pistons would also show signs of contact with the valve heads.

As a consequence it was strongly recommended that all the valves be replaced as a precautionary measure.
