# KOHLERENgines

# Failure Analysis Guidebook

# **Failure Analysis**

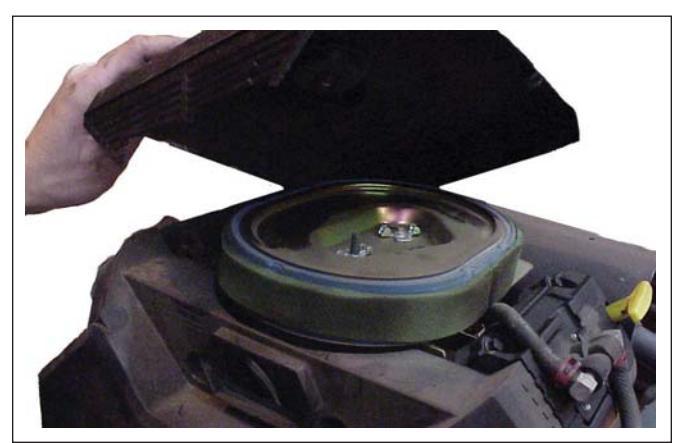
Figure 2.

**Figure 2** – Make a thorough examination of the air cleaner. Remove the outer air cleaner cover and check it for damage or signs of impact.

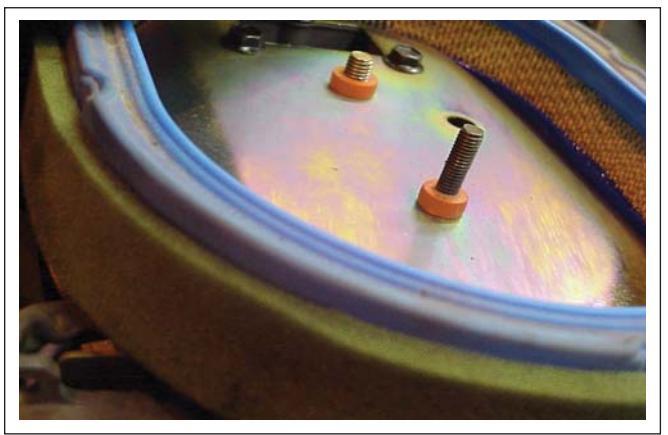
Figure 5.

**Figure 5** – Remove the element cover, if separate otherwise remove the whole element. If there was no rubber sleeve on the outer portion of the stud, you should find one on the inner portion. Check its condition and look for an imprint or mark on the underside of the element cover to indicate that it was making contact and sealing.

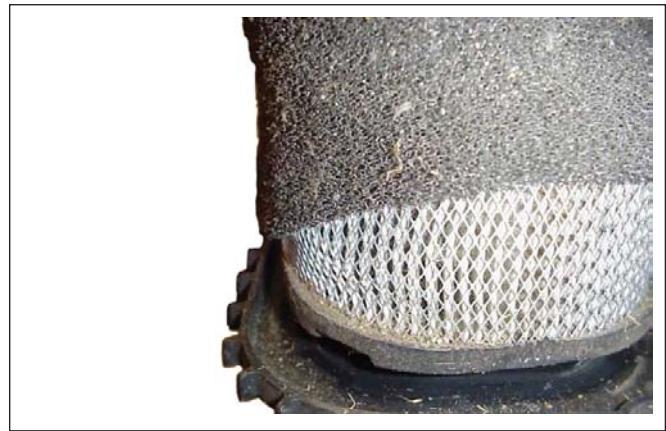
Figure 6.

**Figure 6** – Is the air cleaner element dirty, plugged, or damaged? Is it a genuine factory part?

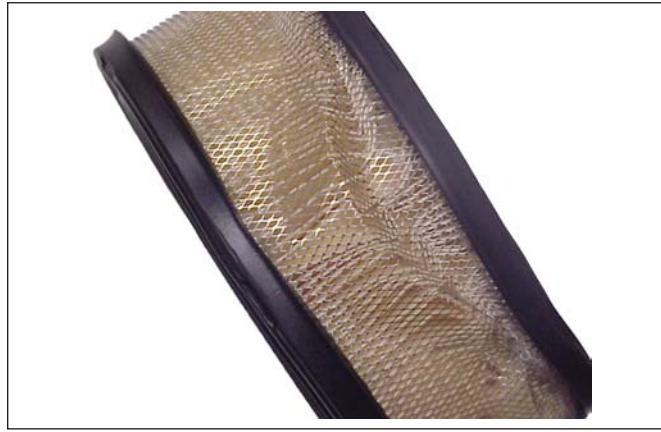
Figure 7.

**Figure 7** – Take a close look at the element sealing surfaces. Are there any dirt tracks across the sealing surface indicating leakage? Have the reinforcing wires punctured the rubber seal? If so, it indicates that the cover was overtightened. Protruding wires could allow leakage. This air cleaner element is obviously damaged. Note the crushed wire mesh. This is an example of an element that can not properly seal out dirt and debris. The lesson here is to check the sealing area of the paper element and the wire mesh for signs of damage due to over tightening, damage or abuse.

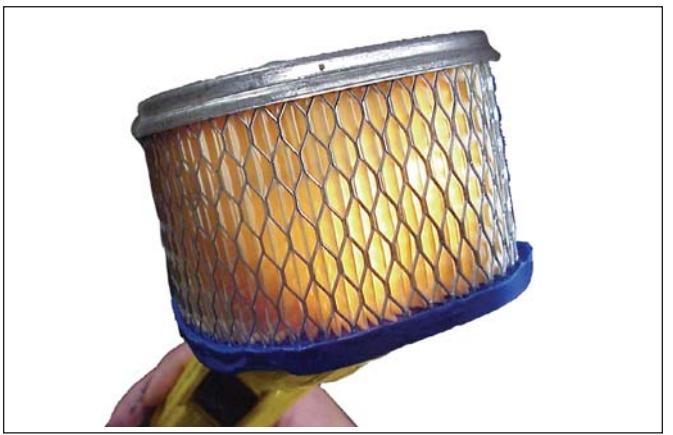
Figure 8.

**Figure 8** – Check the element with a light for punctures in the paper filtering material. If you cannot see any light at the base of the creases, the filter should be replaced.

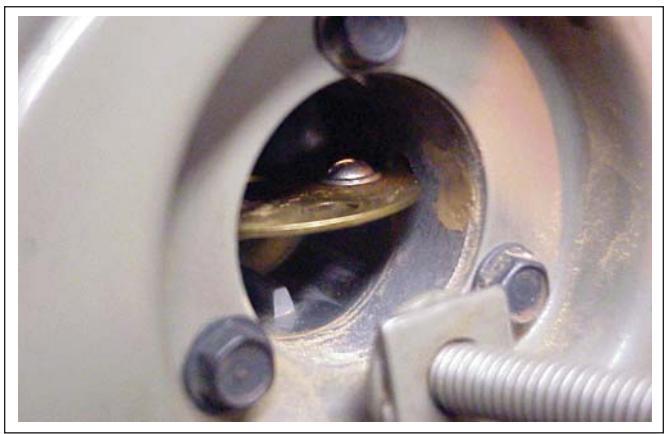
Figure 9.

**Figure 9** – Check the inner portion of the air cleaner base plate and the carburetor throat for signs of dust or dirt. If any traces are found, recheck all of the air cleaner components to determine the source of dirt entry. Perhaps the breather hose was pulled loose from the base plate, allowing dirty entry through the hole.

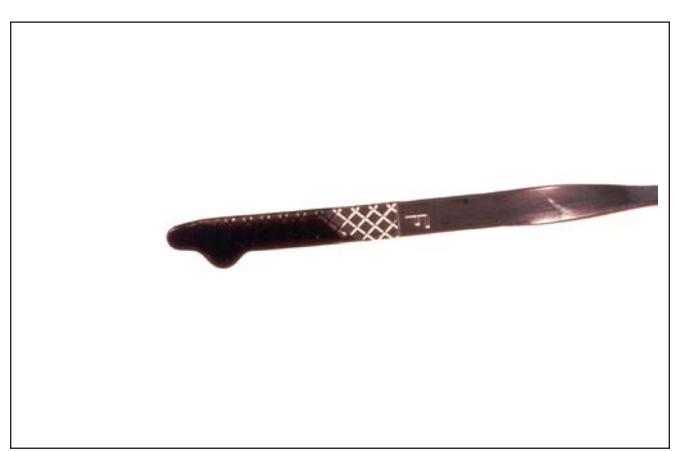
#### Figure 10.

**Figure 10** – Pull the dipstick and check the oil. Look at the level of oil, but also note the color and consistency of the oil. Is it fresh, clean oil that was added after a failure? Or, perhaps, it's so thick and dirty it won't drip off the stick because it hasn't been changed in 150 or 200 hours. When you drain the oil, measure the amount that you drain out and examine it closely. Notice again the color and consistency. Does it have an abnormal smell? Do you see any metal chips or wear particles? Do you notice any sludge? If the engine has an oil filter, notice whether is a genuine factory part.

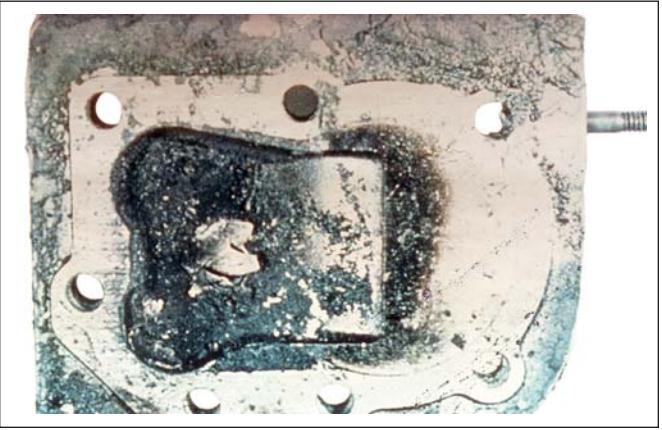
Figure 19.

**Figure 19** – After removal of the spark plug(s) and cylinder head(s), check the combustion deposits, as they are often a good indicator of operating conditions. This head has heavy black oil or gummy-looking deposits, indicating that the engine was burning oil, usually from internal wear. This particular engine had so much oil entering the combustion chamber that it was starting to flush out the combustion deposits. And the head hadn't been cleaned for so long that the deposits completely cover the tip of the spark plug.

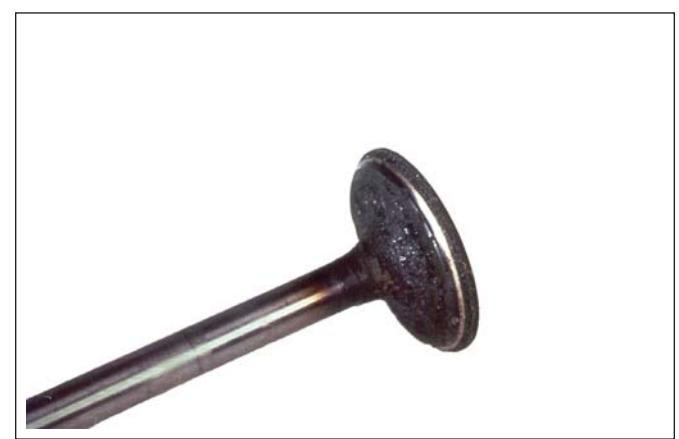
Figure 24.

**Figure 24** – This intake valve was removed from an engine in good operating condition. Notice the bright, uniform sealing ring around the face. The coke deposits on the underside of the head and upper stem are normal for an engine with some running time on it.

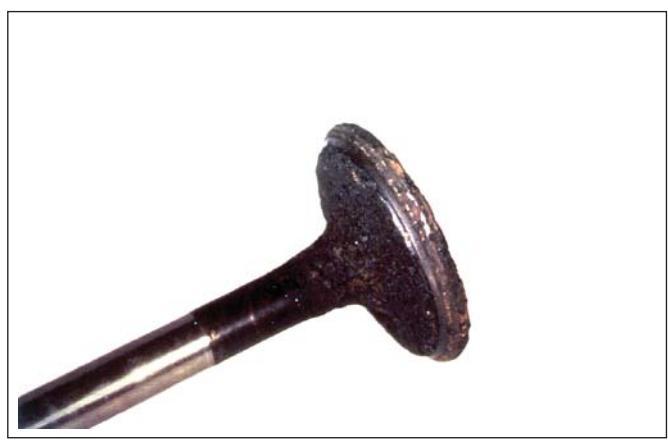
Figure 25.

**Figure 25** – This engine was also in satisfactory running condition. However, you will notice that the "coking" is significantly worse. Possible contributing factors are: prolonged periods of idling, continuous duty at light load, "lugging" the engine during operation, running with a restricted air cleaner, or valve stem and guide wear.

The deposits are not yet interfering with normal operation, but they could if allowed to accumulate much more.

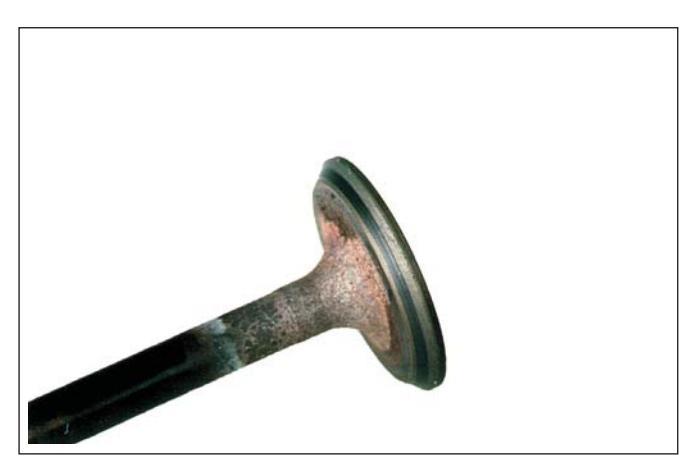
**Figure 26** – This is an exhaust valve from an engine in good operating condition. Again, note a good sealing ring on the face. Relatively light, brownish deposits indicate good operating conditions. An engine running under proper conditions will usually have light brown, brown, or gray deposits.

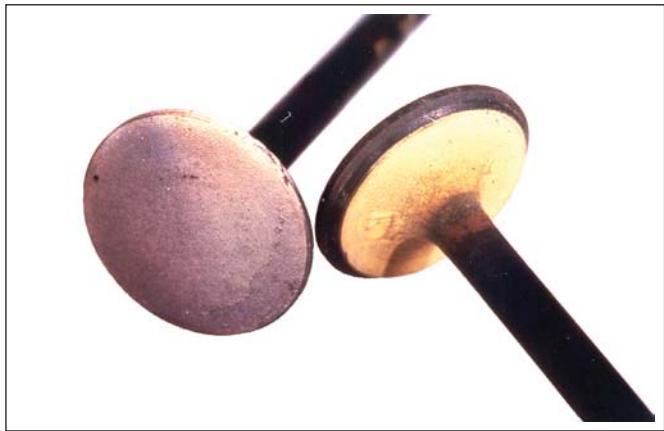
Figure 27.

**Figure 27** – The white deposits, seen here, indicate very high combustion temperatures, usually due to a lean fuel mixture. The engine had only run for a short time, so the faces have not yet started to burn, but you will note that the sealing ring has already started to deteriorate.

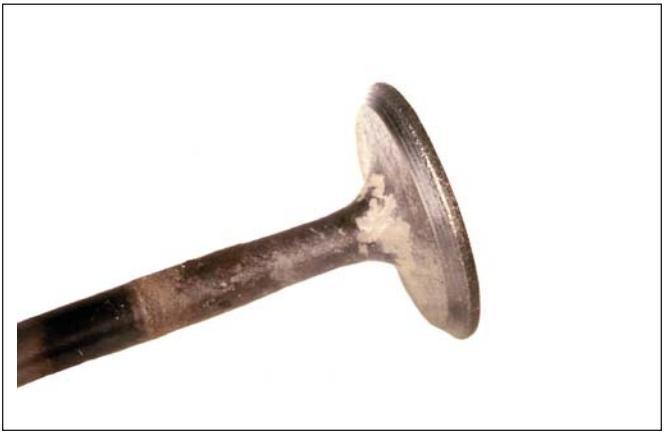
Figure 28.

**Figure 28** – Continued operation with high combustion temperatures will result in more severe burning and deterioration of the valve face.

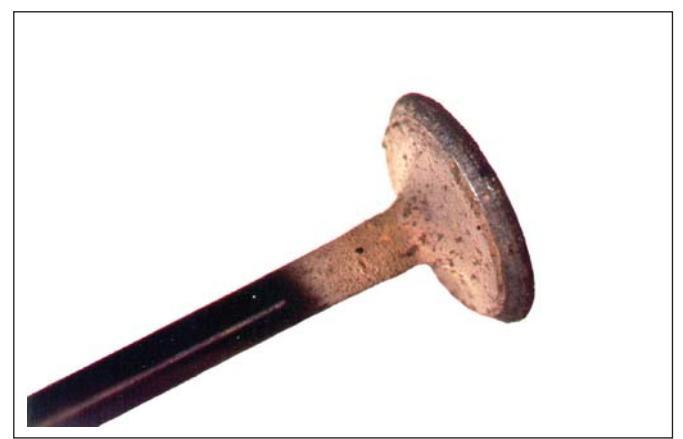
Figure 29.

**Figure 29** – Valve burning will also occur if there are conditions present which prevent the valve from closing or sealing properly. Here we see deposit accumulation around the entire circumference of the face. This would normally indicate that the valve was not closing completely. Perhaps the tappet clearance was incorrectly set, or combustion deposits may have flaked loose in the head and lodged between the valve and seat. Because the valve is not sealing, it will start to burn with continued operation.

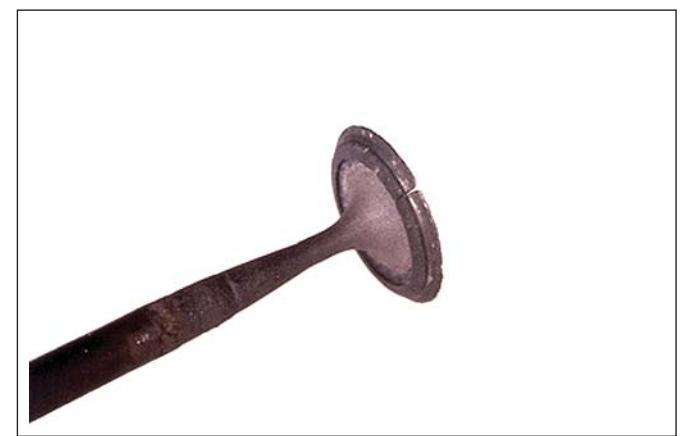
**Figure 30** – When the exhaust valve is burned, or not sealing, the fuel burn is no longer contained within the combustion chamber. Each time the engine fires, a burst of flame passes the valve. As the face continues to burn and deteriorate, the combustion leakage begins to act like a torch. The valve material on the underside of the head and neck begins to burn away, a condition referred to as valve erosion.

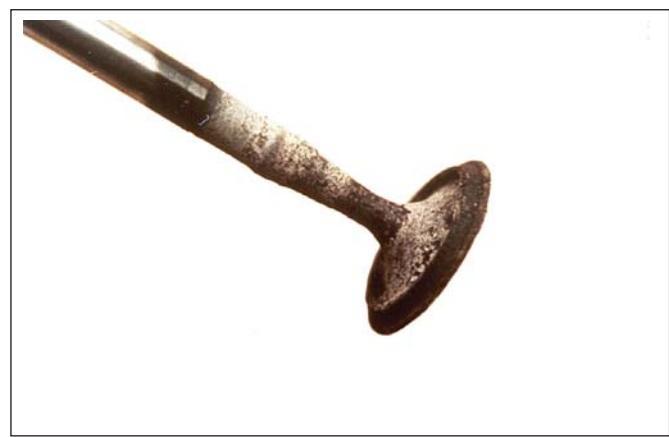
Figure 31.

**Figure 31** – If the initial valve burning was due to extreme combustion temperatures (lean mixture, etc.), the blistered white deposits may also show up in the area of erosion.

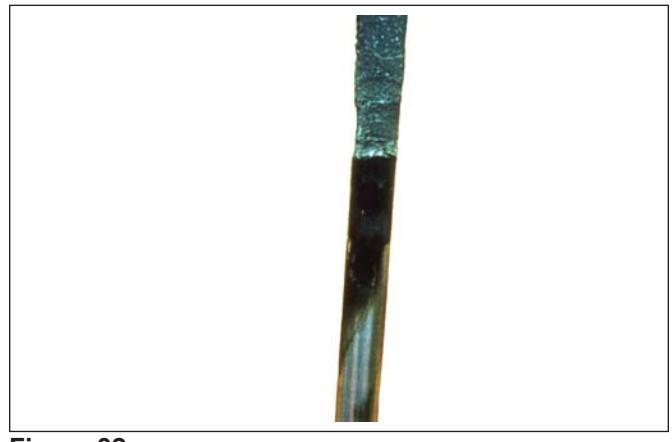
#### Figure 32.

**Figure 32** – Another, fairly common valve-related problem is valve sticking. It is usually caused by an accumulation of burned oil deposits on the valve stem and in the guide.

The customer will usually complain that the engine runs anywhere from 15 to 90 minutes, then loses power or "pops" out the exhaust and stalls. It normally will not restart until the engine cools for 10-15 minutes and a metallic snap is heard. The burned oil deposits normally responsible for valve sticking are due to elevated temperatures in the valve guide area. The problem will usually show up during hot weather, especially on an engine that doesn't get adequate maintenance.

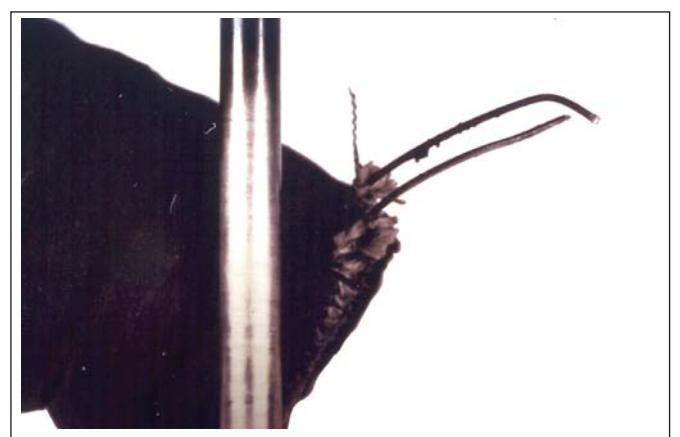
Figure 35.

**Figure 35** – In this example, the dirt entry was due to a leaking remote air filtration system. Again notice the "buffed" appearance of the valve stem.

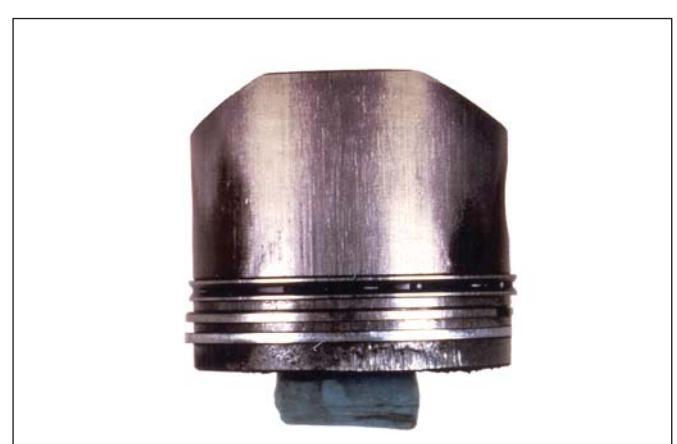
#### Figure 38.

**Figure 38** – Excessive wear can often be detected visually, even before any measurements are taken. From normal operation, the wear pattern on the thrust face of a piston will cover about 20-40% of the face. If it cover 50% or more, with visible vertical scratches, you know there has been contamination between the piston and cylinder wall causing excessive wear.

The erosion at the very top edge of the piston is also due to the wear. As the rings wear, oil consumption increases resulting in more combustion deposits, and a carbon ridge forms at the top of the cylinder. In the area near the exhaust valve, the carbon becomes very hard and abrasive from the exhaust temperatures. When the piston repeatedly hits those hard deposits, the material is gradually eaten away. The newer Mahle pistons, used in most Kohler engines today, have the top land machined to a smaller diameter to allow more clearance and help prevent this type of damage.

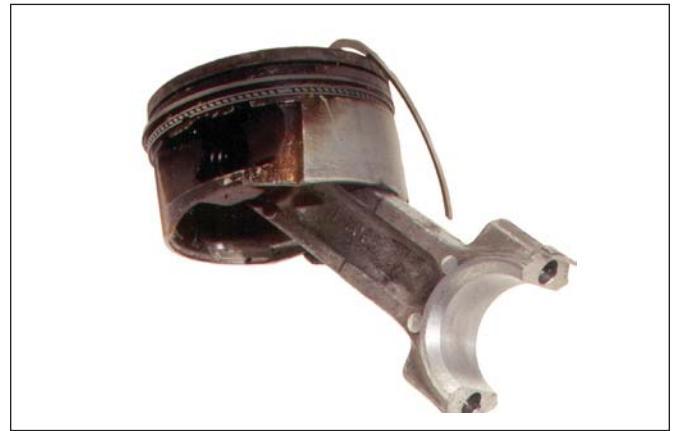
Figure 40.

**Figure 40** – If the engine is running hot (blocked screen or fins) and ingesting dirt at the same time, the wear will occur even more rapidly. This Command engine was completely worn out after just 125 hours of operation. The oil ring rails are so badly worn that the expander was rubbing the cylinder walls.

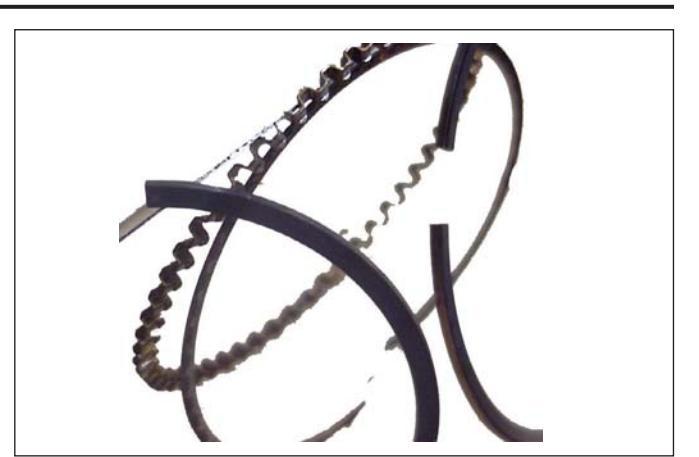
Figure 41.

**Figure 41** – On the other hand, heavy ring wear, with little or no bore wear, indicates that high operating temperatures were present, but little or no dirt.

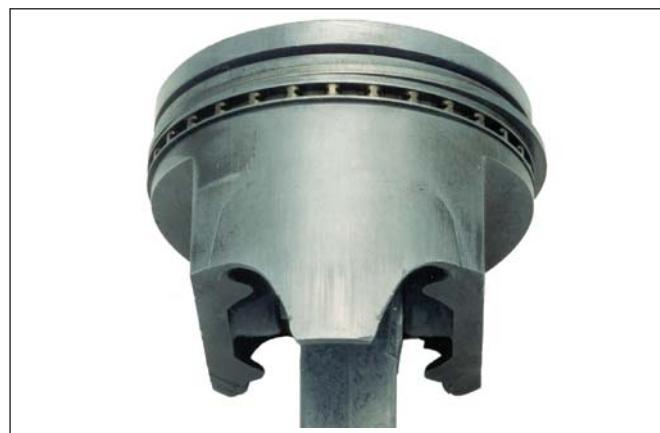
Figure 43.

**Figure 43** – With continued operation, the cracks will progress across the thrust face and/or up toward the oil ring groove.

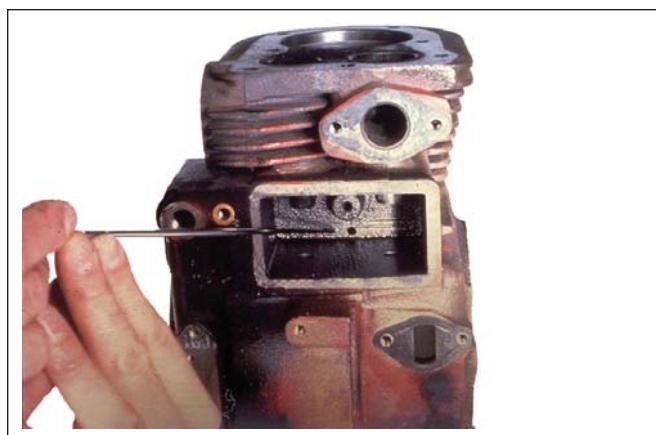
Figure 48.

**Figure 48** – On a single cylinder block, also be certain to clean and flush out the oil drain hole which goes from the valve chamber into the cylinder.

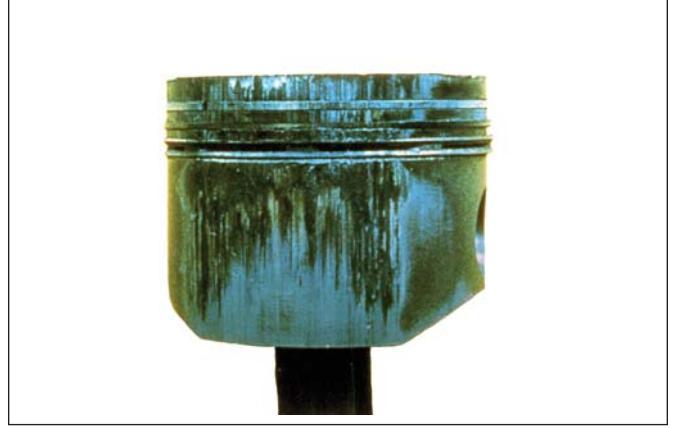
Figure 49.

**Figure 49** – Piston seizure is also visually obvious, but it can be a little more difficult to analyze. There are a number of possible causes, but the appearance doesn't vary much from one to another. Possible causes include overheating from insufficient cooling air, lack of lubrication, insufficient running clearance, oil additives, and contamination or foreign material in the engine. This is one instance where your preliminary examination may be very helpful. Did you find dirty, thick oxidized oil in the engine? Was the cooling system restricted?

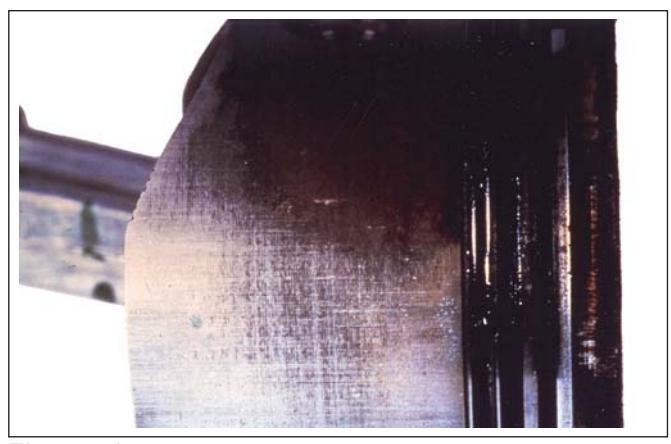
Figure 50.

**Figure 50** – The scoring on a seized piston is sometimes just on the primary thrust face. Look at the opposite thrust face and the sides for other possible indicators.

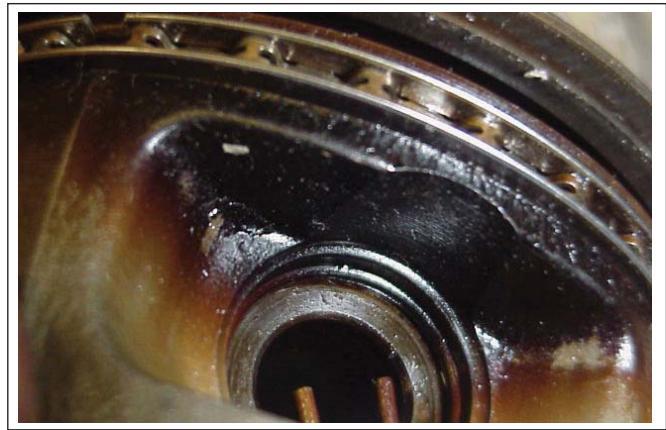
Figure 51.

**Figure 51** – This piston shows evidence of overheating. Notice the dark brown deposits as well as the blackened area near the wrist pin. This is severely overheated oil starting to bake. Your next challenge would be to see what is causing this condition.

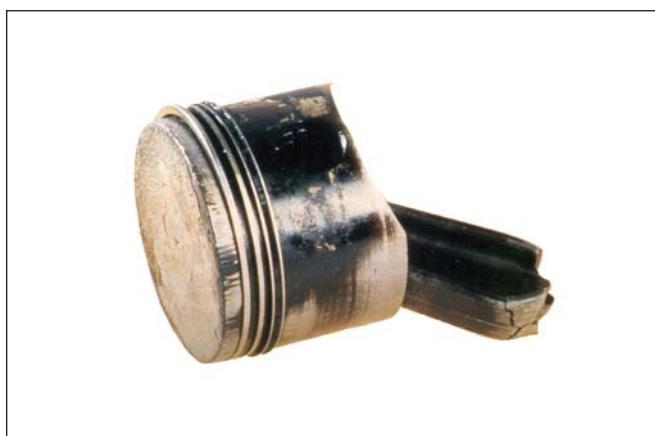
Figure 52.

**Figure 52** – This engine had high combustion temperatures and restricted cooling, resulting in very black, scorched deposits.

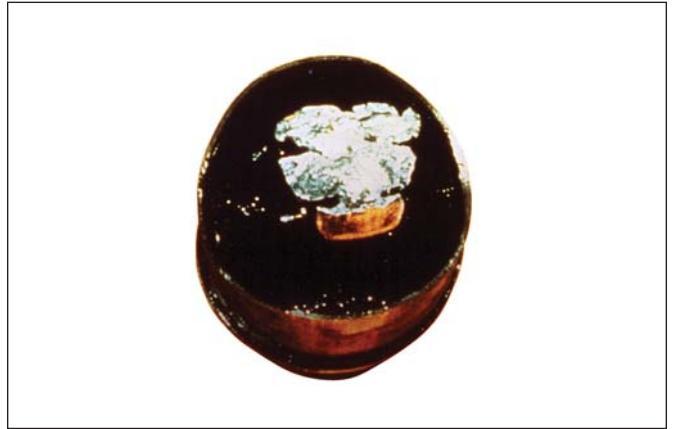
Figure 53.

**Figure 53** – Severe oxidation or use of an oil additive can cause a complete breakdown of the oil. The deposits will appear to be a cross between axle grease and tar.

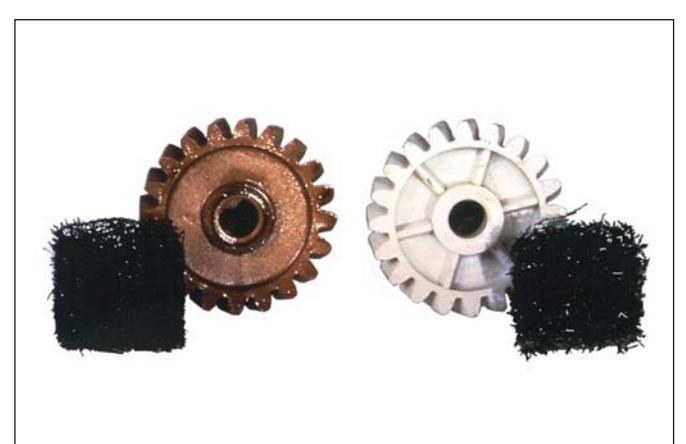
Figure 54.

**Figure 54** – If the piston has signs of overheating and/ or oxidized oil, look at the governor gear and breather filter for further confirmation. The governor gear takes on a dark orange or rust color when exposed to overheated oil. The breather filter will also be discolored with burned oil deposits. In severe cases it may be so brittle that it crumbles.

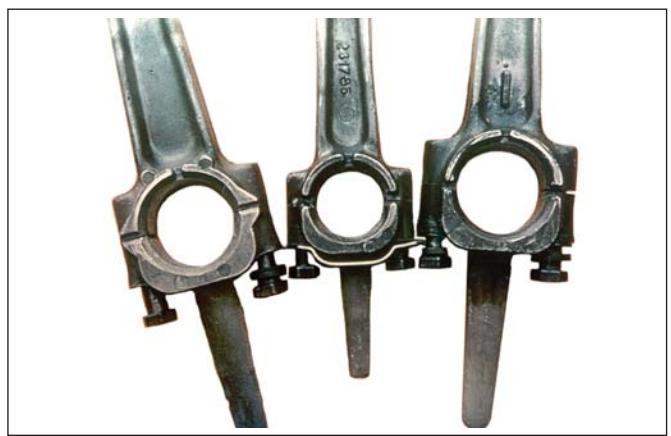
Figure 57.

**Figure 57** – All of these rods failed by seizing onto the crankpin. While there are many similarities, if you look closely, there are also some subtle differences.

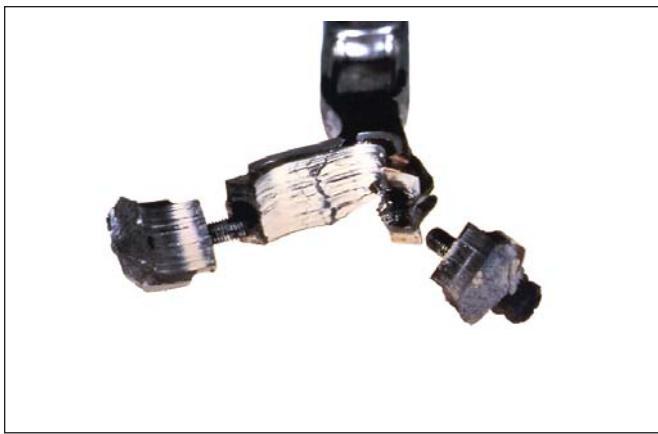
Figure 68.

**Figure 68** – The aluminum in a forged connecting rod appears brighter than a die cast rod. This is a forged rod that failed from running without oil. The smeared aluminum is very bright with no burned oil deposits. Because a forging is stronger than a die casting, you may also notice some unusual twisting or distortion.

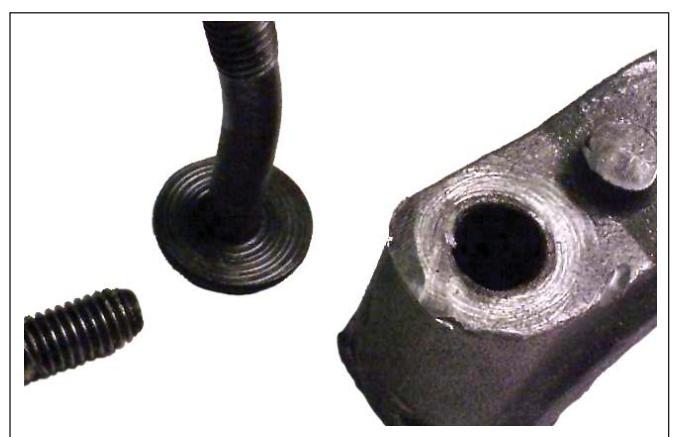
Figure 80.

**Figure 80** – This is a shot of the rod you saw in Figure 79. Again notice the way the bolt is elongated and how there is no sign of heat or burned oil.

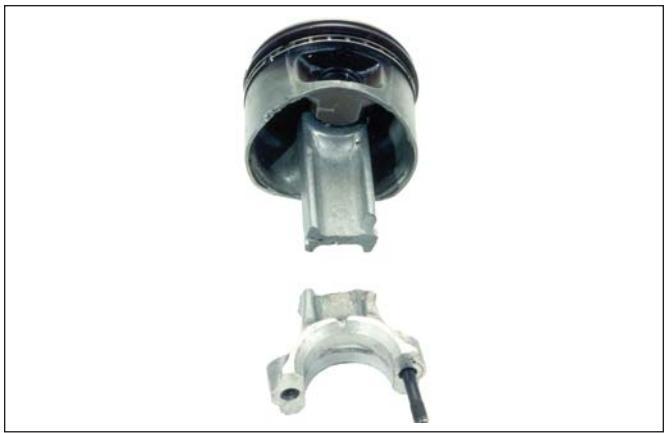
Figure 85.

**Figure 85** – This rod broke toward the bottom. Notice the slight smear of aluminum and blackened oil. The piston shows signs of overheating. This could have been caused by an improper honing/oversize procedure, where the piston to bore clearance was too tight, causing the stress and failure of the connecting rod. Notice that the rod bolt is sheared.
