KMP BRAND TECHNICAL BULLETIN

Gasket Kit Failures

KB-15007

This bulletin will address the types of failures and the possible causes that can occur with cylinder head gaskets.

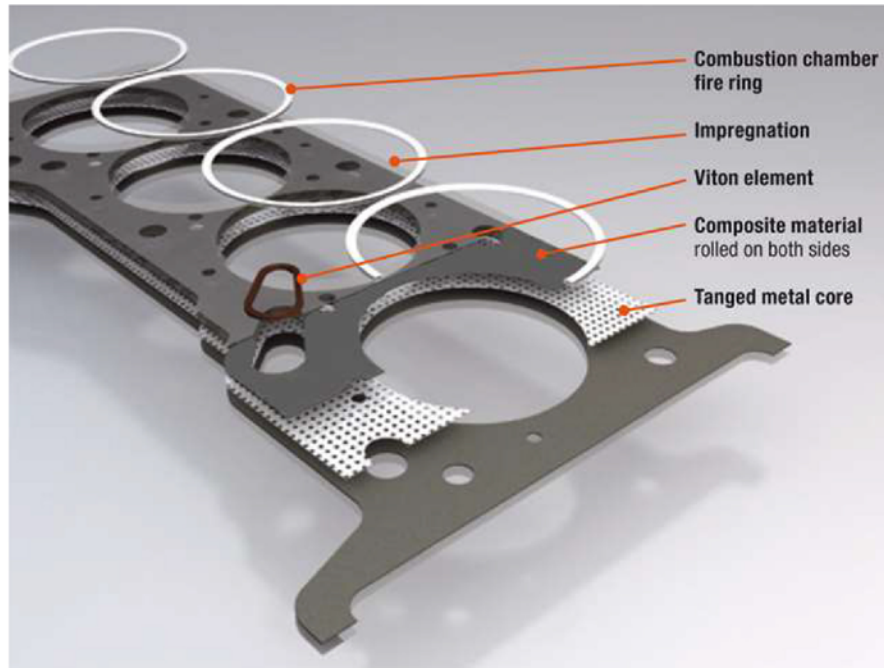
The head gasket seals the engine's combustion gases as well as the coolant and oil passages between the cylinder head and the block.

COMPOSITE HEAD GASKET CONSTRUCTION

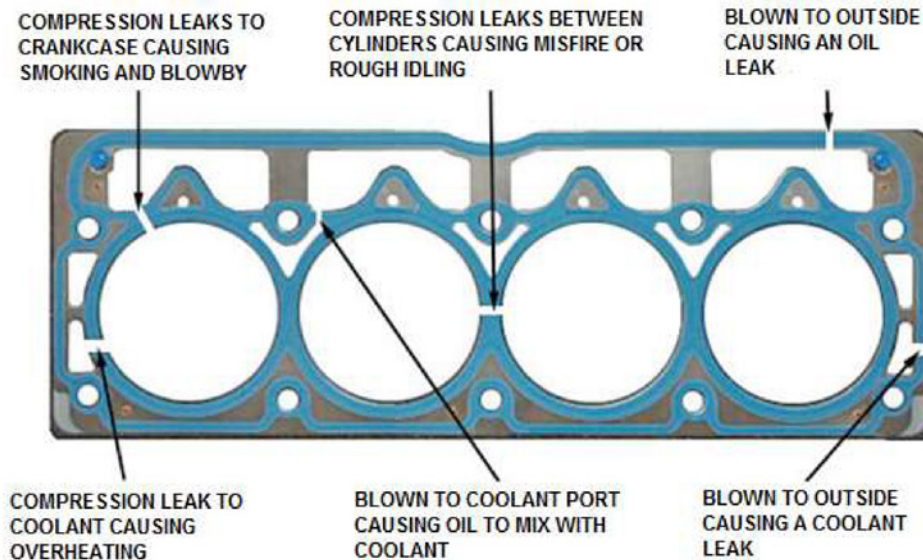
The possible areas where leakage can occur are shown below and an important point to remember is that the gasket which is removed should be carefully examined because it could provide a clue as to what caused the failure.

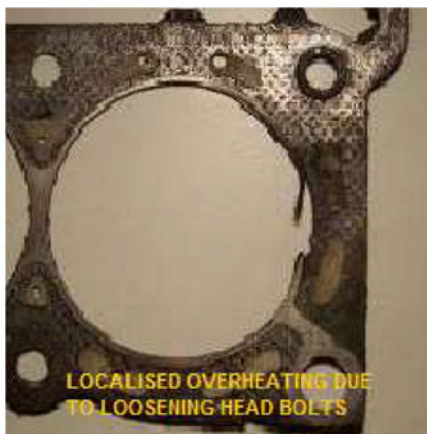
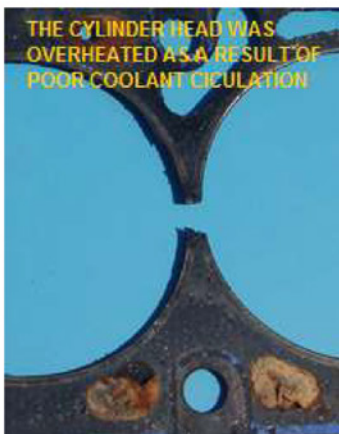
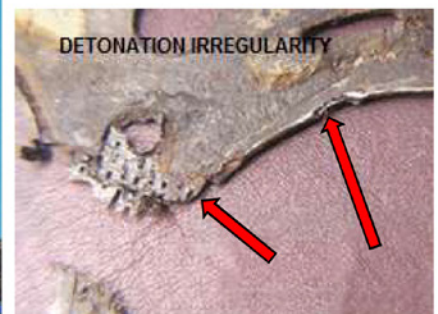
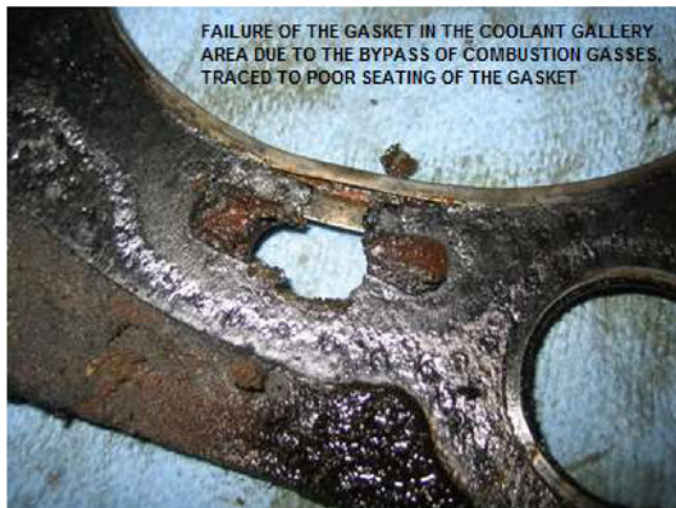
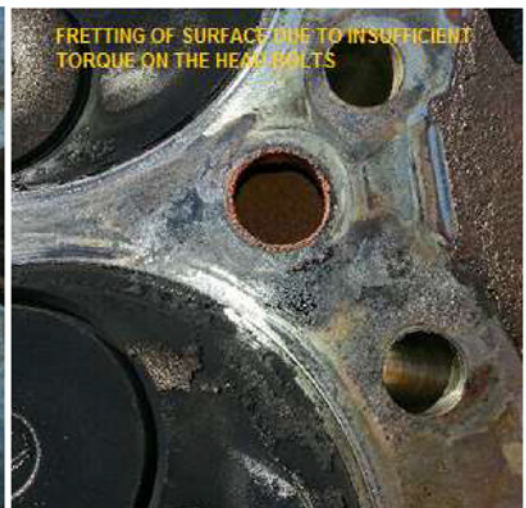
EXAMPLES OF FAILURES

The above examples have resulted from a number of abnormalities varying from surface preparation, mating surface finish, debris entrapment, combustion irregularities, overheating and insufficient torque on the cylinder head fasteners.
