# Guide for judging condition of relevant piston-running components

LINERS, PISTONS AND PISTON RINGS  
Version 3.0 June 2018

**This booklet shall serve as a guide for judging the condition of relevant components (liners, pistons and piston rings) for the condition-based maintenance during piston and liner overhauls of engines with latest piston-running standard with full CC (chromium ceramic) piston ring packages or CC top ring and lower RC (running-in coating) rings for smaller bores.**

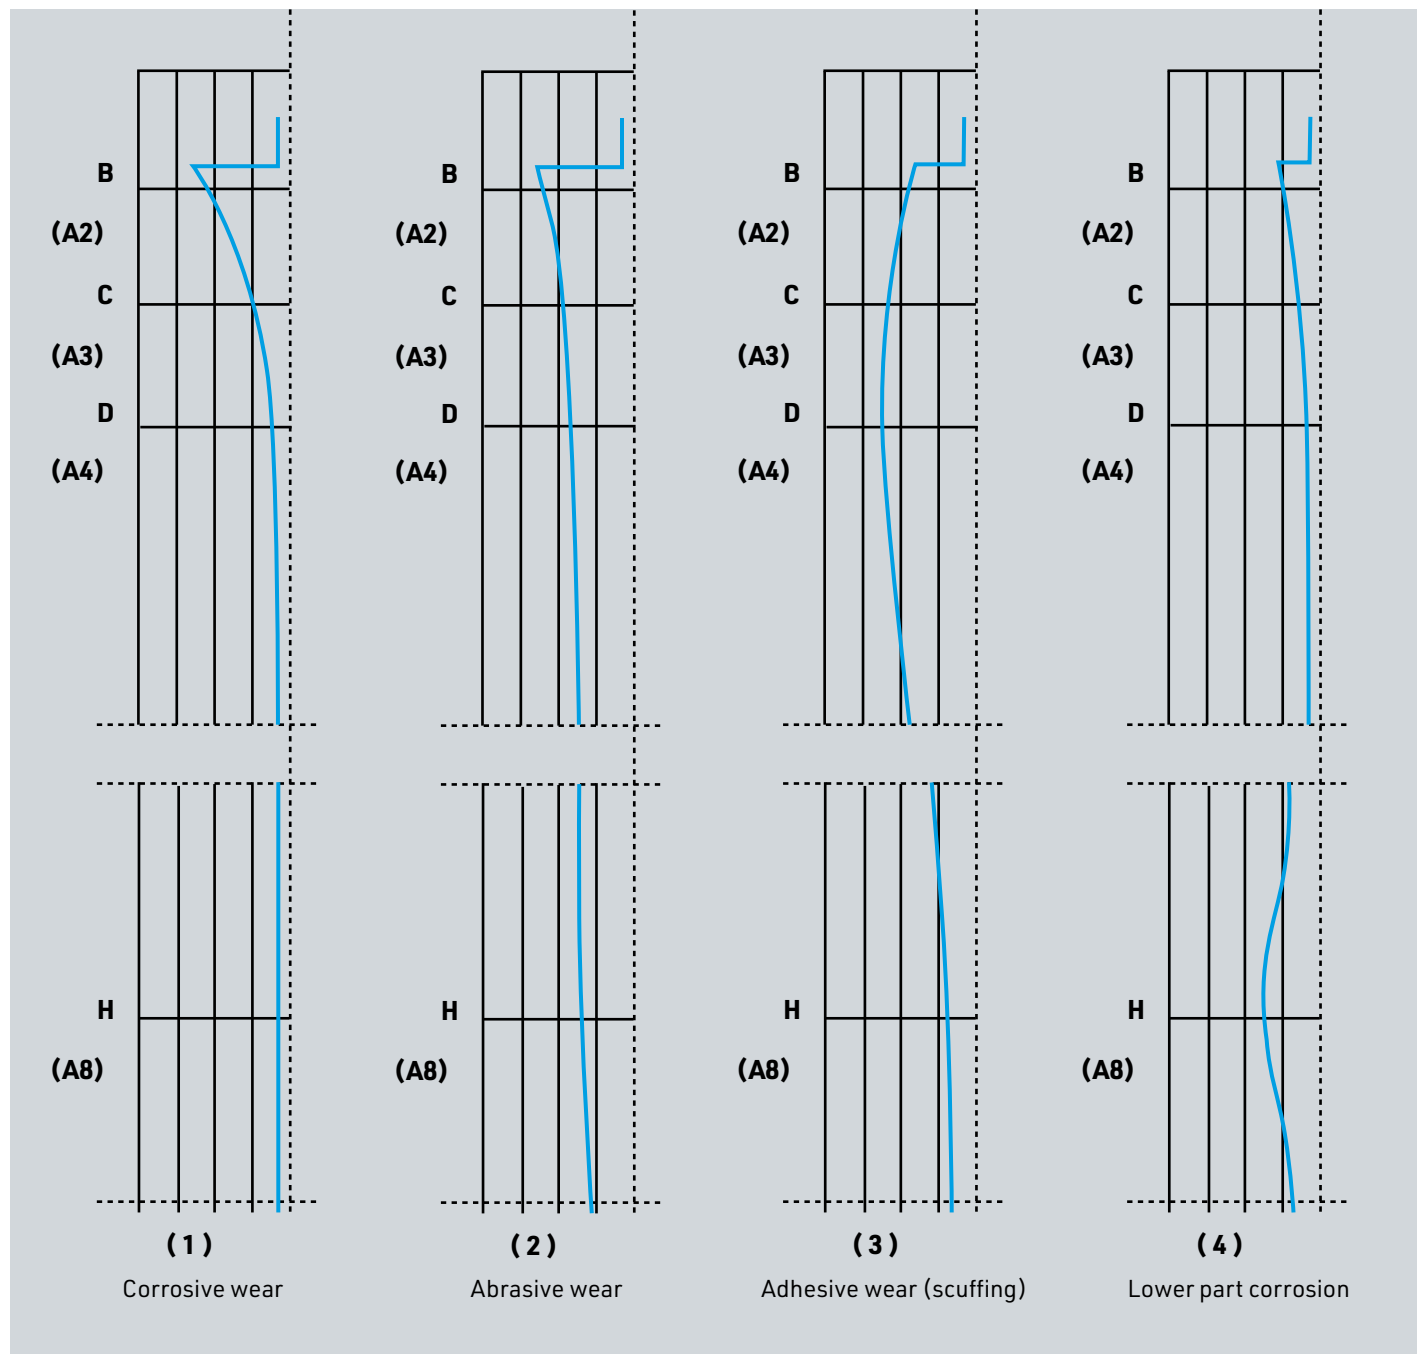
## 5.2 Typical liner wear patterns

The wear pattern on the liner itself also gives some indication as to the nature of the cylinder liner wear and may differ from engine type to engine type.

The actual wear on cylinder liners and piston rings is not simply a linear function, but depends on operating conditions and can be a combination of above wear modes.

- Wear profile with greatest wear at measuring point C or mostly D, see also chapter 5.2
- Visual appearance of liner seems to be visually in homogenous condition, but microstructure of such a liner is destroyed
- Wear steps on running surface, in range of lubricating oil grooves or around scavenging air ports
- Sharp burrs on scavenging air ports

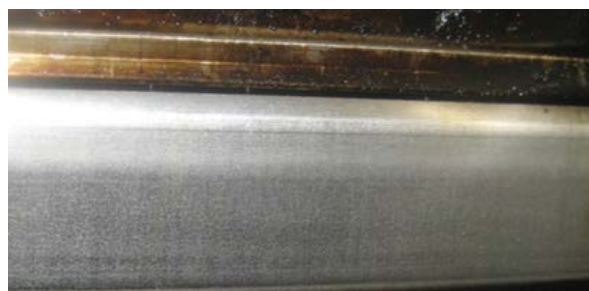
**Ring type:** SCP1CC20, A ring  
**Condition:** Normal condition, secondary crack network slightly visible  
**Acceptance:** Normal  
**Action:** No action required

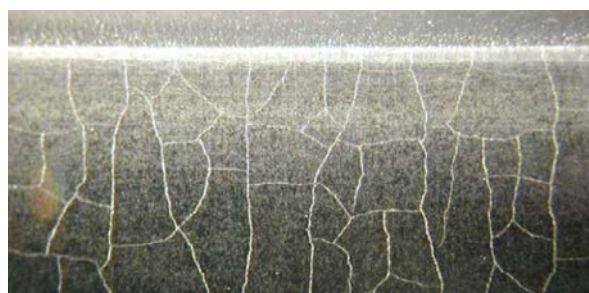
**Ring type:** SCP1CC20, A ring  
**Condition:** Normal condition, regular secondary crack network  
**Acceptance:** Normal  
**Action:** No action required

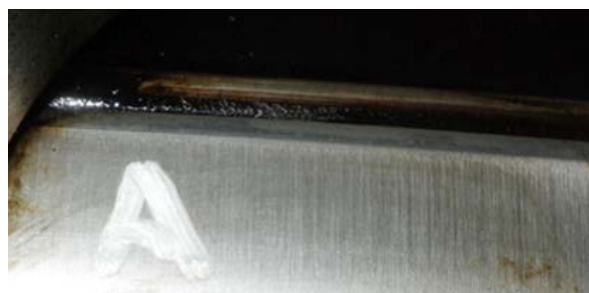
**Ring type:** SCP1CC20, A ring  
**Condition:** Abrasion (3 body abrasion) can be caused by catalyst fines in fuel oil, or foreign hard particles (e.g. sand in intake air).  
**Acceptance:** Acceptable  
**Action:** See technical bulletin RT-140

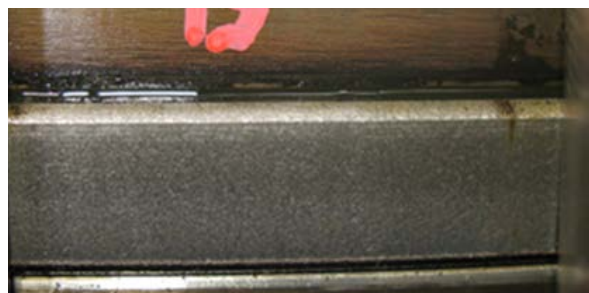
**Ring type:** SCP1RC16, B ring  
**Condition:** RC running-in coating in spotless condition  
**Acceptance:** Acceptable  
**Action:** No action required

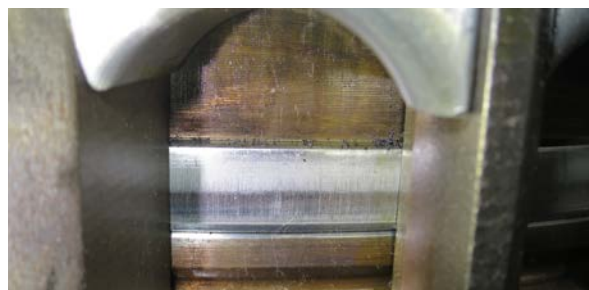
**Ring type:** GTP1CC17  
**Condition:** Abrasive scratches on piston ring running surface by foreign particles  
**Acceptance:** Acceptable  
**Action:** No action required

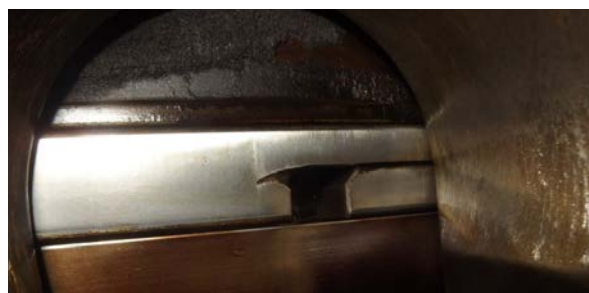
**Ring type:** GTP1CC24  
**Condition:** Erosion at GT ring gap by combustion gases  
**Acceptance:** Normal  
**Action:** No action required

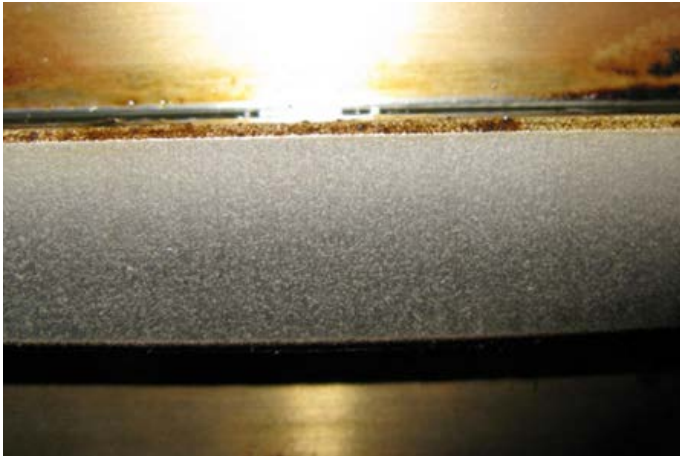
**Ring type:** SCP1RC16, C ring  
**Condition:** RC running-in coating gone, ring running on base material, spotless condition  
**Acceptance:** Normal  
**Action:** No action required

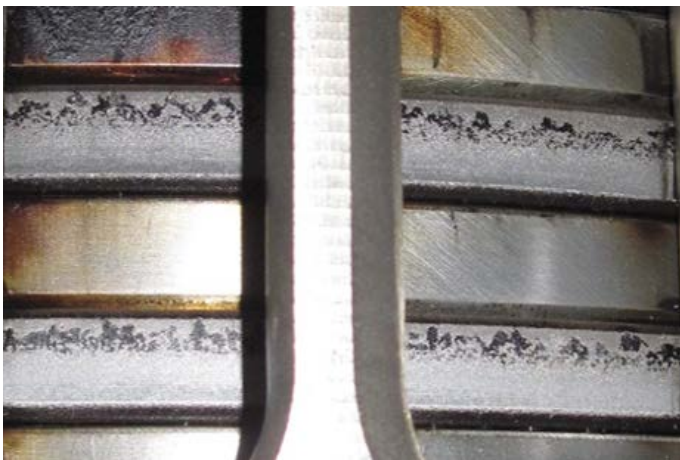
**Ring type:** SCP1RC15, B and C ring  
**Condition:** Some RC running-in layer spalling  
**Acceptance:** Acceptable  
**Action:** No action required

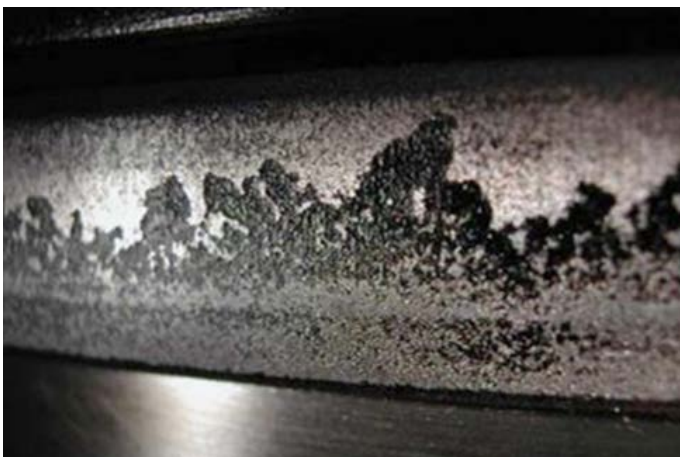
**Ring type:** SCP1RC15, B ring  
**Condition:** Some RC running-in layer spalling  
**Acceptance:** Acceptable  
**Action:** No action required

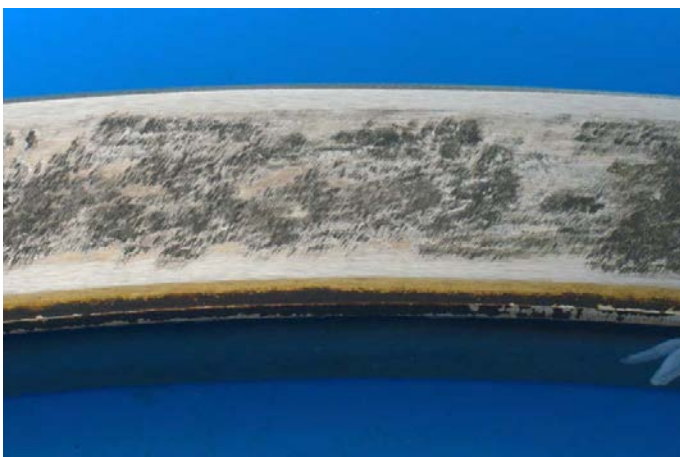
**Ring type:** GTP1CF24, A ring  
**Condition:** Bottom face Cr coating fretting  
**Acceptance:** Acceptable  
**Action:** No action required

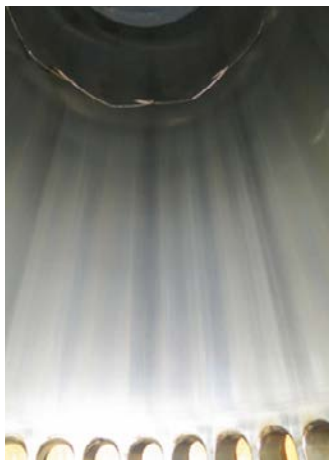
**Condition:** Good liner condition, smooth and homogenous liner appearance, honing marks not visible anymore  
**Acceptance:** Normal  
**Action:** No action required

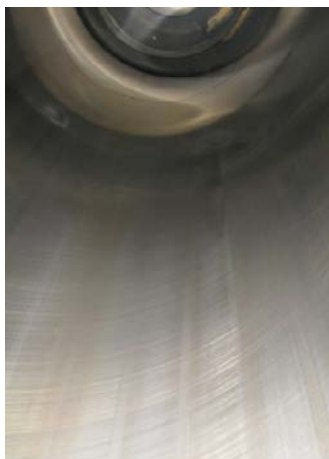
**Condition:** Cylinder liner with minor cold corrosion (milky spots)  
**Acceptance:** Normal  
**Action:** No action required

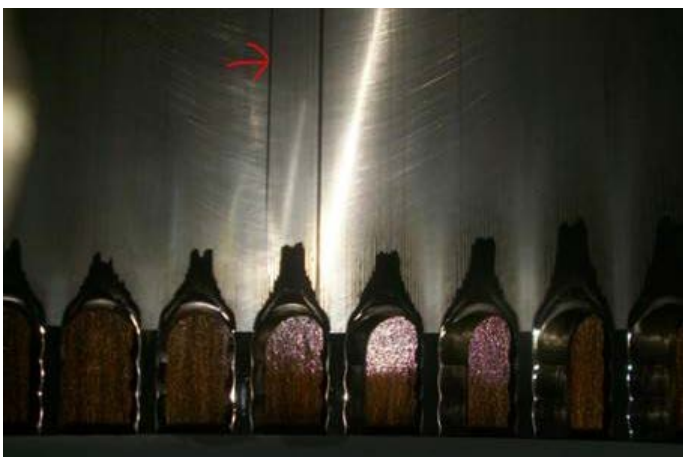
**Condition:** Single scratches on liner surface  
**Acceptance:** Normal  
**Action:** No action required

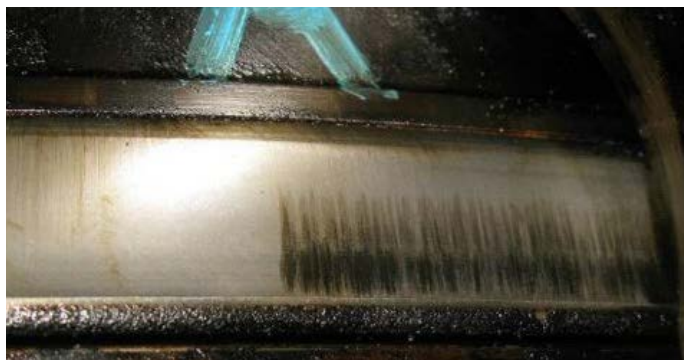
**Ring type:** SCP1CC20, A ring  
**Condition:** Hard contact marks  
**Acceptance:** To be monitored. Piston ring may recover  
**Action:** Check entire ring surface. Temporary increase of set feed rate by 0.2 g/kWh and if possible reduce injection correction factor in flexView or UNIC to 80% or install spacer in fuel pump for RTA engines. Consider exhaust gas deviation alarm.

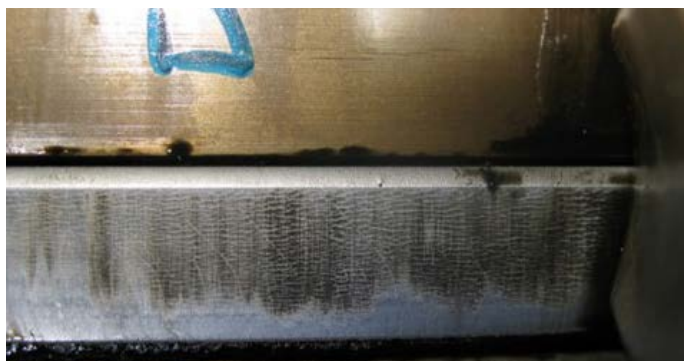
**Ring type:** SCP2CC20, D ring  
**Condition:** Hard contact marks  
**Acceptance:** To be monitored. Piston ring may recover  
**Action:** Check entire ring surface. Temporary increase of set feed rate by 0.2 g/kWh and if possible reduce injection correction factor in flexView or UNIC to 80% or install spacer in fuel pump for RTA engines. Consider exhaust gas deviation alarm.

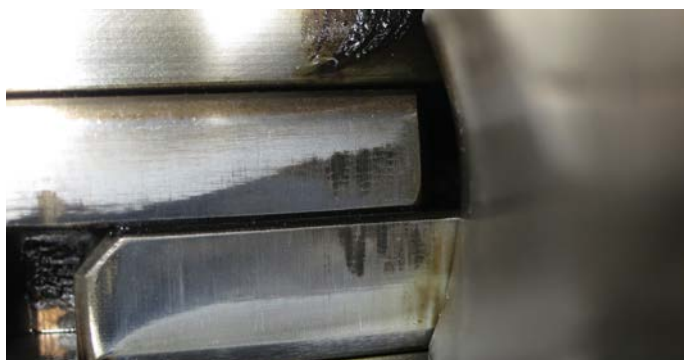
**Ring type:** GTP1CC22, A ring  
**Condition:** Hard contact marks caused by high contact pressure  
**Acceptance:** To be monitored.  
**Action:** Dressing-up on hard contact spots by hand with 80 grain size emery paper

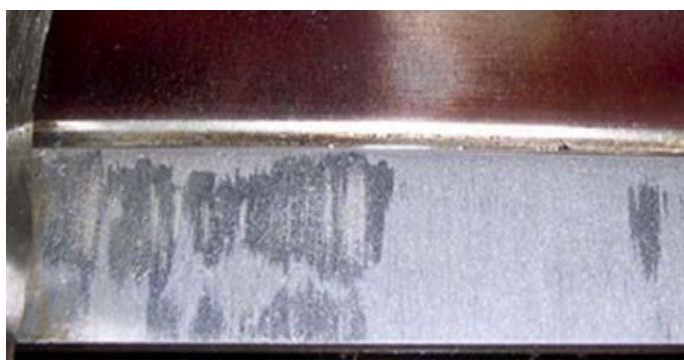
**Ring type:** SCP1RC20, B ring  
**Condition:** Hard contact marks, RC coating gone, ring running on base material  
**Acceptance:** To be monitored. Piston ring may recover  
**Action:** Check entire ring surface. Temporary increase of set feed rate by 0.2 g/kWh and if possible reduce injection correction factor in flexView or UNIC to 80% or install spacer in fuel pump for RTA engines. Consider exhaust gas deviation alarm.

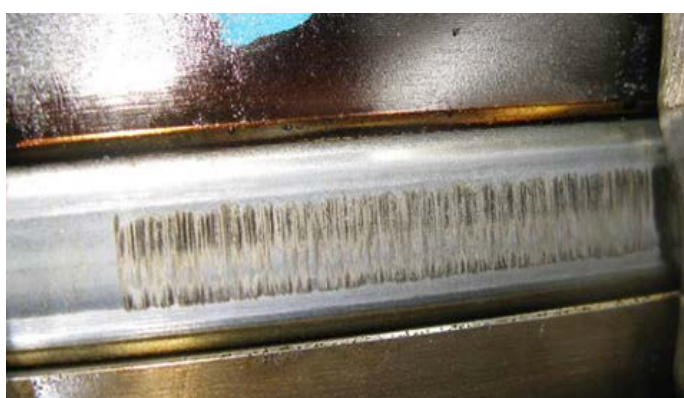
**Ring type:** SCP1CC20, B ring  
**Condition:** Scoring marks  
**Acceptance:** To be monitored. Piston rings may recover  
**Action:** Check entire ring surface. Temporary increase of set feed rate by 0.2 g/kWh and if possible reduce injection correction factor in flexView or UNIC to 80% or install spacer in fuel pump for RTA engines. Consider exhaust gas deviation alarm.

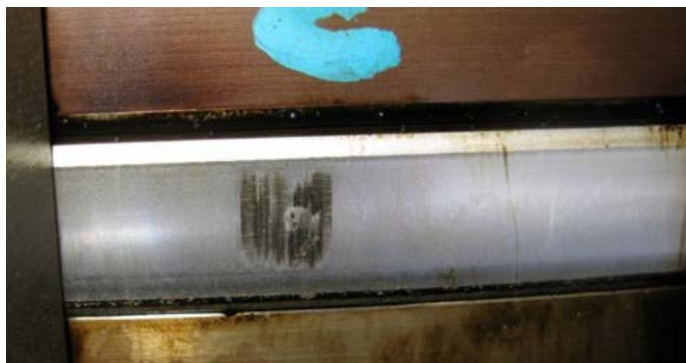
**Ring type:** SCP2CC20, C ring  
**Condition:** Hard contact marks, scoring marks and initial coating spalling  
**Acceptance:** To be monitored. Piston rings may recover  
**Action:** Check entire ring surface. Temporary increase of set feed rate by 0.2 g/kWh and if possible reduce injection correction factor in flexView or UNIC to 80% or install spacer in fuel pump for RTA engines. Consider exhaust gas deviation alarm. Dressing-up on hard contact spots by hand with 80 grain size emery paper.

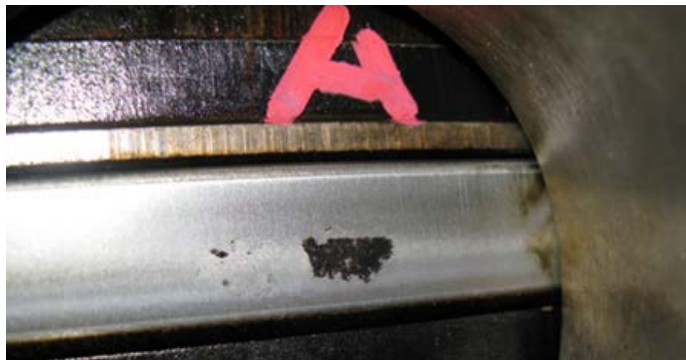
**Ring type:** SCP1CC20, A ring  
**Condition:** Cracked CC coating and spalling  
**Acceptance:** To be monitored. Limited size of spalling  
**Action:** Check entire ring surface. In case spalling is less than 20 mm in length and less than half of the ring height the condition is still acceptable

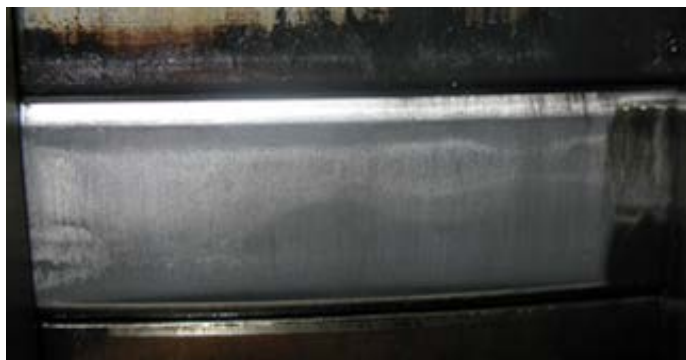
**Ring type:** GTP1CC24, A ring  
**Condition:** Corrosive attack of CC coating  
**Acceptance:** To be monitored. Corrosion may result in high wear on ring and liner  
**Action:** Check correct cylinder oil feed rate setting. Check residual base number (BN) in piston underside drain oil.

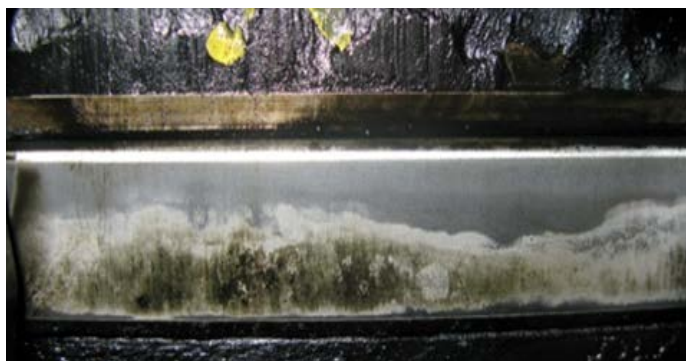
**Ring type:** SCP1CC20, A ring  
**Condition:** Ring with severe corrosion spots  
**Acceptance:** To be monitored. Corrosion may result in high wear on ring and liner  
**Action:** Check correct cylinder oil feed rate setting. Check residual BN in piston underside drain oil. Check remaining CC coating thickness.

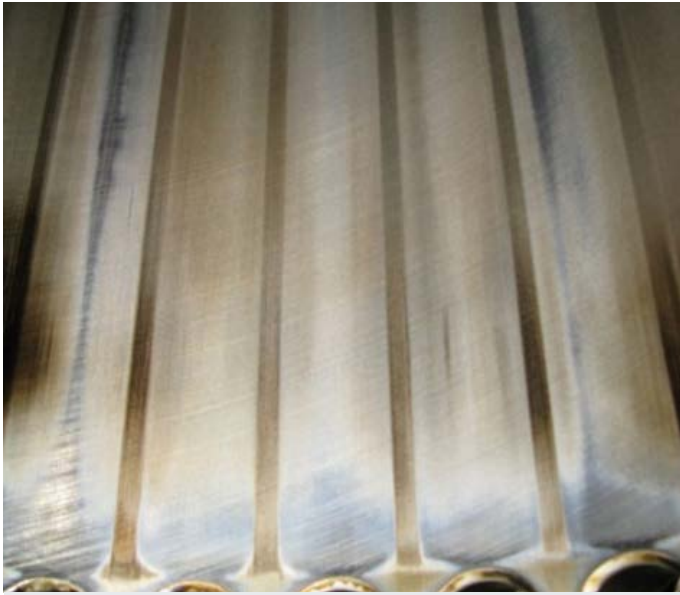
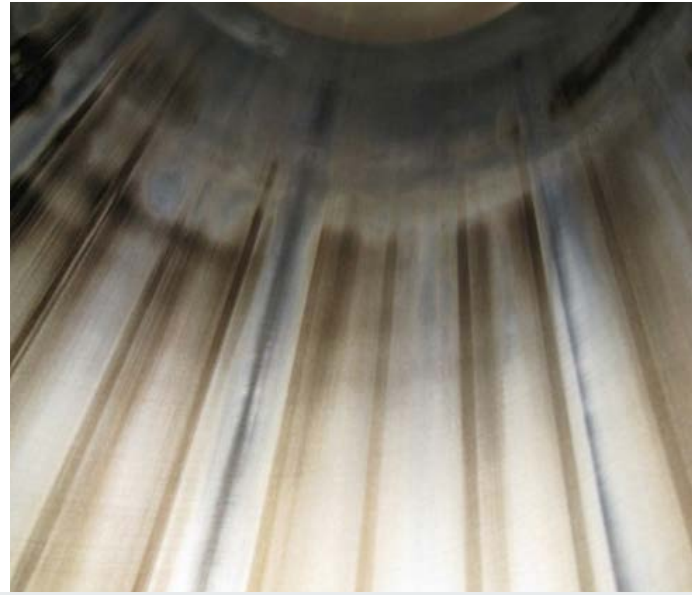
**Condition:** Cylinder liner with quite some cold corrosion and some black lacquer  
**Acceptance:** To be monitored  
**Action:** Check correct cylinder oil feed rate setting.  
Check residual BN in piston underside drain oil.

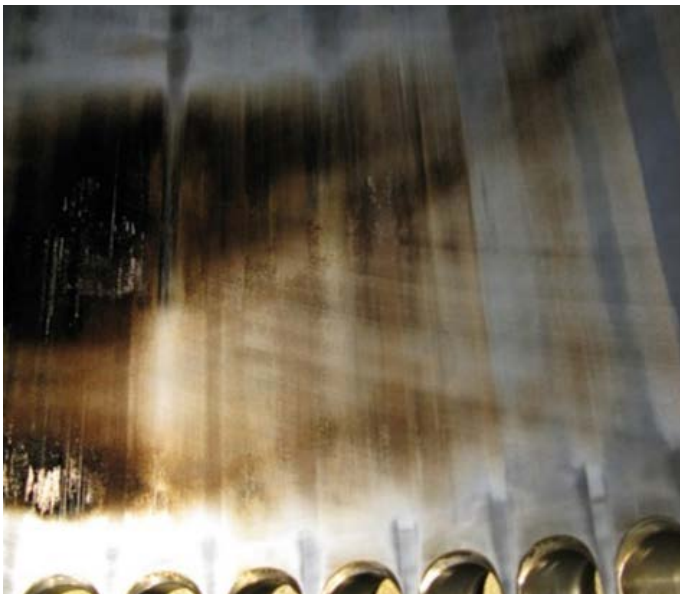
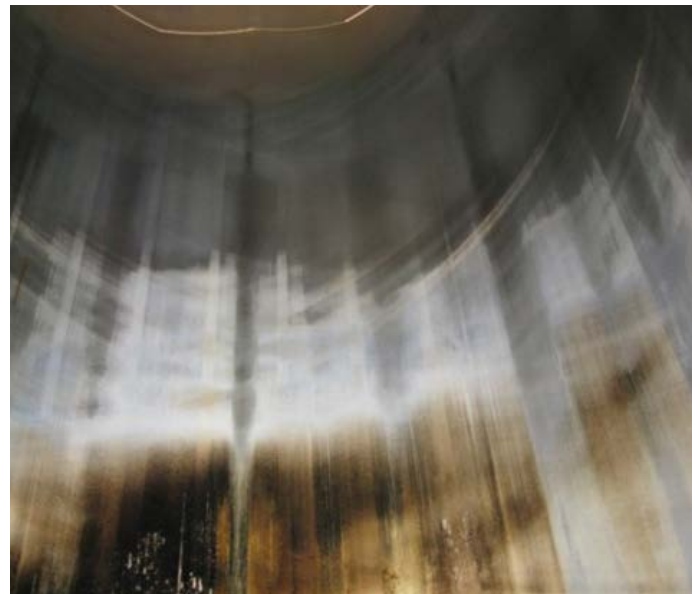
**Condition:** Cylinder liner with black lacquer and cold corrosion  
**Acceptance:** To be monitored  
**Action:** Check correct cylinder oil feed rate setting.  
Check residual BN in piston underside drain oil.

The formation and extent of this lacquer formation depends mainly on engine load, sulphur content in fuel oils (~2.7% or higher), set cylinder oil feed rate and air humidity.

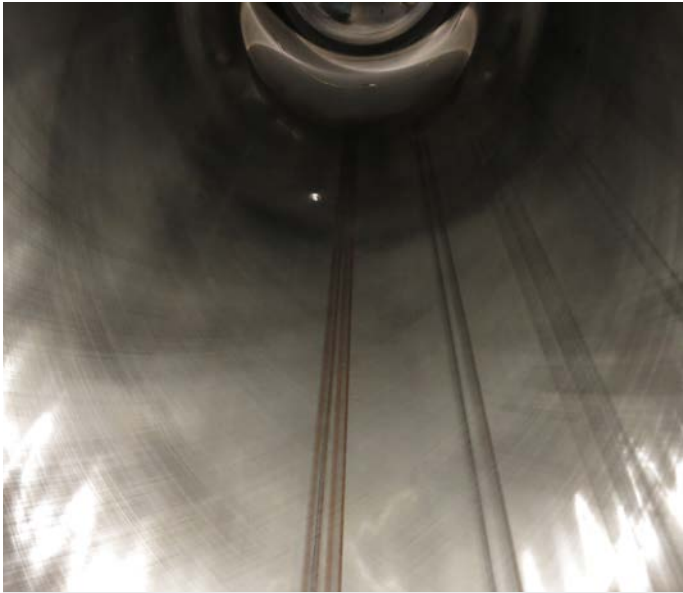
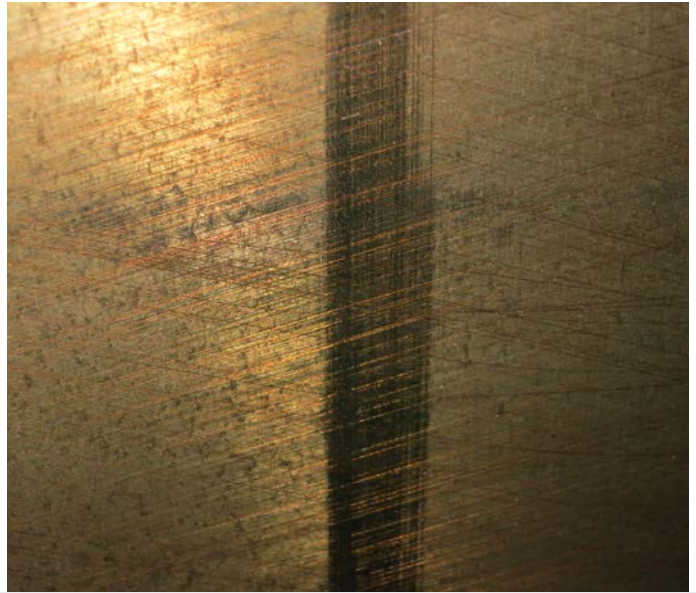
**Condition:** Hard contact marks on cylinder liner  
**Acceptance:** To be monitored, piston rings have to be checked all around  
**Action:** No action required

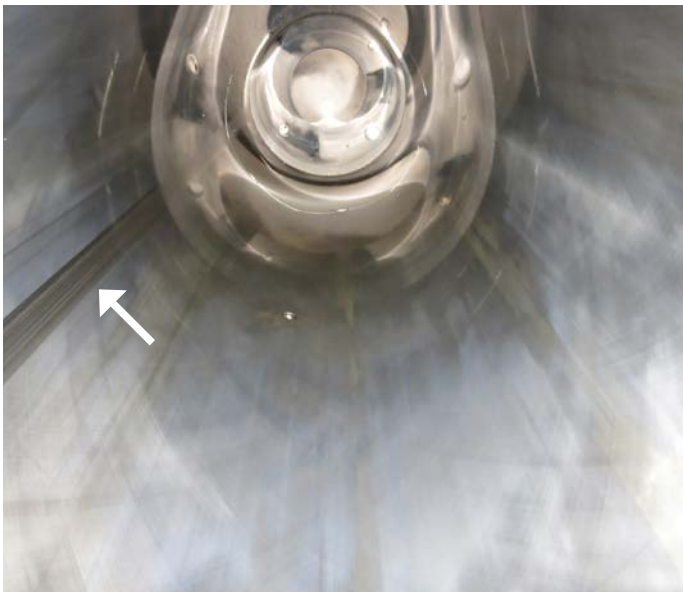
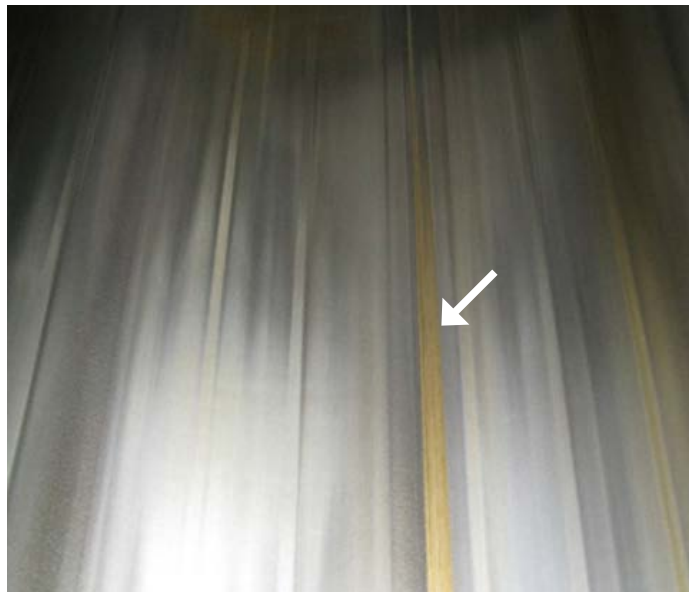
**Condition:** Single scoring marks on cylinder liner  
**Acceptance:** To be monitored, piston rings have to be checked all around  
**Action:** In case the liner scoring develops further, the unit should be overhauled at the next opportunity and local scoring is to be dressed up

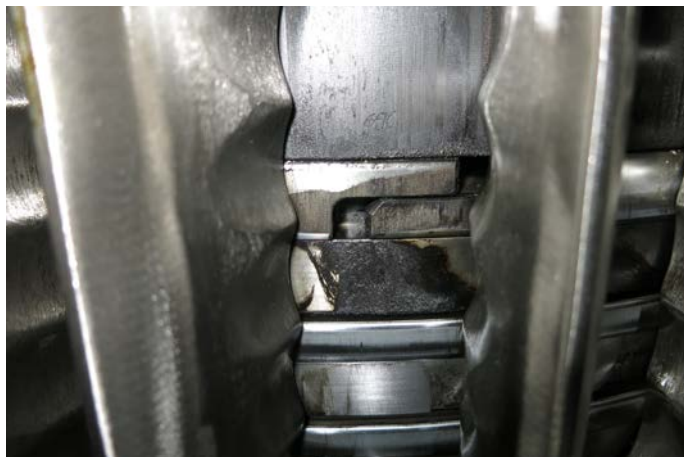
**Ring type:** GTP1CC20, A-ring  
**Condition:** Local scoring / scuffing of ring gap ends  
**Acceptance:** Critical, to be monitored very closely.  
**Action:** Local dressing up of ring end gaps with emery cloth (80 grain size) through scavenging air ports. If condition deteriorates, then piston ring to be replaced and scorings on liner to be dressed up

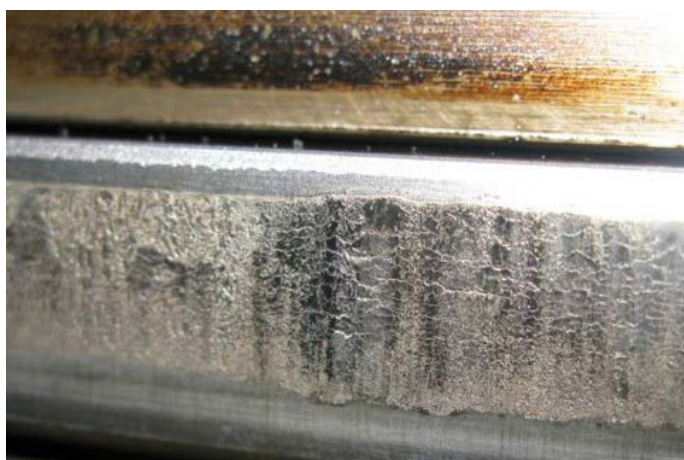
**Ring type:** SCP1CC20  
**Condition:** Active scuffing, CC coating destroyed, active scuffing  
**Acceptance:** Critical condition  
**Action:** Unit to be overhauled. Temporary increase of set cylinder oil feed rate by ~0.2 g/kWh and reduce injection correction factor in flexView or UNIC to 80% or install spacer in fuel pump for RTA engines until unit is overhauled. Consider exhaust gas deviation alarm. If ships schedule permits it, switch off the unit, till unit is overhauled.

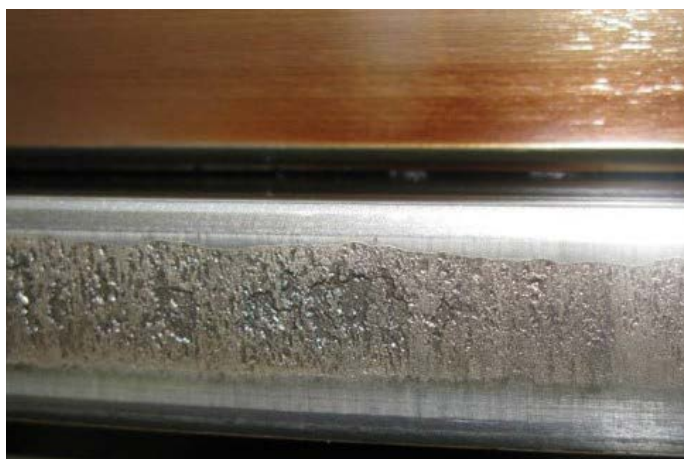
**Ring type:** SCP1CC20, C ring  
**Condition:** Scuffed, CC coating destroyed and cohesive spalling, active scuffing  
**Acceptance:** Critical condition  
**Action:** Unit to be overhauled. Temporary increase of set cylinder oil feed rate by ~0.2 g/kWh and reduce injection correction factor in flexView or UNIC to 80% or install spacer in fuel pump for RTA engines until unit is overhauled. Consider exhaust gas deviation alarm. If ships schedule permits it, switch off the unit, till unit is overhauled.

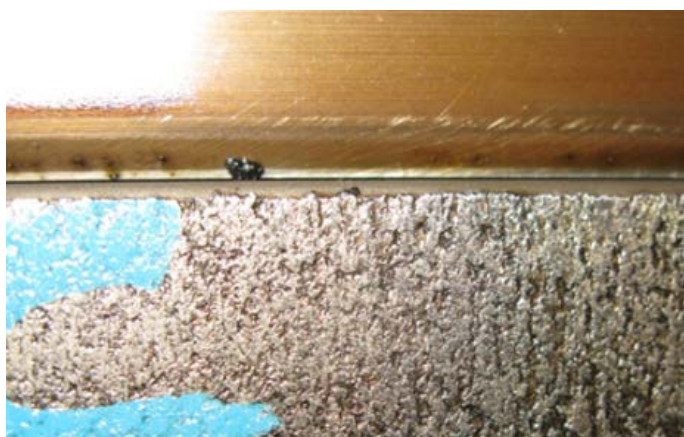
**Ring type:** SCP2CC20, C ring  
**Condition:** Scuffed with some CC remaining active scuffing  
**Acceptance:** Critical condition  
**Action:** Unit to be overhauled. Temporary increase of set cylinder oil feed rate by ~0.2 g/kWh and reduce injection correction factor in flexView or UNIC to 80% or install spacer in fuel pump for RTA engines until unit is overhauled. Consider exhaust gas deviation alarm. If ships schedule permits it, switch off the unit, till unit is overhauled.

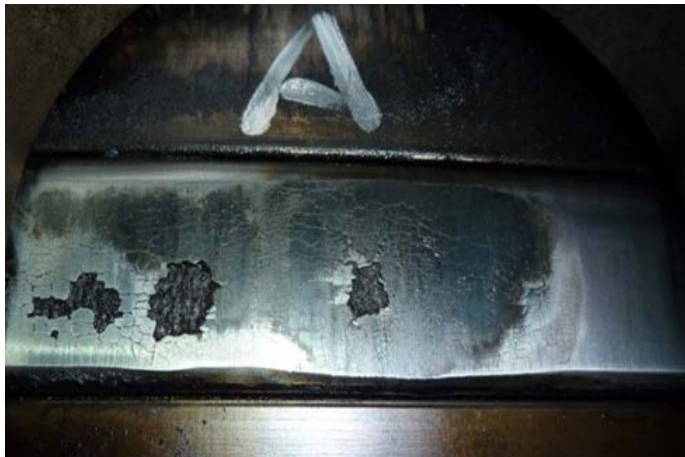
**Ring type:** GTP1CF24, A ring  
**Condition:** Locally scuffed, CC coating destroyed and spalling, scuffing not active  
**Acceptance:** Critical condition  
**Action:** Unit to be overhauled. Temporary increase of set cylinder oil feed rate by ~0.2 g/kWh and reduce injection correction factor in flexView or UNIC to 80% or install spacer in fuel pump for RTA engines until unit is overhauled. Consider exhaust gas deviation alarm

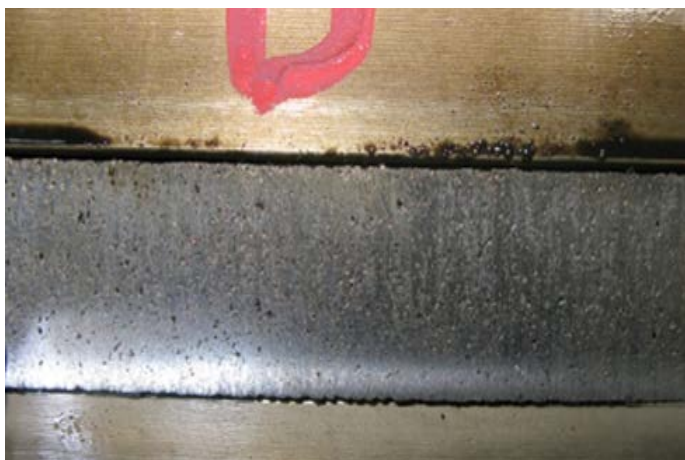
**Ring type:** SCP2CC20, D ring  
**Condition:** Partly recovered from scuffing, sharp edges with burrs, coating worn down  
**Acceptance:** Critical condition  
**Action:** Unit to be overhauled. Temporary increase of set cylinder oil feed rate by ~0.2 g/kWh and reduce injection correction factor in flexView or UNIC to 80% or install spacer in fuel pump for RTA engines until unit is overhauled. Consider exhaust gas deviation alarm

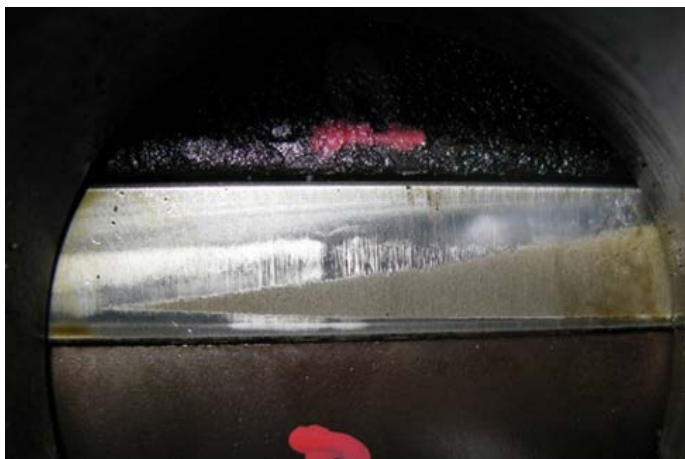
**Ring type:** SCP1CC20, A ring  
**Condition:** CC coating worn down to base material, corrosion on remaining CC coating  
**Acceptance:** Critical condition, further operation of such rings will result in a greater liner wear and increased risk for scuffing  
**Action:** Unit to be overhauled  
**Remark:** See next picture for possible root cause

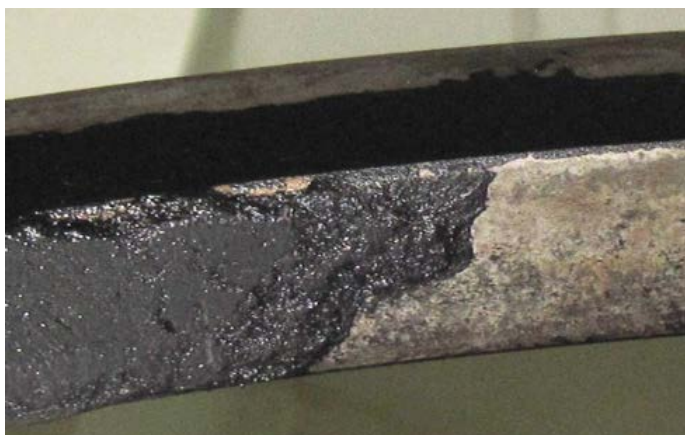
**Ring type:** GTP1CF24, A ring  
**Condition:** Excessive deposits on ring inner diameter (backside)  
**Acceptance:** Critical condition, may lead to high ring wear and ring can stick  
**Action:** Unit to be overhauled

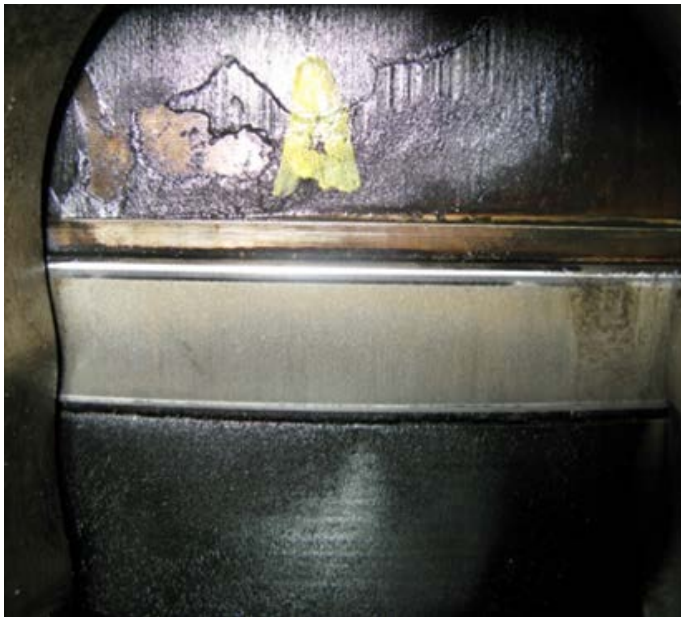
**Ring type:** SCP1CC20, A ring  
**Condition:** Completely worn CC coating  
**Acceptance:** Critical condition, further operation of such rings will result in a greater liner wear and increased risk for scuffing.  
**Action:** Unit to be overhauled

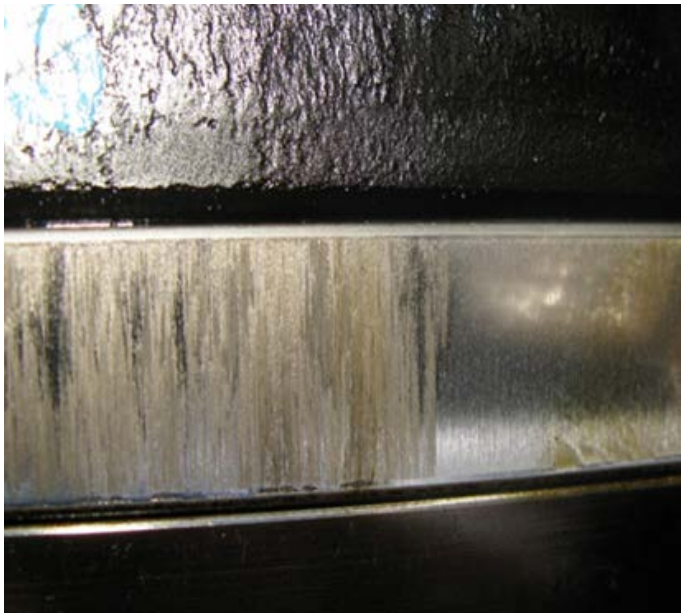
**Ring type:** SCP1CC20, A ring  
**Condition:** Scoring marks on a worn CC ring  
**Acceptance:** Critical condition  
**Action:** Unit to be overhauled. Temporary increase of set cylinder oil feed rate by ~0.2 g/kWh and reduce injection correction factor in flexView or UNIC to 80% or install spacer in fuel pump for RTA engines until unit is overhauled. Consider exhaust gas deviation alarm.

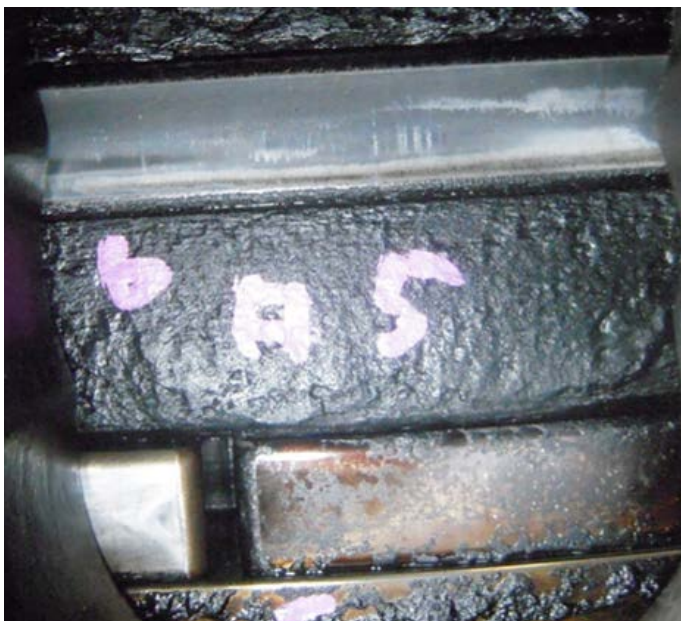
**Ring type:** SCP1CC20, A and B ring  
**Condition:** A ring with some corrosion, B ring lost tension, with excessive deposits, cylinder oil feed rate, BN and fuel oil sulphur content not matching  
**Acceptance:** Critical condition  
**Action:** Unit to be overhauled. Check correct cylinder oil feed rate setting. Check residual BN in piston underside drain oil.

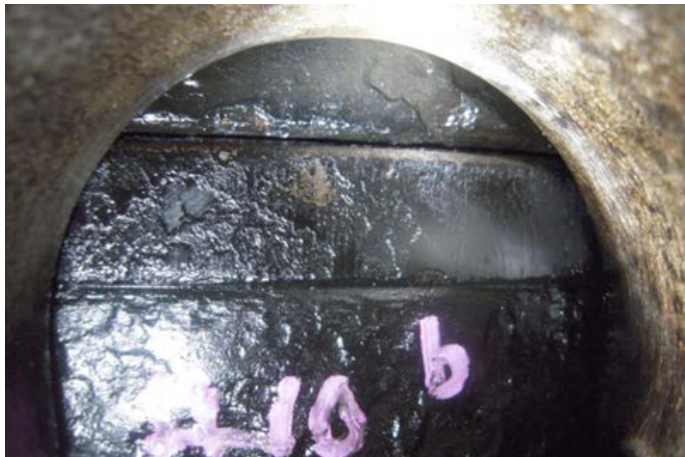
**Ring type:** SCP1CC20, A ring  
**Condition:** Ring collapsed, with excessive deposit  
**Acceptance:** Critical condition  
**Action:** Unit to be overhauled. Switch-off unit

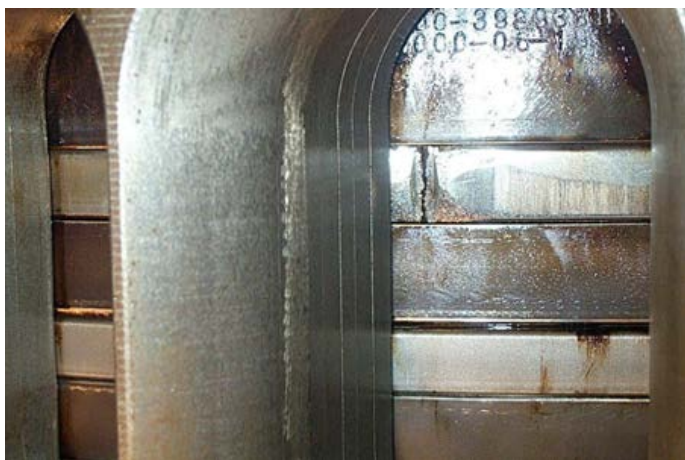
**Ring type:** SCP1CC20, A ring  
**Condition:** Ring broken  
**Acceptance:** Critical condition  
**Action:** Unit to be overhauled. Switch-off unit

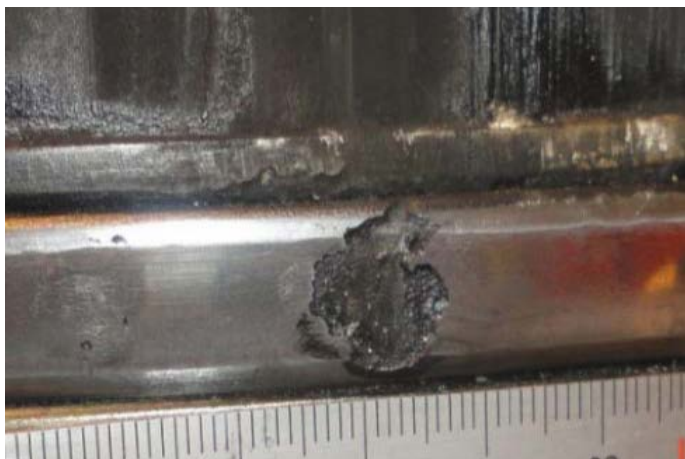
**Ring type:** SCP1CC16, A ring  
**Condition:** A ring with excessive spalling across full ring height  
**Acceptance:** Critical condition  
**Action:** Unit to be overhauled. Temporary increase of set cylinder oil feed rate by ~0.2 g/kWh and reduce injection correction factor in flexView or UNIC to 80% or install spacer in fuel pump for RTA engines until unit is overhauled. Consider exhaust gas deviation alarm

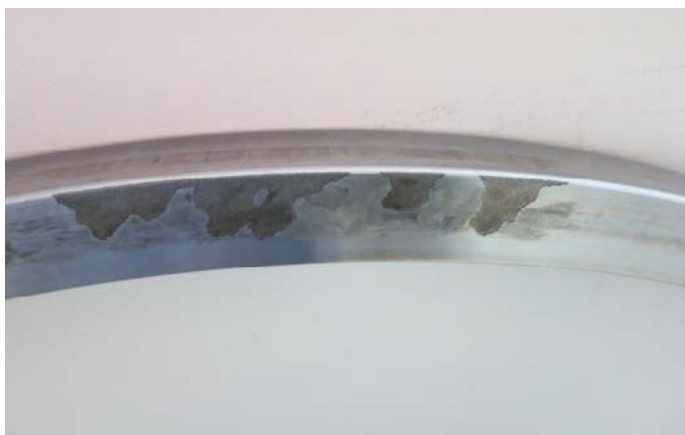
**Ring type:** GTP1CF24, A ring  
**Condition:** Bottom face Cr coating spalling  
**Acceptance:** Critical condition  
**Action:** Piston ring to be replaced

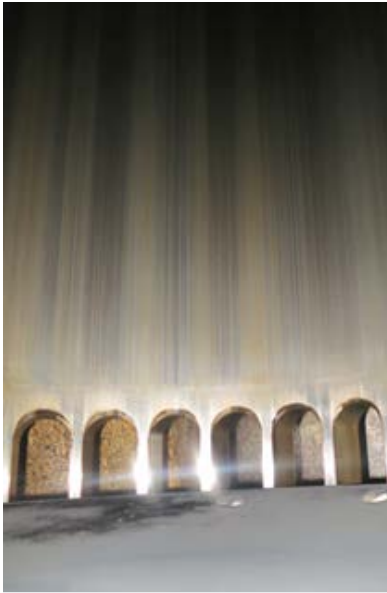
**Condition:** Cylinder liner with scoring marks  
**Acceptance:** Critical condition  
**Action:** Depending on piston ring condition unit should be overhauled and liner re-honed. If piston rings are in spotless condition, the unit can be kept in operation

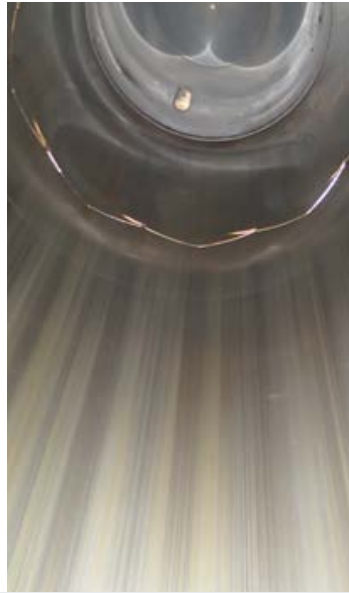
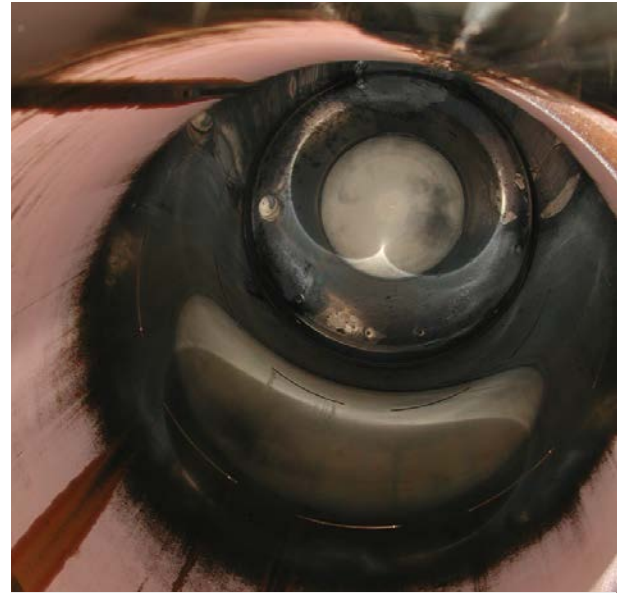
**Condition:** Water ingress caused rusty liner surface. Only applicable on engines with quills through water guide jacket  
**Acceptance:** Critical condition  
**Action:** Lubricating quills to be checked and overhauled. Check cylinder cover and liner for cracks.

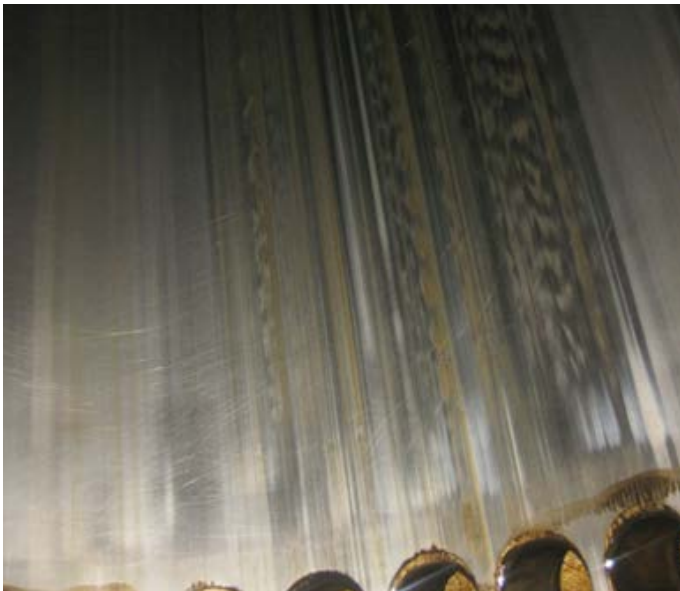
**Condition:** Liner with local scoring and scuffing, marks  
**Acceptance:** Critical condition  
**Action:** Depending on piston ring condition unit should be overhauled and liner dressed-up or re-honed. If piston rings are in spotless condition, the unit can be kept in operation

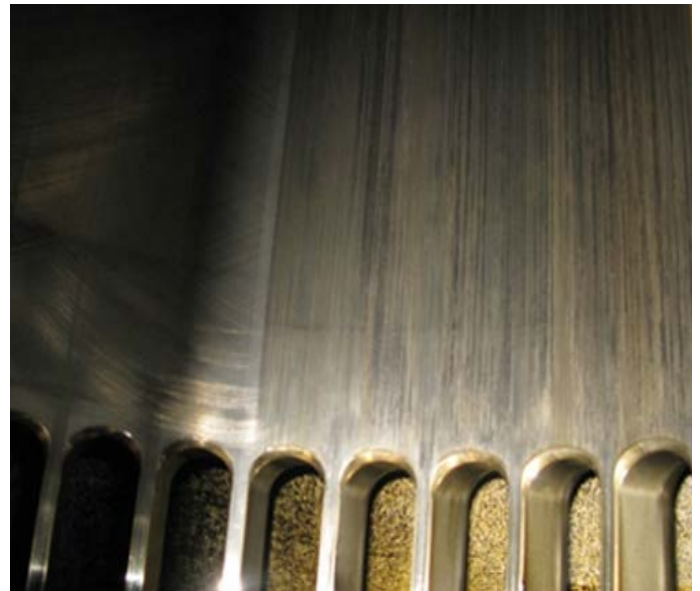
**Condition:** Scuffing marks on liner  
**Acceptance:** Critical condition  
**Action:** Unit to be overhauled. Local scoring and scuffing marks are to be dressed up or re-honed

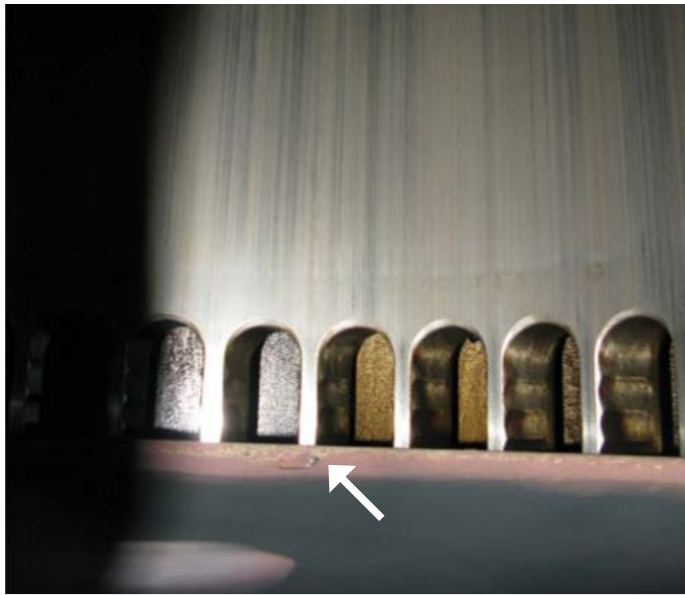
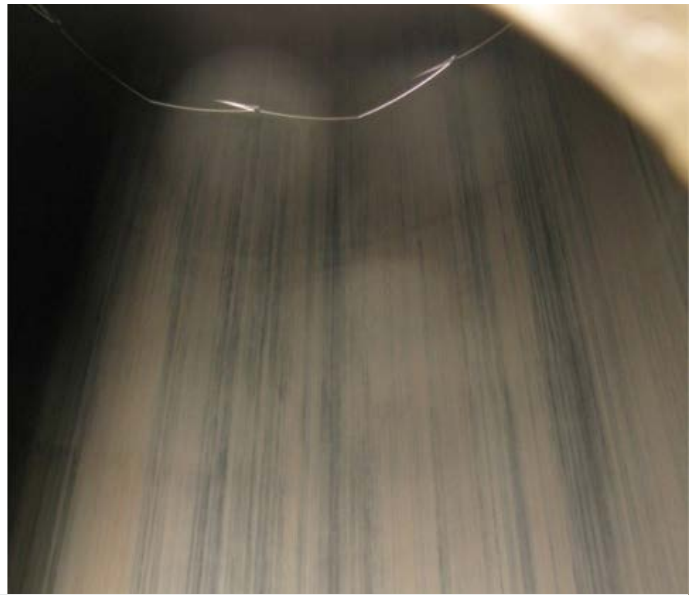
- Condition:** Totally scuffed unit with dull appearance. Note the reddish spots on the piston crown top, which are oxidised iron from the liner
- Acceptance:** Critical condition
- Action:** Such a liner has to be replaced as soon as possible

Adhesive wear (scuffing) results in a destroyed microstructure of the cast iron (thermo mechanical transformation layer), which is unfavourable for safe piston-running. If only the piston rings are replaced the piston running behaviour will be unstable and unit may fail again. Such a liner is to be replaced even if the wear limit has not yet been reached.

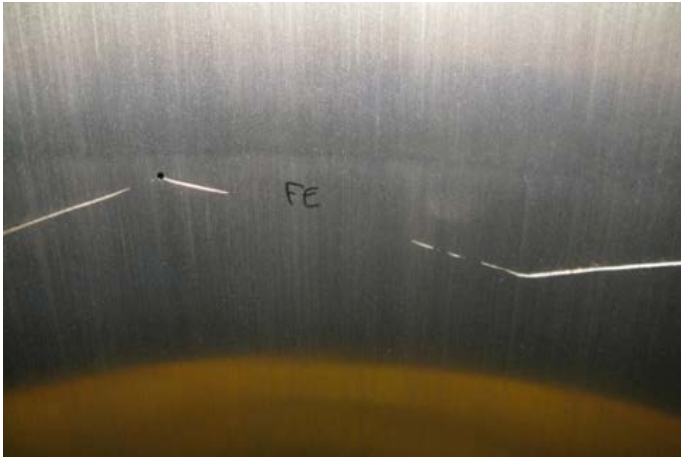
**Condition:** Totally scuffed liner surface and liner grooves partly worn down

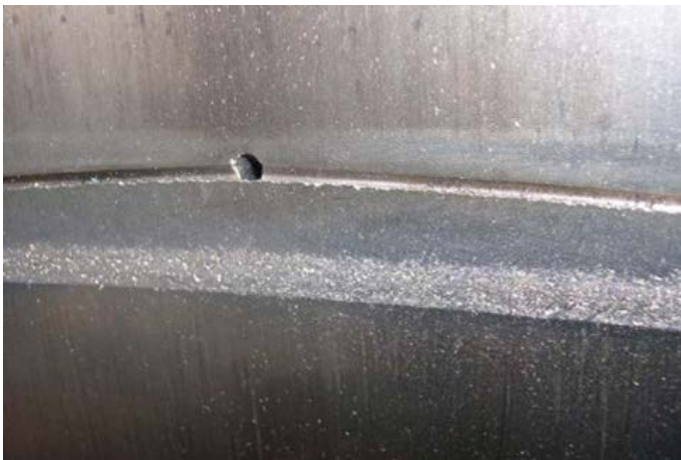
**Condition:** Scuffed liner with wear step in the region of the liner grooves

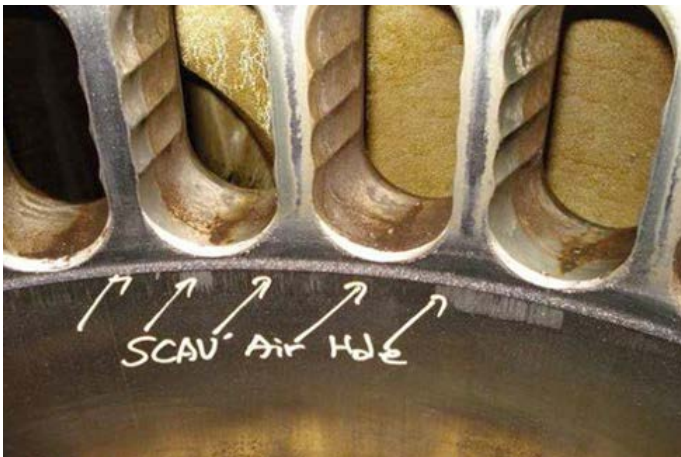
**Condition:** Scuffed liner with wear step in the region of the scavenging ports
