# Guide for judging condition of relevant piston-running components

LINERS, PISTONS AND PISTON RINGS  
Version 3.0 June 2018

**This booklet shall serve as a guide for judging the condition of relevant components (liners, pistons and piston rings) for the condition-based maintenance during piston and liner overhauls of engines with latest piston-running standard with full CC (chromium ceramic) piston ring packages or CC top ring and lower RC (running-in coating) rings for smaller bores.**

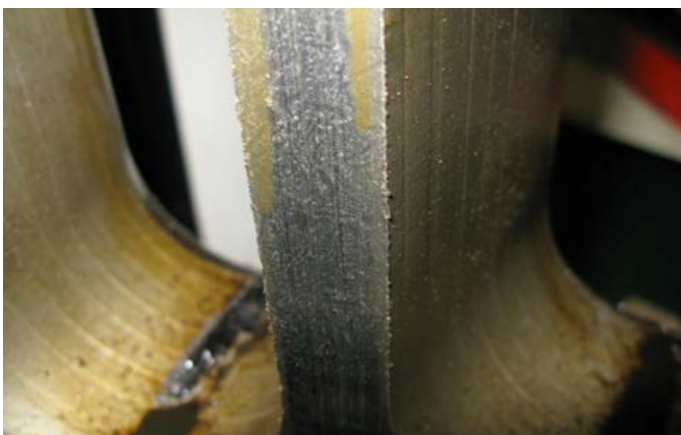
**Condition:** Scuffed liner with burrs on the edges of the scavenging air ports

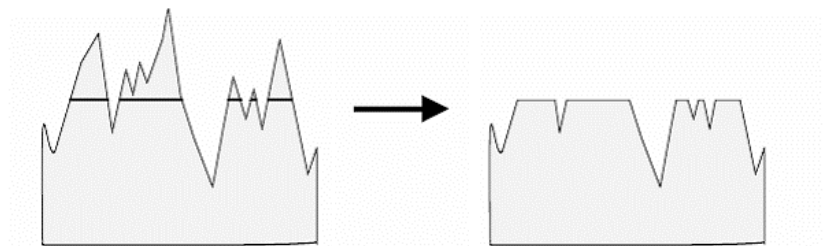
For such kind of scoring marks it is not the intention to remove them complete as this might result in a liner shape that is too uneven and causes blow by, but to break the surface of such scored liner structure.

Scored surface before dressing up

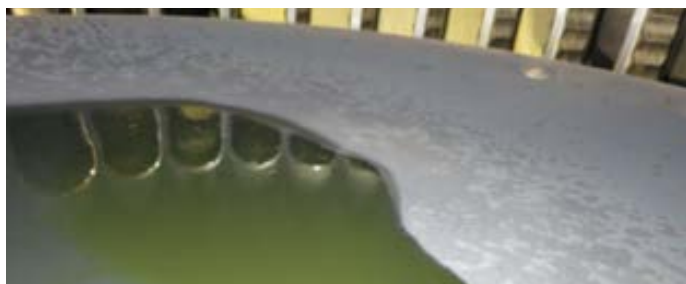
**Condition:** Oil on top of piston, leaking from valve shaft (rod joint ring)  
**Acceptance:** Critical condition  
**Action:** Source of oil leak to be found and rectified

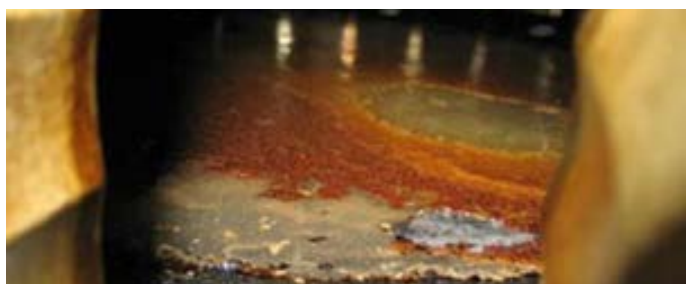
**Condition:** Water on top of piston leaking from a cracked valve seat, liner or cover  
**Acceptance:** Critical condition  
**Action:** Source of water leak to be found and rectified

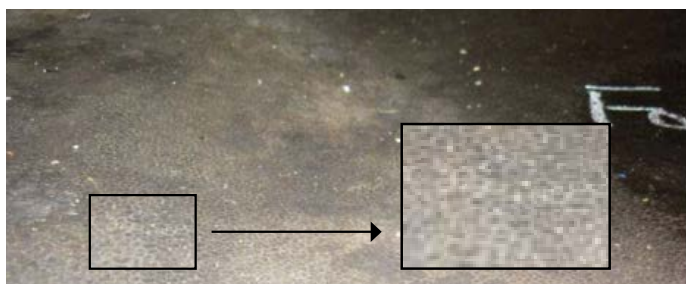
**Condition:** Loss of material, so-called 'paving stone' or 'elephant skin' appearance, indicating high-temperature corrosion  
**Acceptance:** Acceptable  
**Action:** Wear to be checked and recorded (Template 94366)

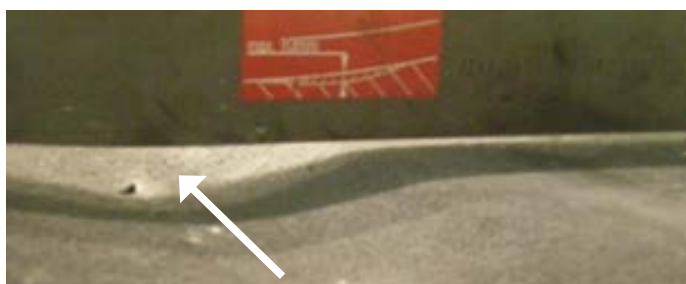
**Condition:** Excessive loss of material, above wear limit. See arrow, clearance between template 94366 and piston  
**Acceptance:** Critical condition  
**Action:** Piston to be replaced

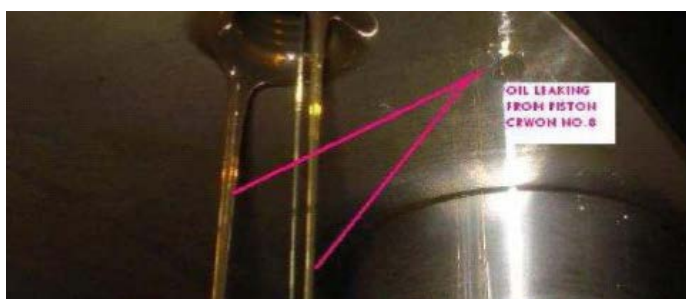
**Condition:** Piston cooling oil leakage caused by defective o-ring in piston crown  
**Acceptance:** Critical condition  
**Action:** Source of oil leak to be found and rectified

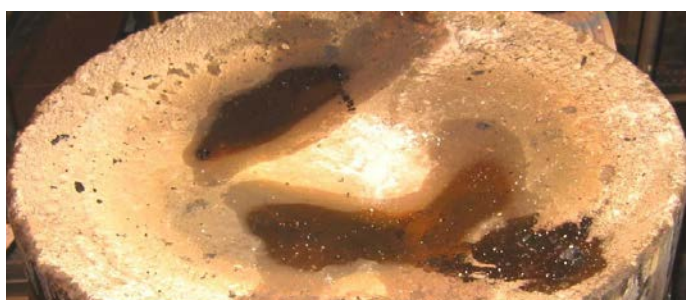
**Condition:** Carbon deposits on piston crown  
**Acceptance:** Critical condition  
**Action:** Piston underside drain oil analysis highly recommended. Consider to reduce feed rate or switch to a lower BN cylinder oil if not yet in use.

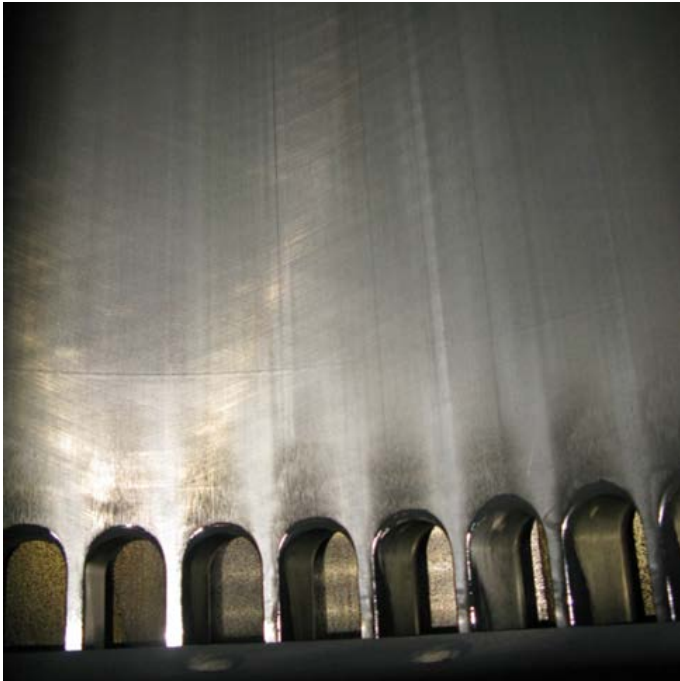
Condition of piston crown top and liner surface above scavenging air port

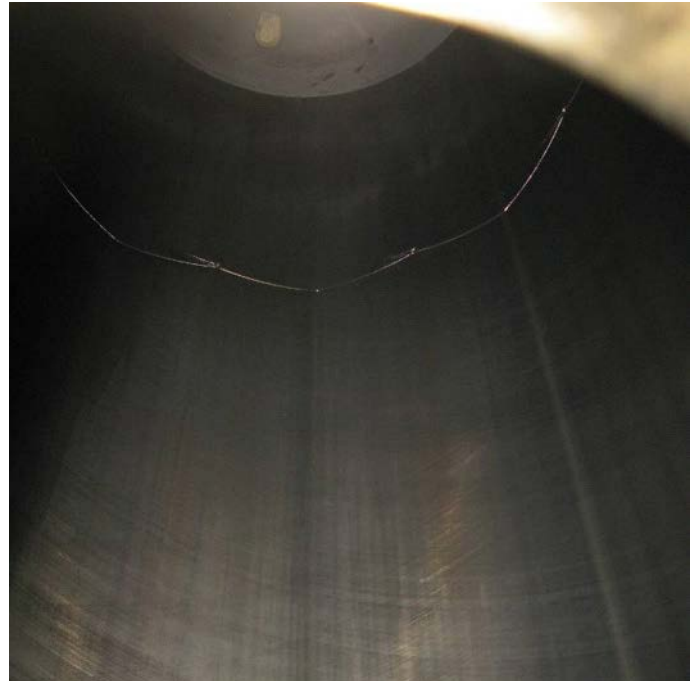
Liner surface as high as possible

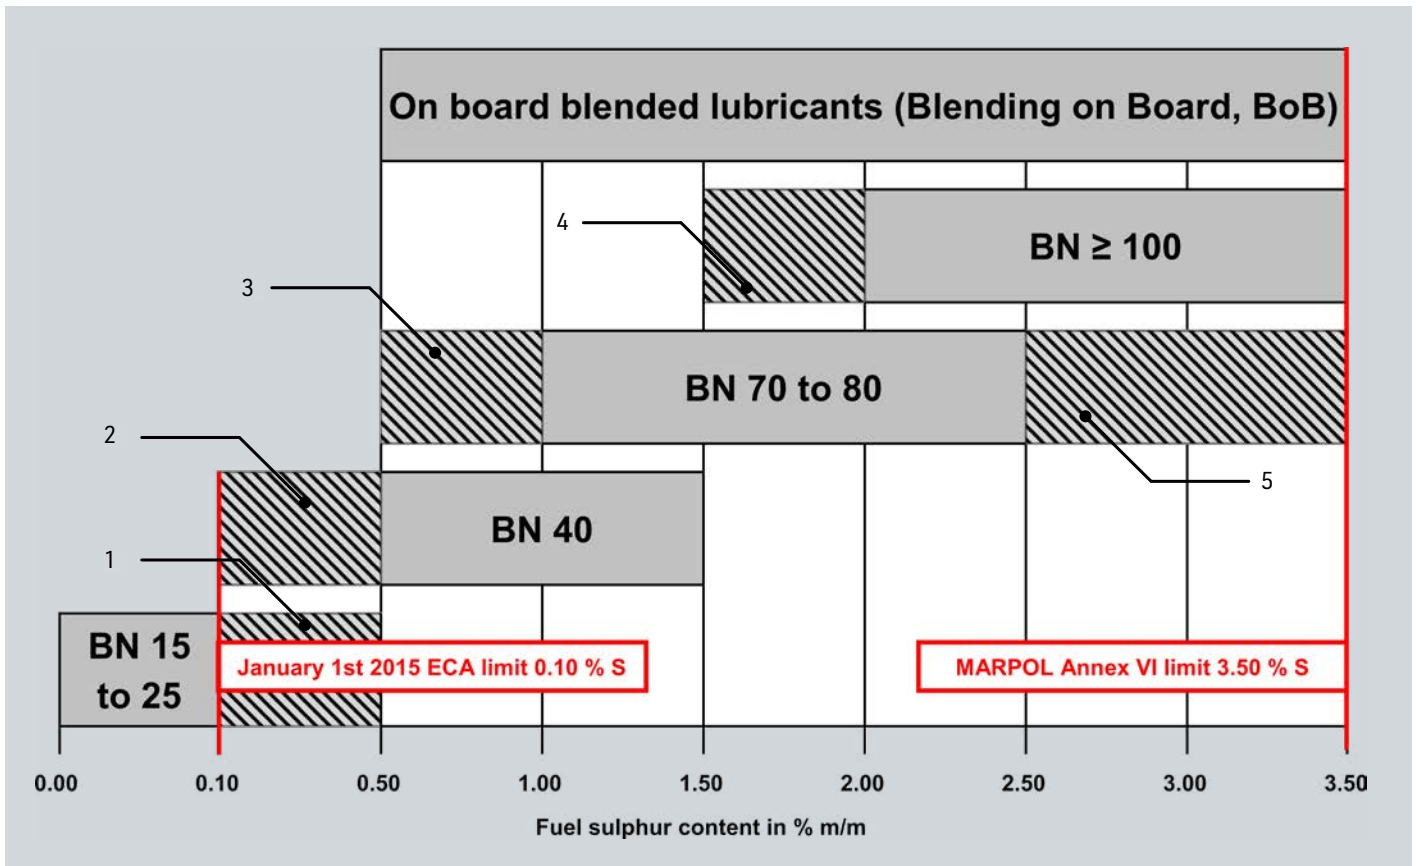
The selection of the correct BN of the cylinder lubrication oil must be driven by the results from piston underside drain oil analysis. However, as a general guidance for suitable combinations, the following figure shows starting points for the optimization process and recommendations if piston underside drain oil monitoring is not done.

- 0.1% < Sulphur < 0.5% m/m:** On board piston underside drain oil monitoring must be strictly followed, residual BN must not be lower than BN10, iron (Fe) must be measured as well and should be below 500 mg/kg. Additionally, piston and piston ring condition must be inspected through scavenge ports in regular intervals.
