ENGINE BEARING:

FAILURE ANALYSIS AND CORRECTION

Technical information

OEB-2-1114

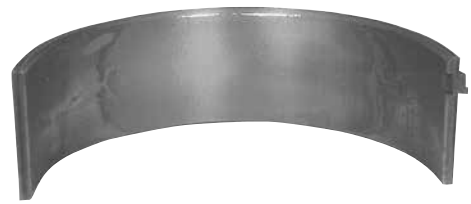
4 Normal appearance

Uniform wear pattern over approximately 2/3 of the bearing's surface. Wear should diminish near the parting line ends of the bearing, and the wear pattern should extend uniformly across the bearing in the axial direction.

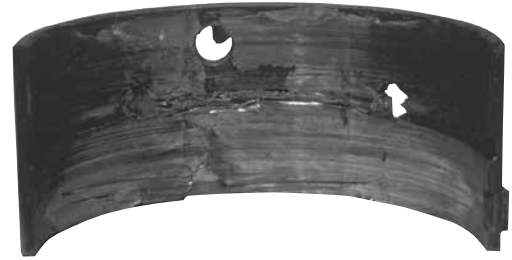
A hot short is a catastrophic failure that results from one of the conditions already covered in detail. To properly correct this it must first be determined which specific condition lead to the hot short. For further details please see:

1. Foreign Particles in Lining (Page 8)
2. Foreign Particles on Bearing Back (Page 9)
3. Out-of-Round Bore (Page 18)
4. Excessive Crush (Page 12)
5. Bent or Twisted Connecting Rod (Page 14)
6. Shifted Bearing Cap (Page 11)
7. Distorted Crankcase (Page 16)
8. Bent Crankshaft (Page 17)
9. Oil Starvation (Page 20)
10. Misassembly (Page 10)

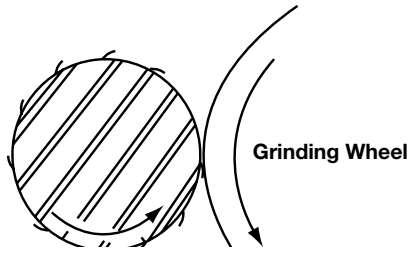
Fig. 4
 Directions of shaft and grinding wheel rotation and lay of
 fuzz which results

Having determined the desired surface lay from polishing, we must next establish the proper direction for grinding to produce a surface lay opposite to that resulting from polishing. Figure 4 shows the grinding wheel and shaft directions of rotation and surface lay for grinding when viewed from the front or nose end of the crankshaft. This orientation will be achieved by chucking the flywheel flange at the left side of the grinder (in the headstock). Achieving the best possible surface finish during grinding will reduce the stock removal necessary during polishing.

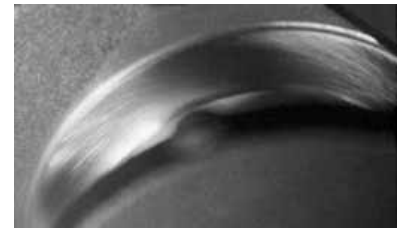
Obtaining a good finish on the thrust face of a crankshaft is difficult to do because it uses side-wheel grinding. Side grinding causes marks that spiral outward toward the OD of the thrust face and may also cause crosshatch marks resembling honing patterns. Both patterns are detrimental to the formation of an oil film because they work like wipers as the shaft rotates. Grinding marks must be removed by polishing. Only a circular pattern should remain. Surface finish should be checked in a tangential direction and must be held to 10 Ra max. The thrust surface should be flat within .0002" max.

avoid - swirl pattern
