Eaton® Fuller® Clutches

Failure Analysis Guide
All Clutch Models

Troubleshooting Guide CLTS-1271 June 2003

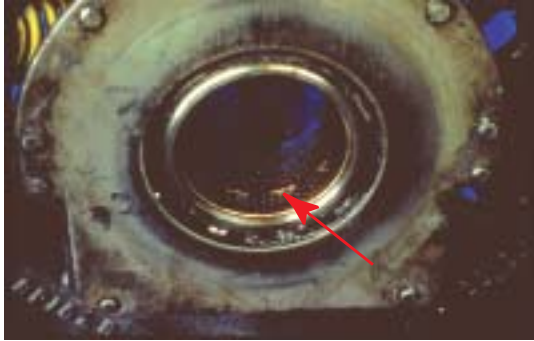
Fig 11

Failure to center the input shaft with the sleeve of the release bearing assembly, when installing the transmission, can cause this failure. If the transmission hangs up during installation, investigate the cause before proceeding as excessive force can damage the bushing (see arrow in Figure 12). Allowing the transmission to hang unsupported in the sleeve bushing can damage the bushing. The arrow in Figure 11 shows another example of sleeve bushing damage on a heavy duty clutch.

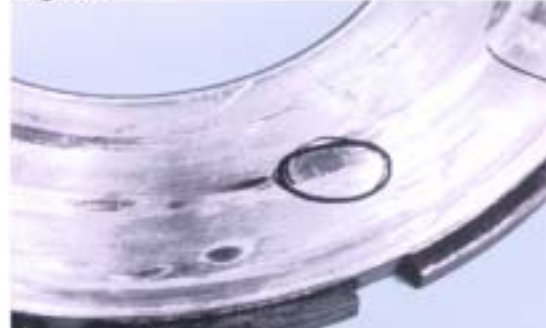
Fig 15

In Figure 15, an area of the intermediate plate has been circled to reveal the damage of heat checks. These heat checks are actually small cracks with raised ridges that are capable of shaving off the facings of the driven disc.

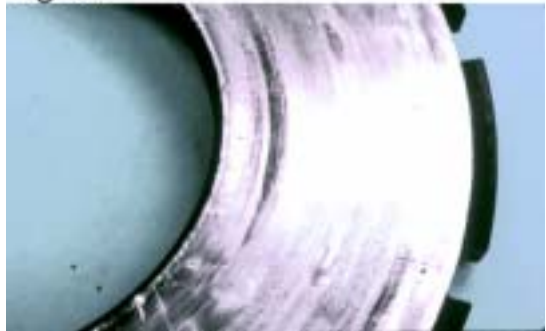
Fig 16

Finally, Figure 16 reveals an example of a burned or scorched intermediate plate in which the metal became so hot that it began to flow. The typical evidence of such a failure will be one or more of the following:

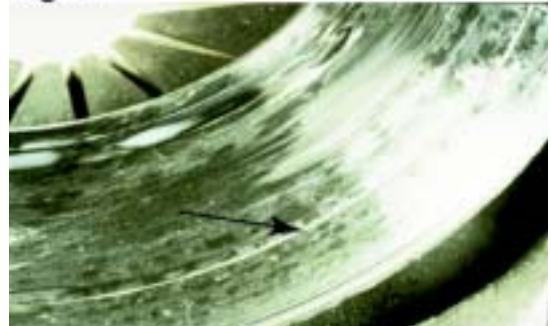
Fig 17

The groove (see arrow in Figure 17) worn into the face of this pressure plate was caused by the rivets of the driven disc facing. (For the related disc failure, see the description under Figure 70). The same damage can occur on both the intermediate plate and flywheel. A surface that is grooved can damage the new driven discs that are installed. As a result, a new clutch assembly should be installed. Refer to the OEM service manual concerning flywheel resurfacing.

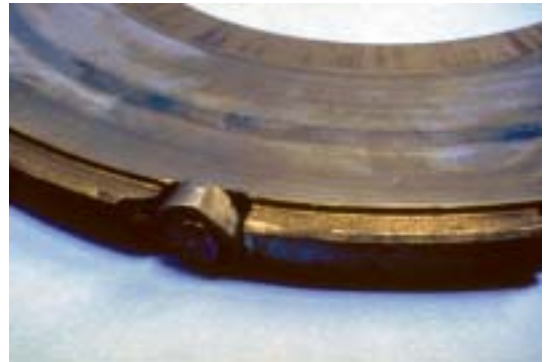
Fig 20

Figure 20 shows a broken drive pin head that has become wedged into the intermediate plate's drive slot. Figure 21 is the same intermediate plate but with excessively worn and broken drive slots. Figure 22 shows a broken drive pin. The above failures can be caused by one or more of the following:

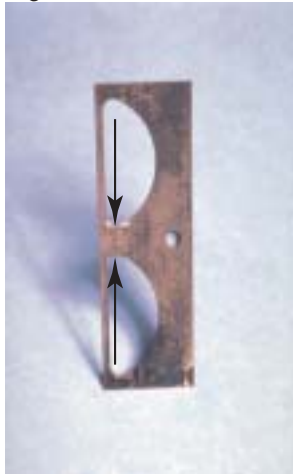
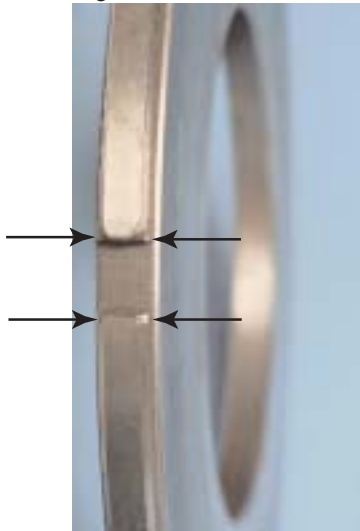
Failure - Anti-Rattle Springs Installed Backwards

As shown in Figures 23 and 24, the intermediate plate was “hanging up” at the corners of the open sections of the anti-rattle springs. The driver’s complaint was a clutch that would not release. It is important that the rounded sections of the anti-rattle springs be installed TOWARDS the flywheel/ engine.

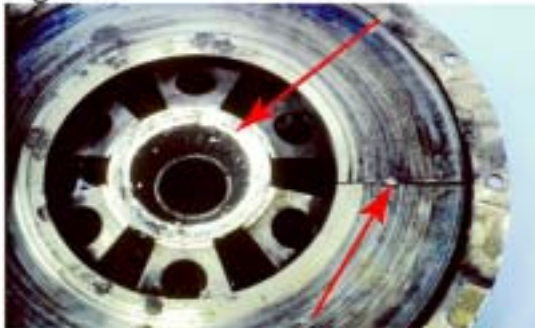
Fig 25

Figure 25 shows the damage done to the nose of the retainer assembly (see arrow) due to contact with the disc rivets. Figure 57 shows the resulting damage done to the rear disc. Adjusting the clutch externally (with the linkage) instead of internally (rotation of adjusting ring) will cause the retainer sleeve/release bearing assembly to move too far forward as the clutch wears, leading to this failure.

An additional result from the above failure is that while the clutch is engaged, it can begin to slip due to the unloading condition created by the disc and retainer interference. This, in turn, will create excessive heat and can cause the pressure plate to break (see Figure 25, black arrow on pressure plate) and /or the ceramic buttons to separate from the disc (see Figure 58). The above failure may also be preceded by a noise complaint.

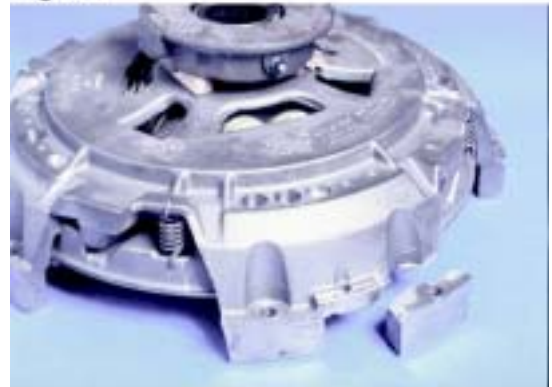
Fig 26

The photo in Figure 27 is a close-up of the broken leg shown in Figure 26. The arrow in this close-up shows where the leg contacted the concrete floor after the clutch was dropped.

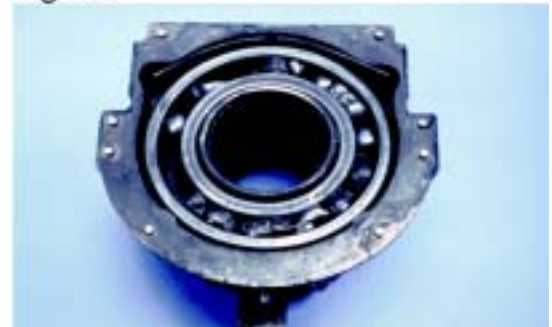
Fig 28

A failed release bearing (see Figure 28) can usually be attributed to one or more of the following situations:

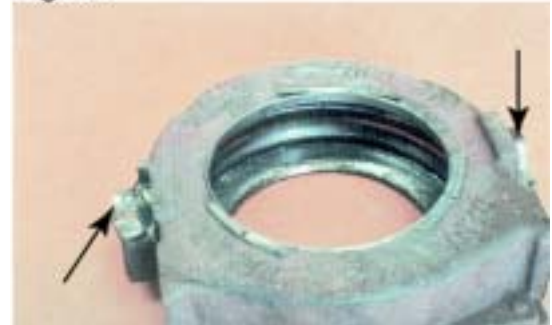
Fig 29

- A dry release bearing due to lack of periodic lubrication (does not apply to sealed bearings).
- Failure to fully release or riding the clutch pedal will place a constant thrust load on the bearing, (see arrows in Figure 29) leading to higher temperatures and consequential loss of lubricant. Failure to maintain free play up in the cab can also cause this condition. Not only will the bearing begin to fail, constant contact in this area will cause both the release yoke fingers (Figure 79), and the wear pads (Figure 29), to wear excessively.

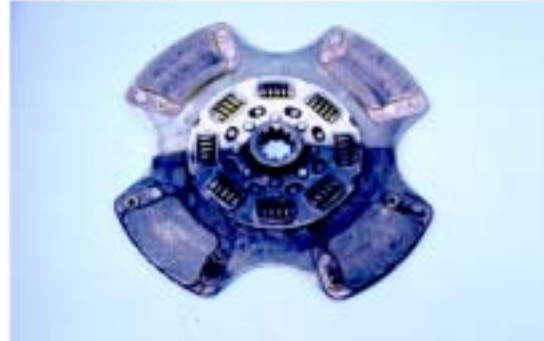
Fig 41 (AR)

A leaking transmission or a leaky rear main engine seal can coat the clutch cover with oil, as indicated in Figure 30. Figure 41 shows the disc which was run with this cover.

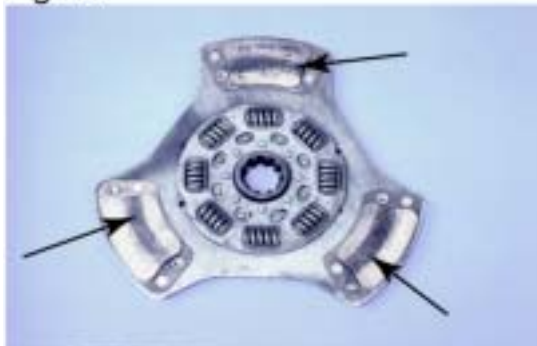
Fig 46

Failure - Abnormal Wear Pattern at Middle of Disc Button

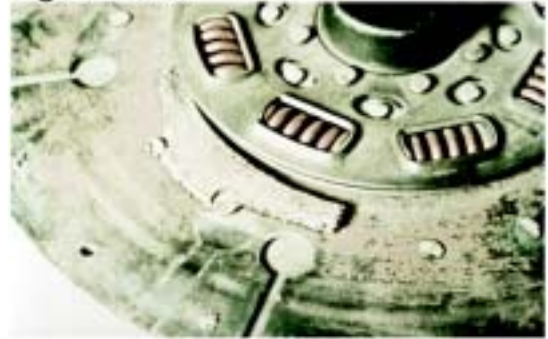
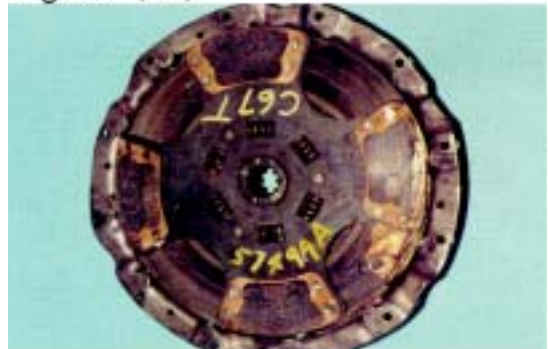
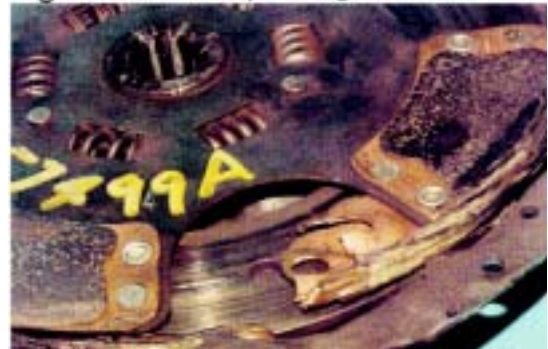
Example: Coasting a tractor down an unloading ramp can burst a driven disc. See Figures 67, 68, and 69.

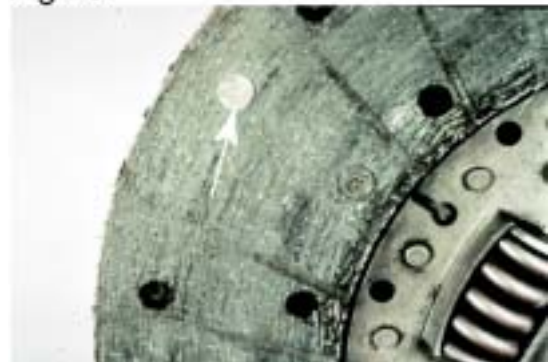
Fig 70

Failure - Worn Driven Disc Facings

When the rivets (those which secure the facing material to the driven disc) begin to contact either the pressure plate, intermediate plate, or flywheel, then the entire clutch assembly is ready for replacement. Referring to the arrow in Figure 70, this rivet has been making contact with the pressure plate shown in Figure 17. Note the "shiny" appearance of the rivet and also the resulting "groove" on the pressure plate.

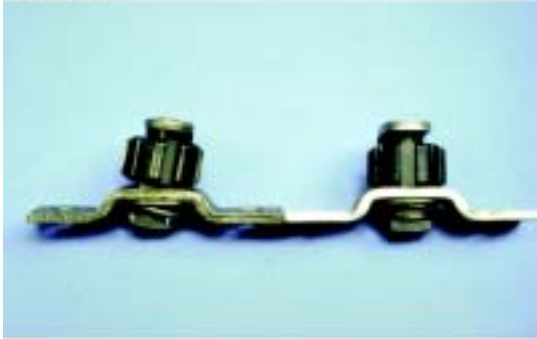
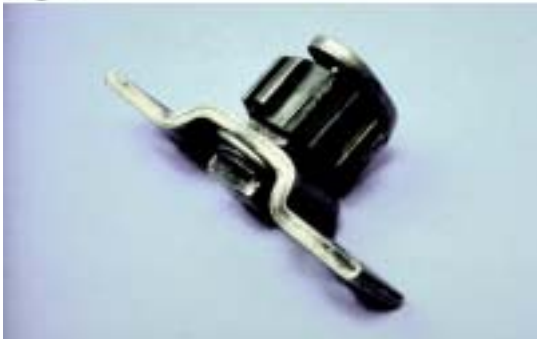
Failure - Bent/Broken Kwik-Adjust® Mechanism

Referring to Figure 71, the kwik-adjust mechanism at the right is a normal and properly functioning adjuster while the one at the left has been damaged, as evidenced by the bent mounting bracket. The one pictured in Figure 72 also has a bent mounting bracket in addition to some broken gear teeth (see arrow). Some causes of these failures can be:

- Forgetting to depress the kwik adjuster while attempting to rotate the gear.
- Only partially depressing the mechanism while attempting to rotate the gear.
- Attempting to rotate the gear while the clutch pedal is in the up position (clutch is not released).

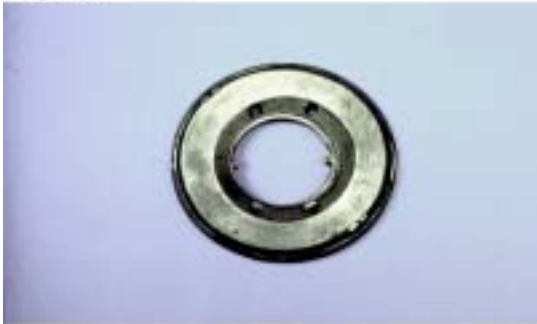
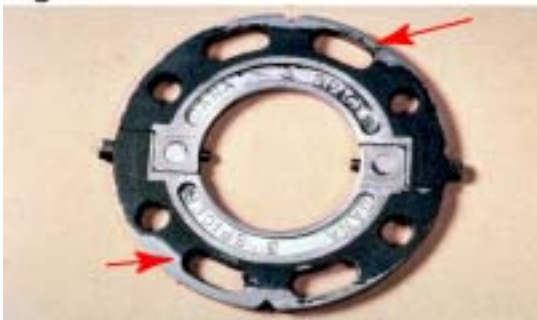
Failure - Worn Clutch Brake

As shown in Figure 73, the facing material on this clutch brake is completely worn away. Figure 74 shows a clutch brake that is partially worn (see arrows). Both types of failures can be attributed to one or more of the following:

- A clutch that is releasing poorly (for corrective action, see the troubleshooting section titled "Poor Release"), thus making it more difficult for the clutch brake to stop the transmission input shaft.
- "Hitting" or engaging the clutch brake when the transmission is in gear and the vehicle is in motion.
- The clutch brake was set too high.
- Installing the new clutch brake in front of a worn/rough transmission bearing retainer cap.
- Clutch brake is simply worn out.

Note: A worn clutch brake should be replaced. Be sure to always check the transmission bearing retainer cap for any wear and replace if necessary (see Figure 3).

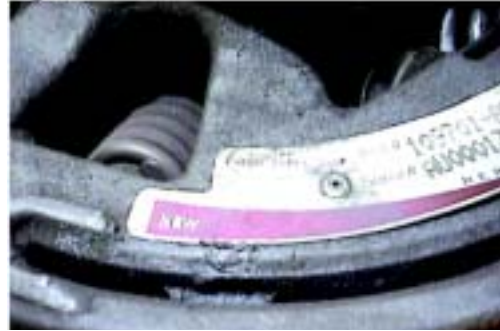
Fig 75

Failure - Solo Cam Tab Broken Off

In Figure 75, the tab was broken when someone was attempting to change the adjustment of the clutch. The clutch cannot break the tab. Many times the tab is broken to change the bearing to clutch brake distance when it is in the proper position. Do not attempt to change the clutch adjustment before measuring the release bearing to clutch brake distance.

Note: Consult the troubleshooting guides for help. If the release bearing is set to the correct dimension, do not attempt to use the cam tab to change the adjustment to the wrong dimension and break off the tab. Troubleshooting guides: CLTS-1296 (Medium-Duty) and CLTS-1295 (Heavy-Duty).

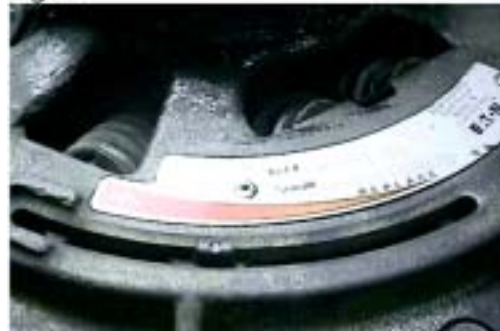
Fig 76

Failure - Solo Over Adjust Problem

Measure the distance between the release bearing and clutch brake. Correct distance should be between .490" and .560" with the pedal up (Figure 76). If the bearing is close to the clutch brake and the clutch has not been removed and re-installed on the fly-wheel, then an overadjust might have occurred. Consult troubleshooting guides for help. Follow the fault tree for proper diagnosis and correction.

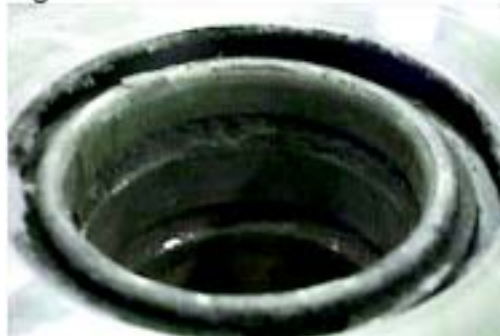
Fig 78

- A potential result of this wear is that the release yoke will force the bearing and sleeve assembly against the input shaft. Consequently, this "side loading" condition can damage the bushing, sleeve, and input shaft (see Figure 78).

Failure - Bushing Wear and Bushing Failure

As shown in Figures 77 and 78, incorrect lube or not enough lube can cause a failure. External contamination will also cause wear to the bushing. The transmission input shaft may be rough and require replacement. Use approved/compatible lube. (High quality N.L.G.I #2 or #3 lithium soap grease with E.P. additives 325 degree operating temperature). Apply ample lube and let it flow out of the opening from the bearing housing. Apply additional lube onto the transmission shaft to ensure the bushing will have proper lube. Apply lube to the tips of the release yoke.

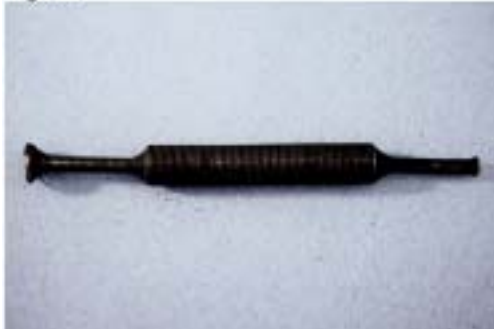
Fig 79

Failure - Solo Cam Tab Spring Broken - Solo Stops Adjusting

Consult troubleshooting guides for help. There will be no tension pulling the cam/wear indicator toward "replace." Troubleshooting guides: CLTS-1296 (Medium-Duty) and CLTS-1295 (Heavy-Duty).

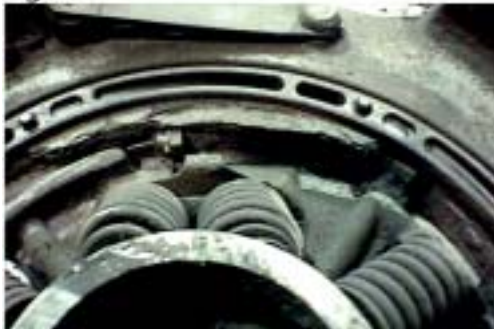
Fig 80

Failure - Solo Adjustment Rings Contaminated - Solo Stops Adjusting

If there is excessive amounts of contamination allowed into the clutch housing, the Solo may stop adjusting and there will be a loss of free pedal in the cab (see Figure 80). Check to see if the inspection cover has been removed. In severe dust applications, it may be necessary to seal all openings in the clutch housing.

Eaton has created a tool that may help free up the clutch to allow it to continue adjusting. #CLPISOLOTOOL can be obtained by calling 800-826-HELP (4357).

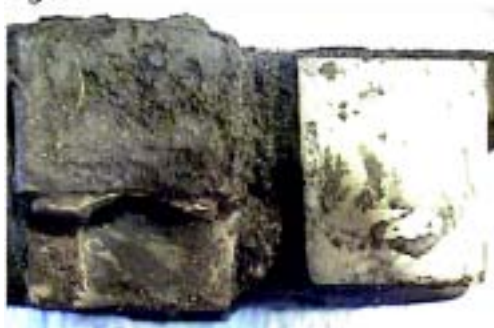
Fig 81

Failure - Worn Wear Pad on Release Bearing caused by Running the Truck without Free Pedal

When the clutch is properly maintained, there should always be free pedal in the cab. This will prevent fork contact with the bearing wear pads and reduce the wear to the pads and the release fork (Figure 81). Follow adjustment instructions for correct clutch and linkage adjustment. Adjust the clutch before free pedal is lost. Apply grease to the yoke fingers to reduce friction when the clutch pedal is stroked.

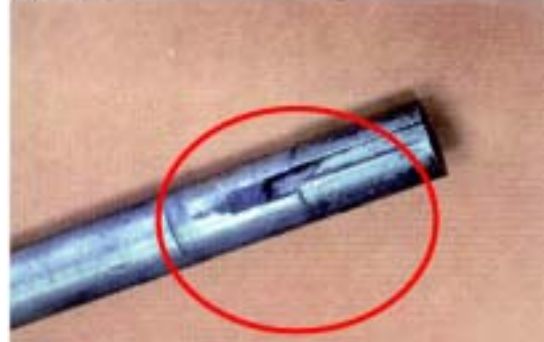
Fig 82

Failure - Cross Shaft Wear

Figure 82 is an example of a worn cross shaft (release shaft). A worn cross shaft (see circle) will occur after high mileage and will be accelerated by a lack of lubrication. Some problems associated with worn cross shafts (and/or worn linkage systems) are:

- Sporadic changes in the amount of free play in the cab
- A binding condition in the linkage system
- Erratic engagement of the clutch
- Side loading of the release bearing housing

As a result, a typical complaint might be that it is impossible to maintain proper clutch adjustment. To prevent future clutch problems, always inspect the linkage system for excessive wear and/or binding conditions before installing the new clutch. Be sure to replace any worn components that might hinder clutch operation. Also, remember to lubricate the linkage pivot points.

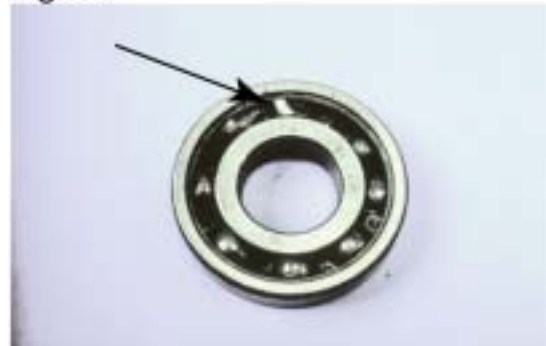
Fig 83

Failure - Seized/Dry Pilot Bearing

Once removed from the flywheel, a failed pilot bearing can be identified by one or more of the following conditions:

- The bearing is dry; it is difficult to turn (rough) or completely seized. Any condition which causes a dry bearing will have been accompanied by a noise complaint while it was in the vehicle.
- A damaged ball bearing cage (see arrow in Figure 83).
- A step is worn into the inner race. The step is caused when the input shaft spins within the inner race, a direct result of the seized pilot bearing.
- The seal is missing and/or damaged because of excessive heat generated by the dry bearing.

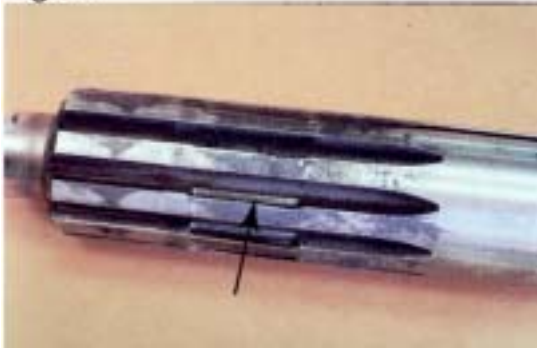
Fig 84

Failure - Input Shaft (Drive Gear) Spline Wear

Drive gear spline wear will cause clutch release problems since the driven discs cannot slide freely on the splines. This is especially true if new driven discs are installed on a worn input shaft (Figure 84). Excessive spline wear can be attributed to torsional vibrations. This type of wear can be eliminated or lessened by the use of dampened driven discs. Spline wear will also occur on the mating driven disc hubs (see Figures 61-62). Misalignment can also be a factor in abnormal spline wear. It is important to always inspect the input shaft for wear before installing a new clutch. If worn, it is recommended that a new input shaft be installed to eliminate possible clutch problems later on.

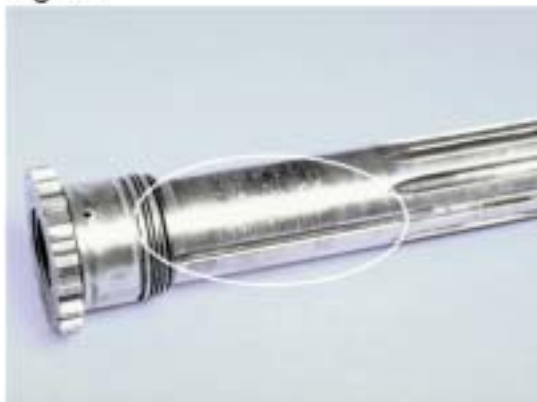
Fig 85

Failure - Galled Input Shaft

This failure resulted when the clutch's release sleeve was being "side loaded" onto the input shaft (Figure 85). A worn linkage system and/or excessive wear on the release bearing "wear pads" and "release yoke fingers" can cause this side loading condition.

A galled or rough input shaft (in the non-splined area) will damage the bushing(s) of not only the original clutch, but also that of the newly installed clutch. As a result, make sure you replace the input shaft and any worn linkage components to prevent the failure from being repeated.

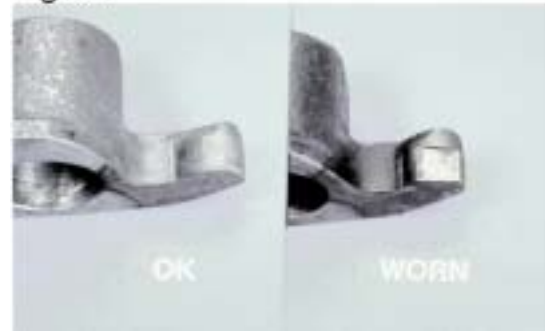
Fig 86

Failure - Worn Fingers on Release Yoke

Consequently, there will be continual contact between the release yoke fingers and the release bearing wear pads. A yoke that is worn excessively may hinder the engagement/control of the clutch. See Figures 1, 5, and 10 for additional photos and descriptions of release yoke failures.
