KMP BRAND TECHNICAL BULLETIN

Valve Failures

KB-15004

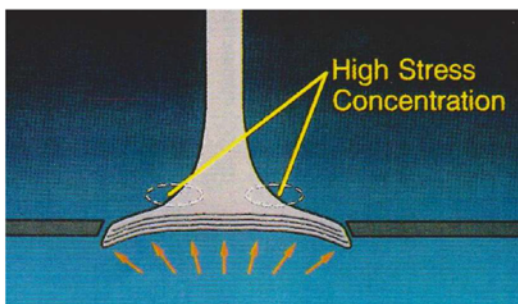
Head breakage can result when the valve head temperature rises above 650°C as this can allow cracks to develop in the areas of stress concentration

These cracks are referred to as chordal fractures and they originate in the lower portion of the underhead radius where they gradually progress through the valve head until a piece/pieces of the head become detached as a result of fatigue which is characterised by the presence of beachmarks across the fracture face. Some possible causes of the high temperatures are, abnormal combustion, inlet air restrictions, high inlet air temperatures or exhaust restrictions. A chordal fracture can also result from misalignment or from impact damage.

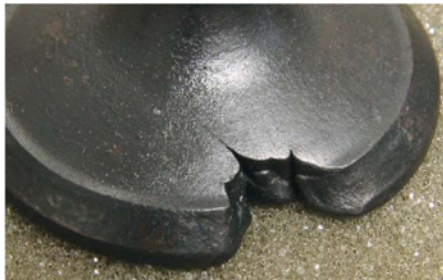
VALVE FACE BURNING

This type of damage can be referred to as channeling, guttering or torching and results from the leakage of burning combustion gases passing between the valve face and valve seat.

The leakage results in elevated temperatures which exceed the melting point of the valve and seat and erosion of the material takes place.

The poor seating of the valve can result from a number of causes, carbon buildup, misaligned or worn valve guide, cracked valve seat or valve, incorrect lash setting, or insufficient stem to guide clearance.

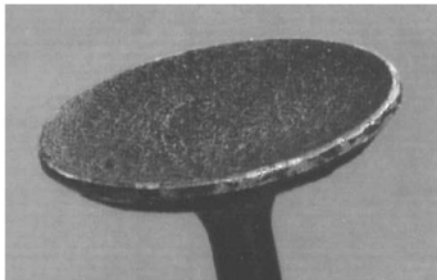
DISTORTION

The valve head is distorted in a manner referred to as cupping or tuliping and results from very high combustion temperatures and pressures.

Some of the possible causes for this type of failure are, a combustion irregularity, excessive valve spring pressure or a cooling system malfunction.

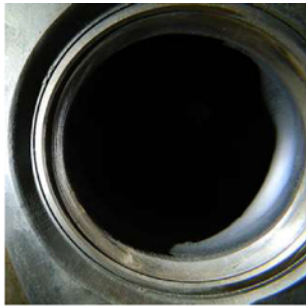
Valve seat recession is another form of wear because when the valve is closing there is a combination of impact and sliding and these result in valve seat wear. As the wear progresses the valve recedes deeper into the insert and this results in the loss of the lash setting and incorrect valve seating.
