# KOHLERENgines

# Failure Analysis Guidebook

# **Failure Analysis**

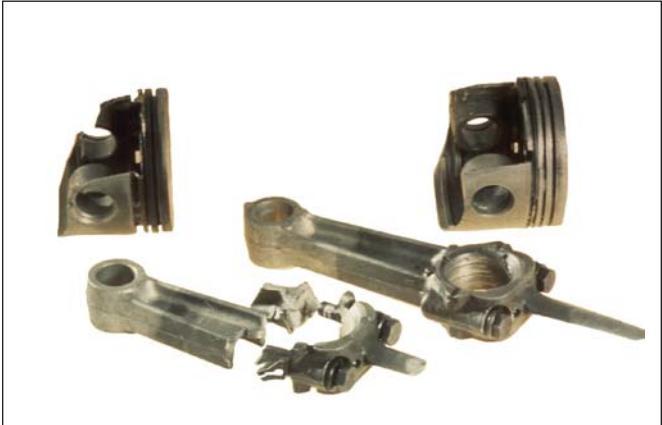
Figure 1.

**Figure 1** shows two sets of parts from the same engine. The original piston failed from excessive clearance and slapping. The mechanic didn't measure the bore for wear and rebuilt the engine with standard parts. The bore wear was still present, so the new piston began slapping and broke up nearly identical to the original.

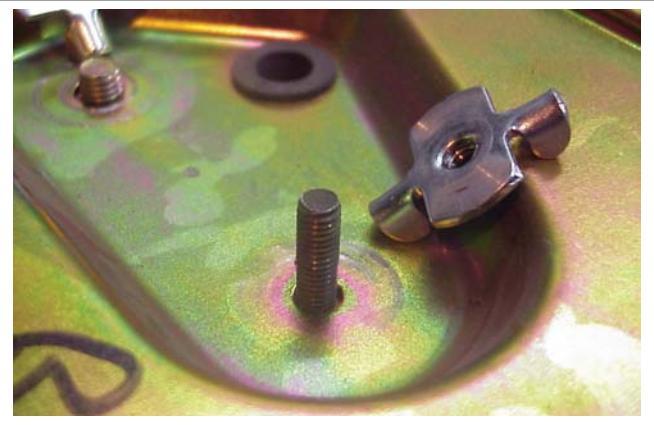
Figure 3.

**Figure 3** – Most engines also have an inner cover on the air cleaner element, which provides backup protection in case the outer cover gets bumped or works loose. The inner cover may be a separate piece of stamped sheet metal, or it may be part of the element.

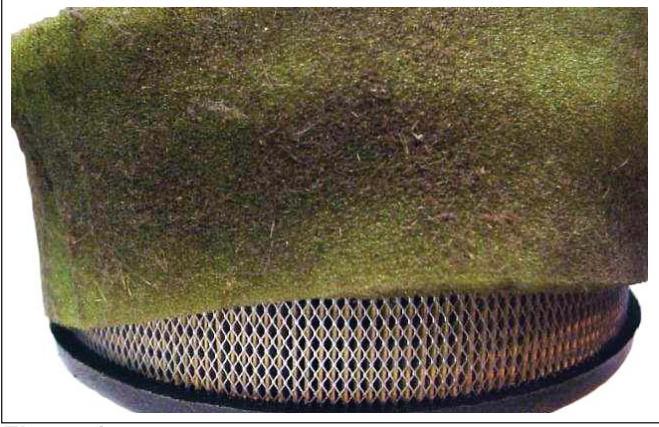
Figure 4.

**Figure 4** – Carefully remove the precleaner. Check it for tears or deterioration. Does it look like it's been serviced regularly, at the recommended 25 hour interval?

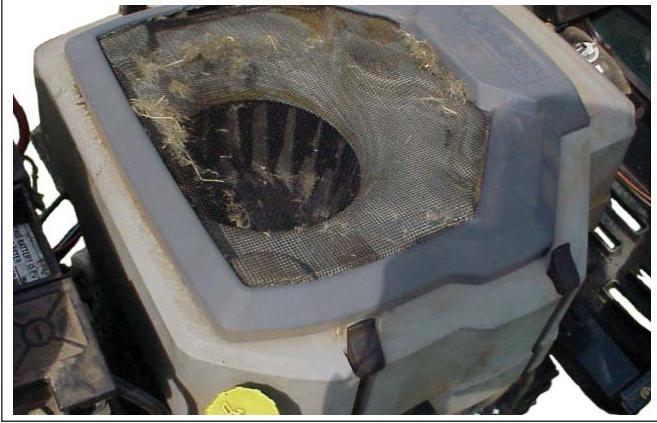
Figure 11.

**Figure 11** – Check the overall condition of the exterior. Is the outside relatively clean, or is there an accumulation of oil, dirt, chaff, etc.? Are there any visible oil leaks? Also check for any indication that the engine may have been disassembled or repaired previously.

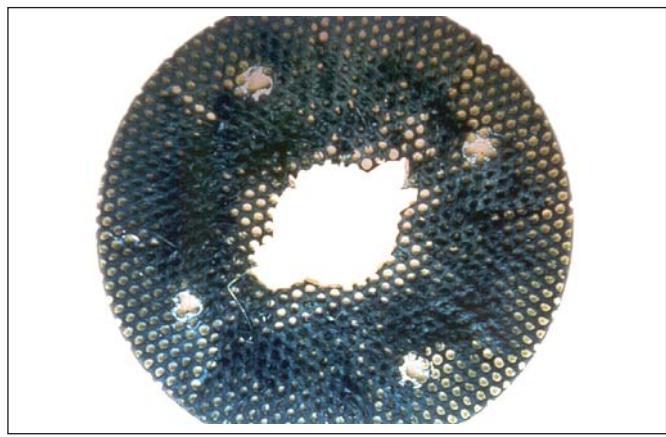
Figure 12.

**Figure 12** – Is the grass screen plugged or restricted, possibly contributing to overheating?

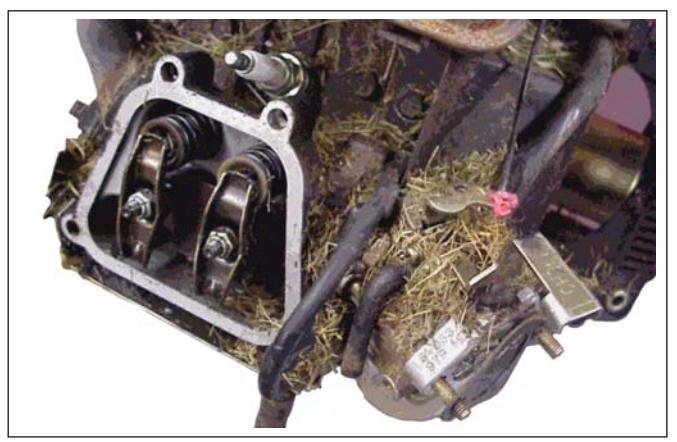
**Figure 13** – What about the cooling fins? The engine needs adequate air flow across the cooling fins to dissipate heat.

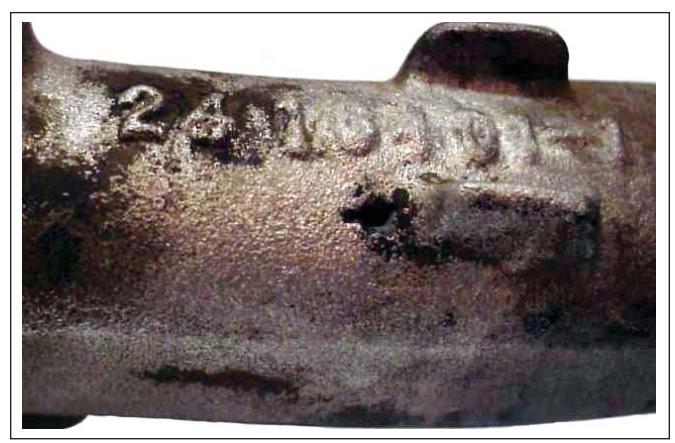
**Figure 14** – Carefully examine the carburetor and the intake manifold. Is anything broken or loose? Is there dirt or debris in the manifold/intake area? Are the mounting gaskets in the right location and are they the right ones?

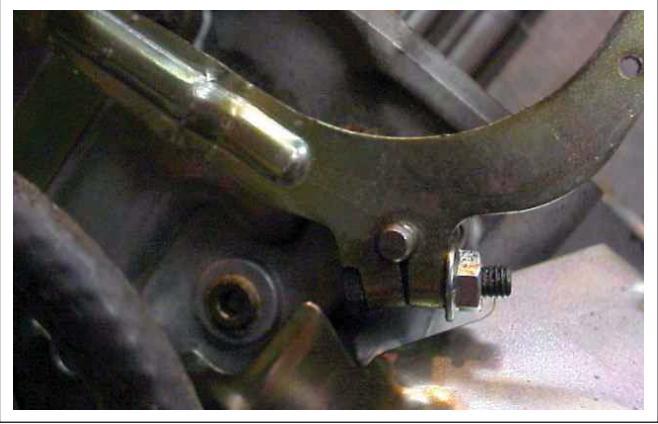
Figure 15.

**Figure 15** – Check the external governor components and linkages. Are any of the pieces bent, broken, or missing? Have any non-factory modifications been made?

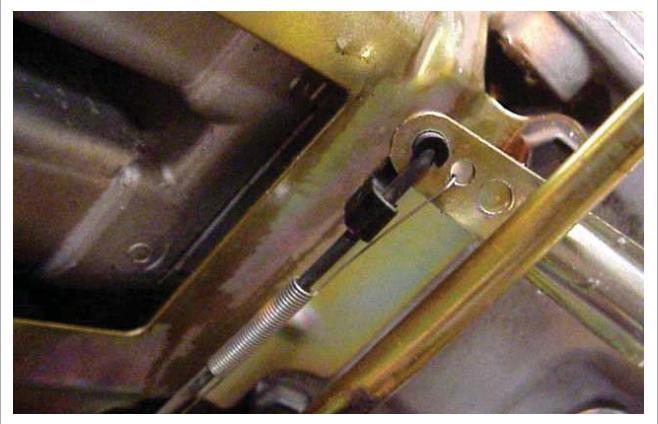
Figure 16.

**Figure 16** – Operate the throttle control and check whether the mechanism can move freely through its normal range. Check the initial governor adjustment setting. Also note the position of the governor spring. Has it been moved?

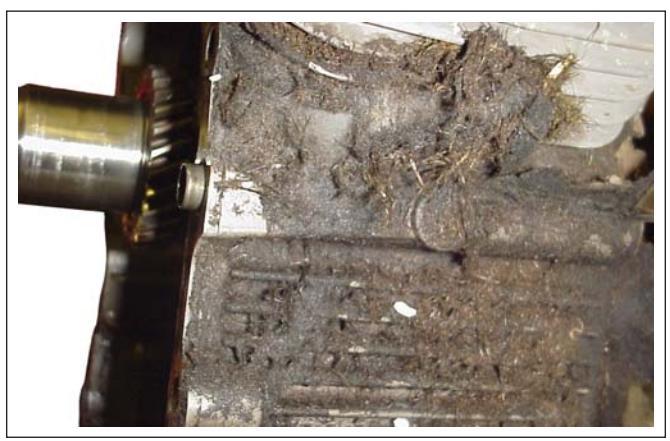
Figure 17.

**Figure 17** – After the shrouds have been removed, check the cooling fins and cylinder block surfaces that were not visible earlier. Note any additional findings on the Engine Inspection Data Record.

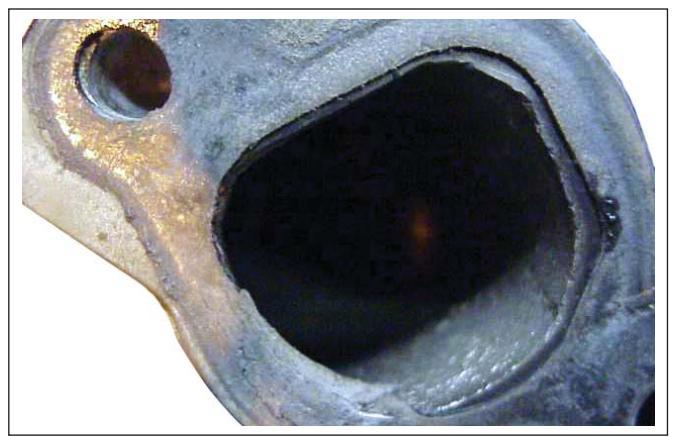
**Figure 18** – After removing the carburetor, check the throat of the intake manifold or intake port for traces of dust, dirt, or other contamination.

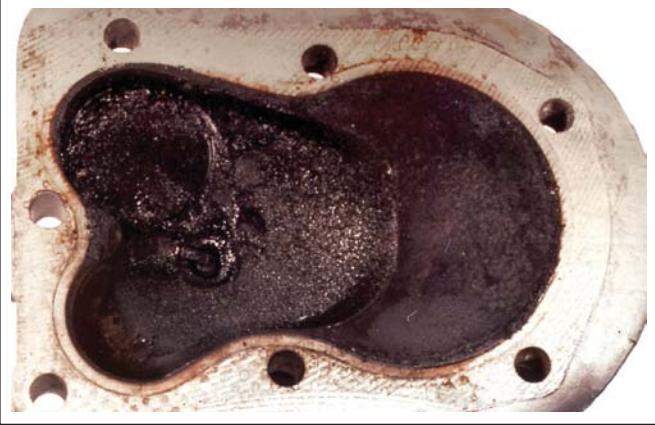
Figure 20.

**Figure 20** – Here is another head with similar oily, glossy-looking deposits. A build-up of crankcase pressure (breather plugged or inoperative), forcing oil past the rings, could cause this also.

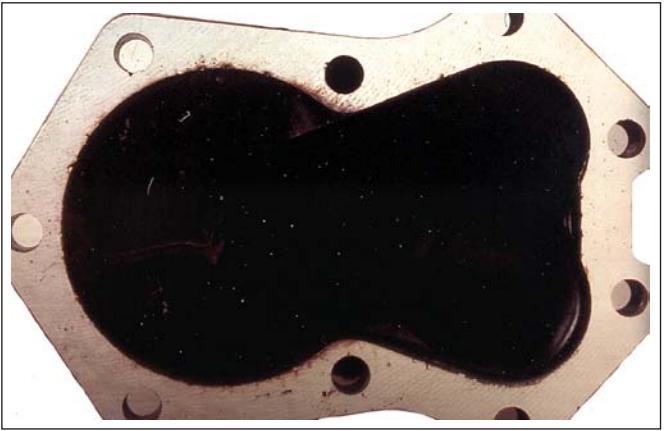
Figure 21.

**Figure 21** – Soft, black, sooty deposits result from incomplete combustion. They could be due to overrich carburetor settings, a blocked air filter, or retarded timing.

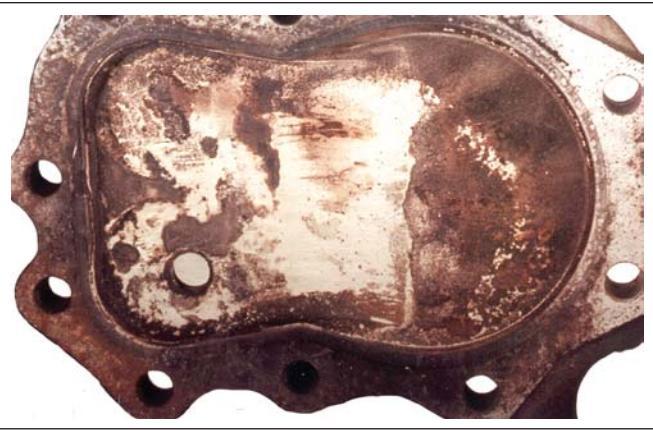
Figure 22.

**Figure 22** - Hard, crusty, mottled white deposits result from high combustion chamber temperatures. They could be from lean carburetion, an intake air leak, over-advanced timing, or poor quality gasoline. Deposits of this type will often be accompanied by a blown head gasket. The high temperatures and pressures that cause the white deposits also cause the head to distort and push the hot exhaust gases past the gasket. If the engine is operated with the blown gasket, the escaping hot gases can act like a torch and burn a slot through the gasket and sometimes even through the head.

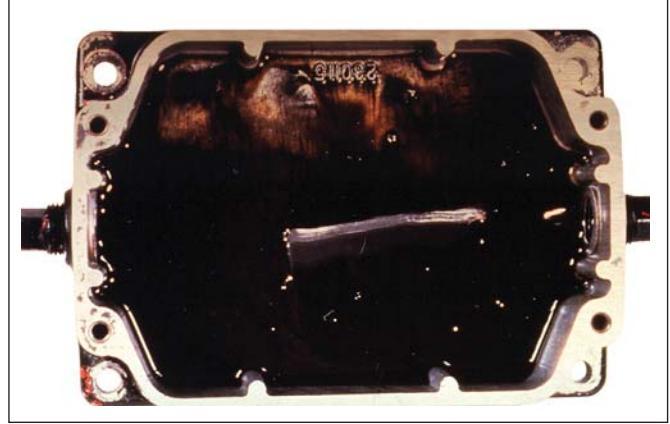
Figure 23.

**Figure 23** – Check the bottom of the oil sump. A layer of sludge in the bottom of the engine indicates that contamination was entering the engine, the oil was not being changed at the recommended interval, or incorrect oil was used.

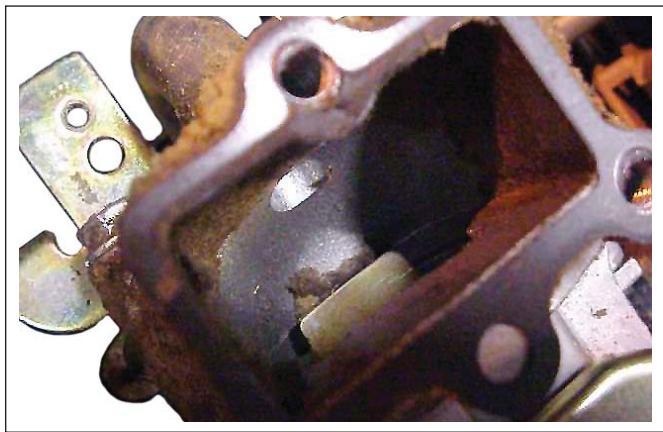
**Figure 33** – If a valve stem shows signs of abrasive material or scoring, check the carburetor inlet and air cleaner base for signs of dirt bypassing the air filter or precleaner.

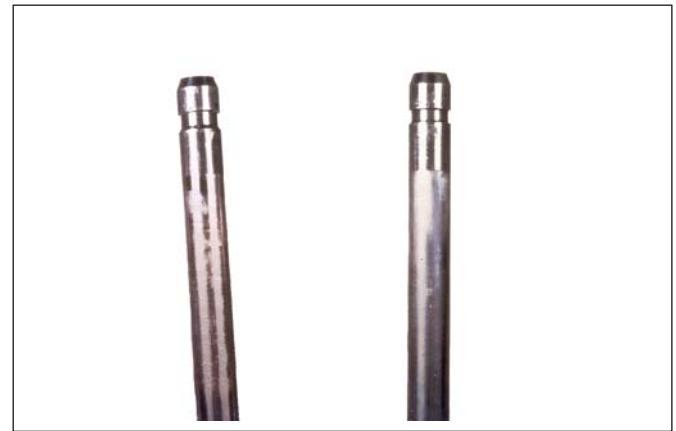
**Figure 34** – If your preliminary examination of the engine indicated the possibility of dust or dirt entry, check the stem of the intake valve(s) for further confirmation. The valve stems should appear shiny like the one on the left. If contamination has been entering through the air intake, the stems will have dull wear patterns where they travel in the guides.

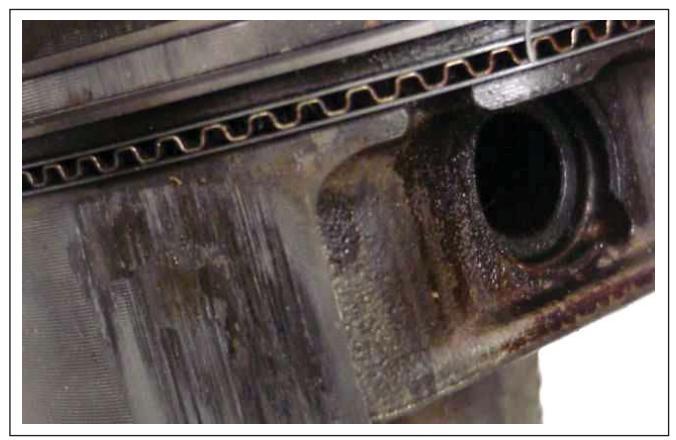
Figure 36.

**Figure 36** – Be careful when disassembling the major components, so you do not disturb or destroy any critical evidence.

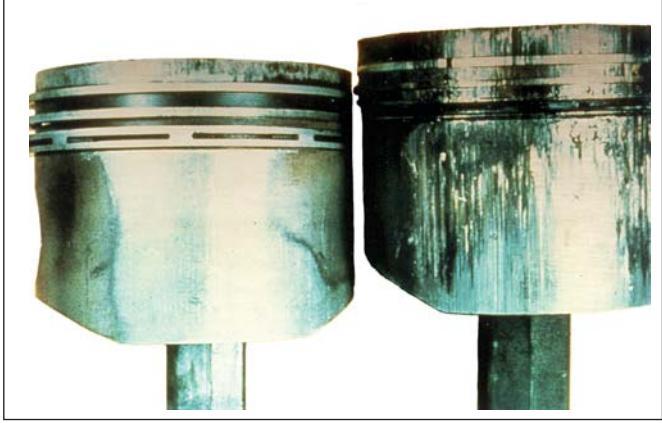
Figure 37.

**Figure 37** – Problems relating to the piston and rings will usually fall into one of two categories, excessive wear or piston seizure.

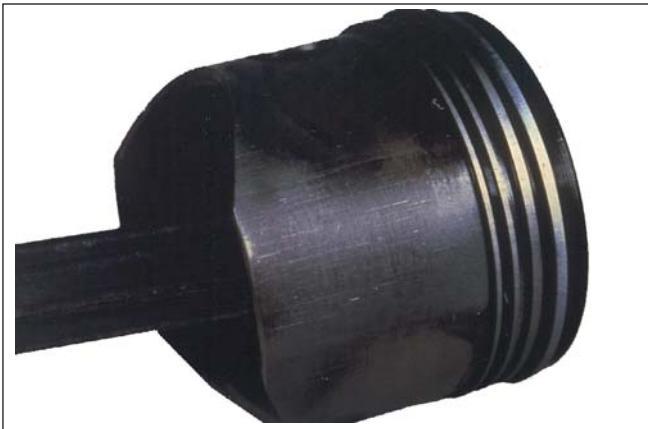
Figure 39.

**Figure 39** – Damage from contamination entering an engine can occur over an extended period of time with very slight leakage, or it can be quite rapid, if a significant amount of dirt is entering. This damage occurred in just 15 hours of running from ingesting about 1/4 teaspoon of dust per hour.

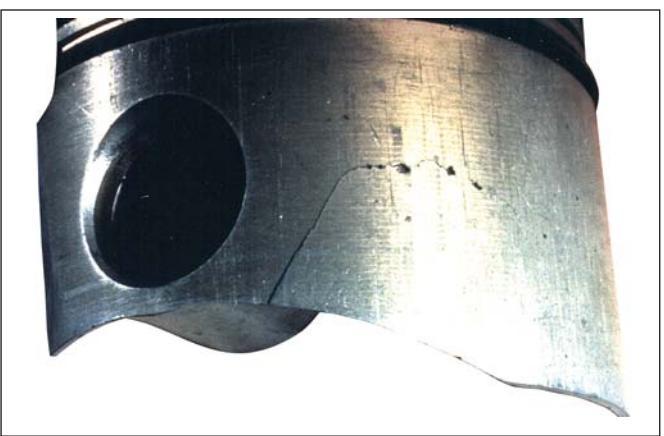
**Figure 42** – If a customer ignores the first signs of wear (oil consumption and blue exhaust smoke) and continues to run the engine, the wear will progress to the point that the piston begins to "slap" because of the excessive running clearance. The piston slap puts increased stress on the piston skirts and they can begin to crack.

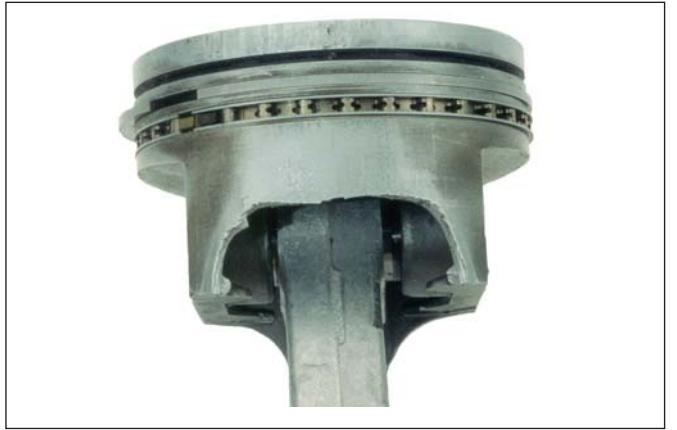
Figure 44.

Figure 44 – In some cases, just the lower portion of the skirt will break off.

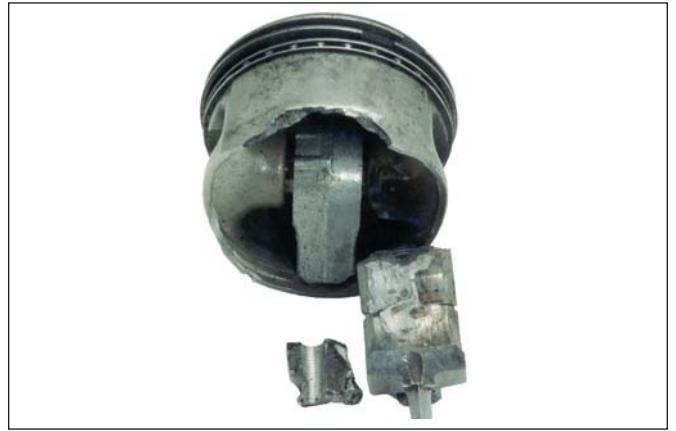
Figure 45.

**Figure 45** – In other cases the whole piston will break up. The customer will not be able to ignore it any longer.

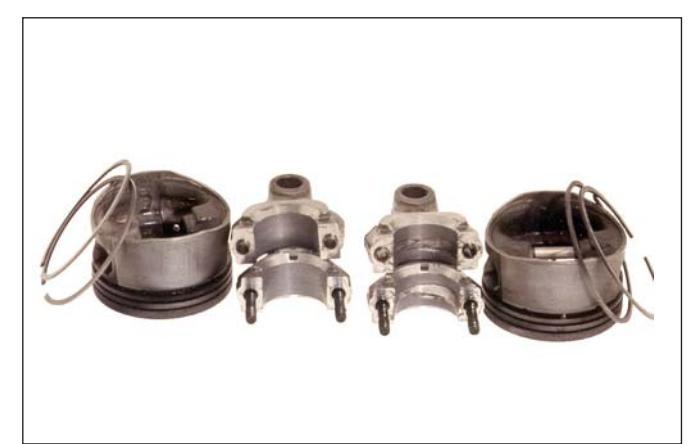
Figure 46.

**Figure 46** – A customer that doesn't maintain a twin cylinder engine ends up with double trouble.

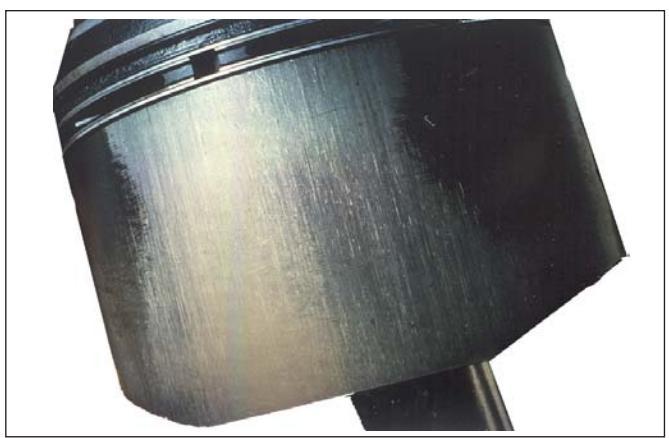
Figure 47.

**Figure 47** – This engine ran for only 6 hours following a rebuild. The piston ring end gaps go as high as .042 in., and the crankpin was .007 in. undersize.

**Figure 72** – This connecting rod came from the engine mentioned earlier (Figure 47) where the block was not cleaned properly after honing. Again note the worn bearing surface with the abrasive trail in line with the oil hole.

Always scrub the cylinder with hot water, detergent, and a brush after it has been bored or honed. Use sufficient detergent to provide good sudsing action. This way, you can be certain that the machining oil is broken down to allow complete removal of the grit particles from the pores of the iron.

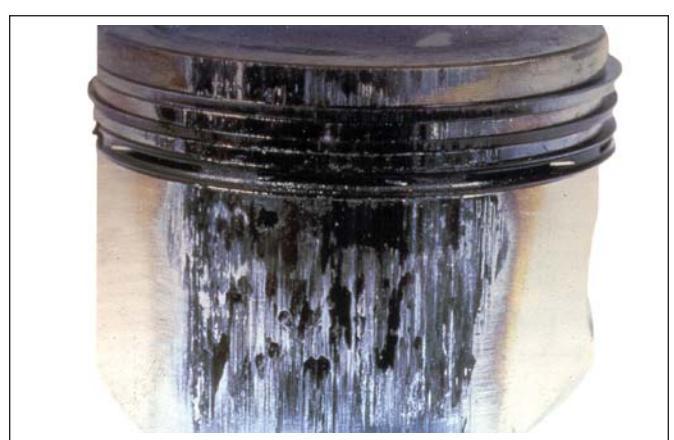
**Figure 55** – Seizures due to insufficient running clearance will usually result in scoring without any other signs. The scoring may show up on both thrust faces, heavier on the primary face (toward the valves).

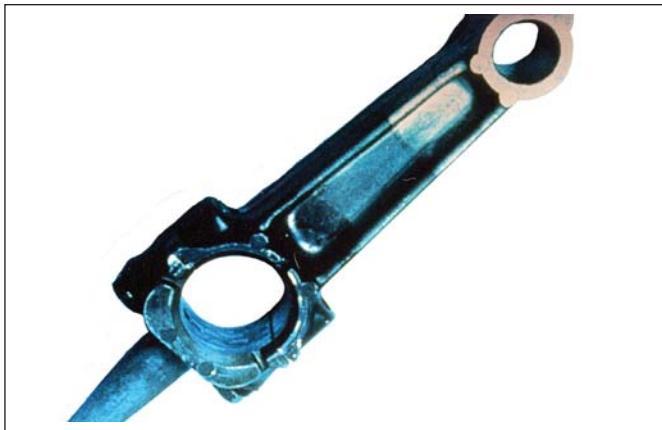
Figure 56.

**Figure 56** – There are many different failure modes on connecting rods, but some of them are more common or prevalent than others. A few years ago, a task force at Kohler Co. analyzed more than 400 connecting rod failures. When they compiled their data, nearly 75% of the failures they had looked at were similar to the rod in this photo, so this could be considered a "typical" connecting rod failure.

The connecting rod had seized onto the crankshaft, melting and searing the aluminum on the bearing surface in the process. The exterior surfaces are dark, with burned oil deposits around the journal area. Often, the burned oil deposits will extend part way up the beam and down onto the dipper (if it's a splash-lube rod). The rod may be fractured, possibly a single break, or several pieces, Sometimes, on twin cylinder engines, the engine keeps on running on the opposite cylinder after one rod has failed, and the broken rod gets smashed into many tiny fragments. Those are probably the most difficult to analyze, because the pieces are so small it's difficult to find and identify any good failure indicators.

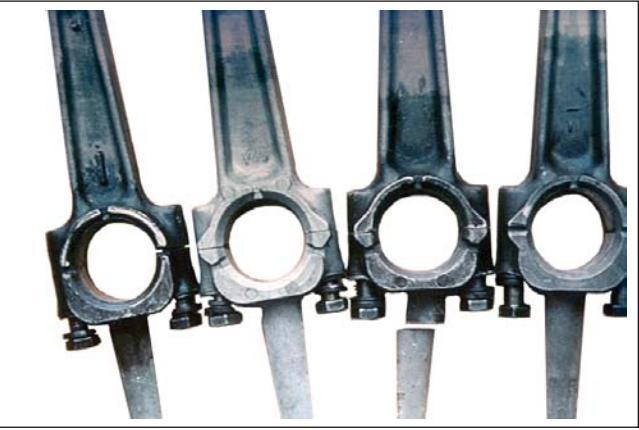
Figure 58.

**Figure 58** – The first area to examine is the journal area and the dipper (if it has one). Did the rod seize, causing the aluminum on the bearing surface to smear and transfer? Is the outside of the journal area discolored/ darkened? Are there burned oil deposits present? Do the burned oil deposits extend down onto the dipper? What is the condition of the dipper (intact, broken, nicked or scraped, discolored)?

The first rod on the left is very similar to Figure 56. It seized on the crank and it has burned oil deposits on the outside of the journal. A seizure results when there is inadequate lubrication between the crankshaft and the rod. The burned oil deposits indicate there was some oil present, but it wasn't providing adequate lubrication. The engine was probably run low on oil.

The second rod had some running time, but it never had failure or problem. It is included in the photograph to help you distinguish color variations.

The third rod has a broken dipper. The lighter color of the broken segment indicates that the break occurred before the rod seized. In fact, the broken dipper caused the failure. If the color had been the same on both sides of the break, it would have indicated that the dipper broke after the seizure and the cause of failure would have to be found elsewhere. The last rod came from an engine that was started with no oil. The bearing surface is smeared, and the rod is darkened from the heat of the seizure, but there are no burned oil deposits because there was no oil present.

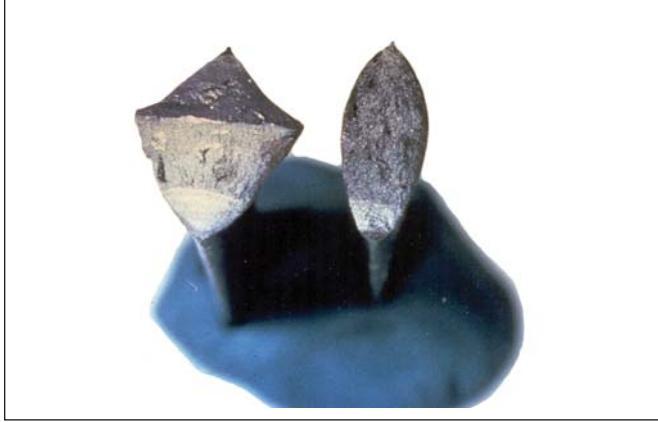
**Figure 59** – If the dipper is broken, look closely at the break surface. Is it a tensile break or a fatigue break?

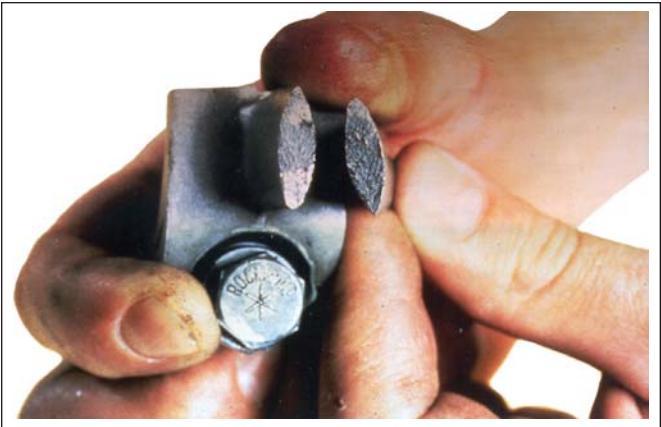
Figure 60.

**Figure 60** – A tensile break results from a single sharp blow that breaks off the dipper. The dipper will have a nick or scrape where it was hit, and the break surface will be quite rough, because the metal has been torn apart. You might also notice a "feather" pattern, which can indicate the direction of the breaking force.

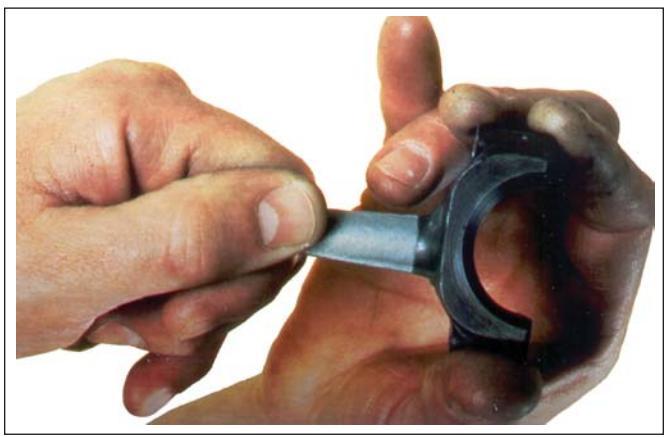
**Figure 62** – After the dipper drops off, the rod will seize because the oil is no longer being circulated to the bearing surface. The high friction temperatures generated during seizure cause the oil to burn around the journal area and down to the break line. A definite color variation will be obvious at the break line.

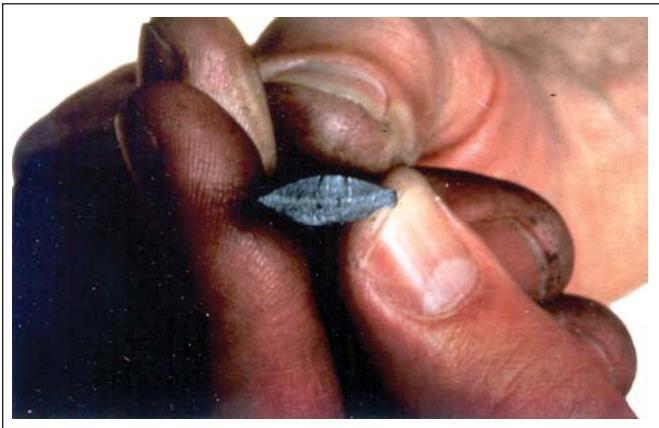
Figure 63.

**Figure 63** – The break surface of a fatigue break will be smoother than a tensile break. Often the fatigue process leaves semi-circular markings, called beach marks, on the break surface. The center of the markings is the point at which the break originated. Here the dipper was bumped or damaged from the side.

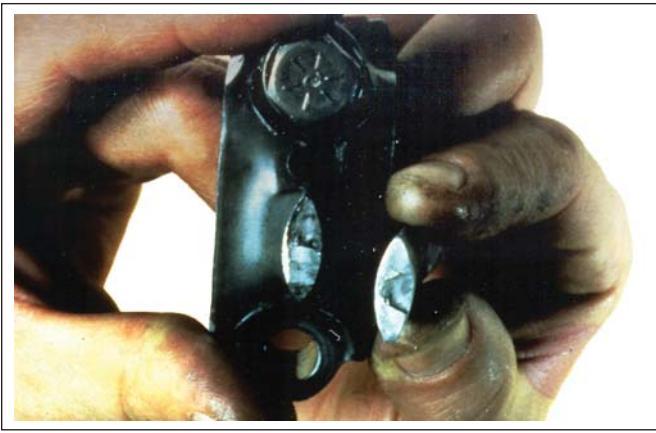
Figure 64.

**Figure 64** – Examination of this break surface confirms that it is a fatigue break, and also reveals the cause of the break, a casting defect.

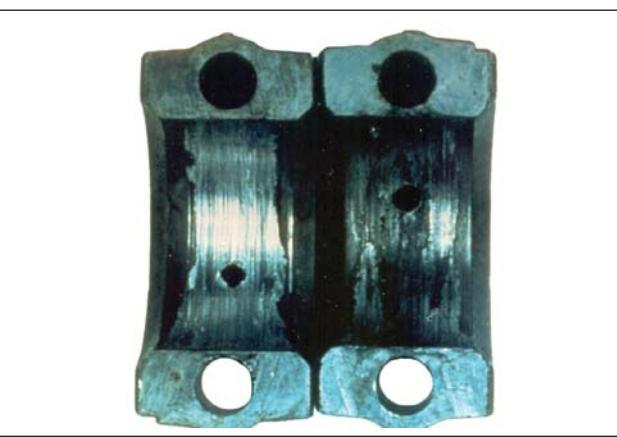
Figure 65.

**Figure 65** – The second area of examination is the bearing surface of the rod. The bearing surface will often be smeared, but it can still reveal clues about the conditions at the time of failure. These two rod caps are a good example. Notice the difference in color.

The cap on the right has streaks of burned oil blended with the smeared aluminum, indicating that there was some oil present, but not enough for adequate lubrication. It's from an engine that was run low on oil. The cap on the left has only the bright, smeared aluminum, no traces of oil. It was from an engine started without oil.

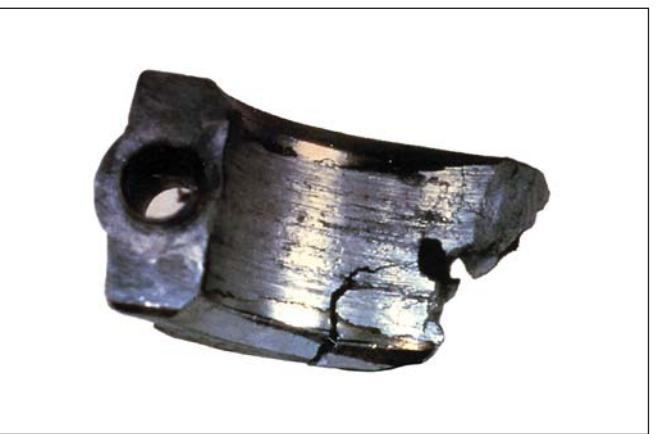
**Figure 66** – What led up to this failure? If you guessed it was another engine started without oil, you're right.

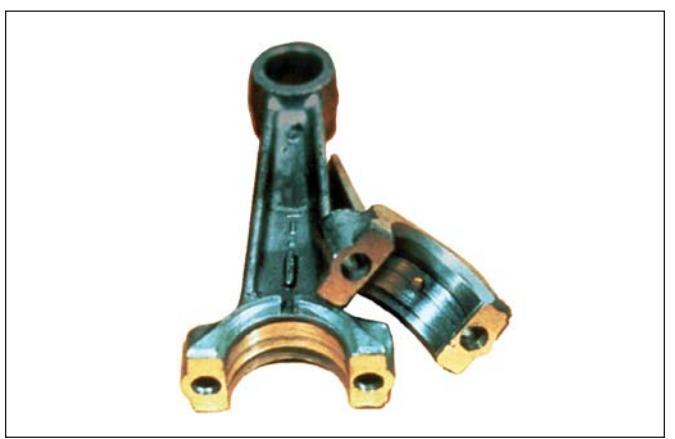
**Figure 67** – Here you see shiny, smeared aluminum in the center of the bearing surface, and no discoloration on the outer surfaces. The failure was due to insufficient running clearance between the rod and crankshaft. The rod had been overtightened and the bearing area collapsed, squeezing out the film of lubricating oil. The engine had oil in it, which cooled the outer surfaces, but it couldn't reach the center of the bearing surface.

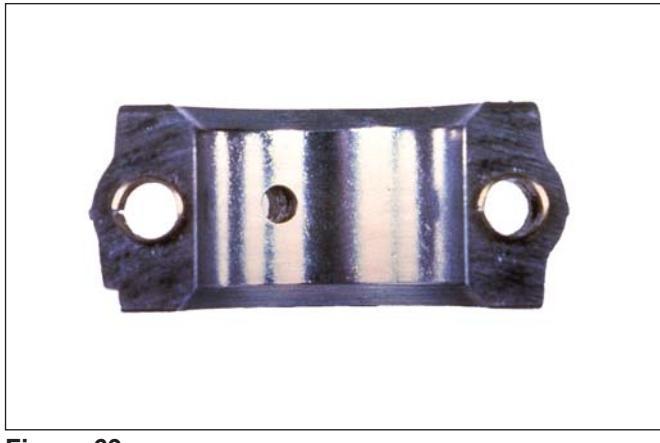
Figure 69.

**Figure 69** – If a connecting rod has not seized, the bearing surface can also be a wear indicator.

The final finishing operation on a connecting rod leaves a textured, but highly polished surface finish. If there is dirt in an engine, it combines with the oil and works like a buffing compound on the bearing surface. The highest loading occurs at the top and bottom of the stroke, so the top and bottom of the journal will show wear first.

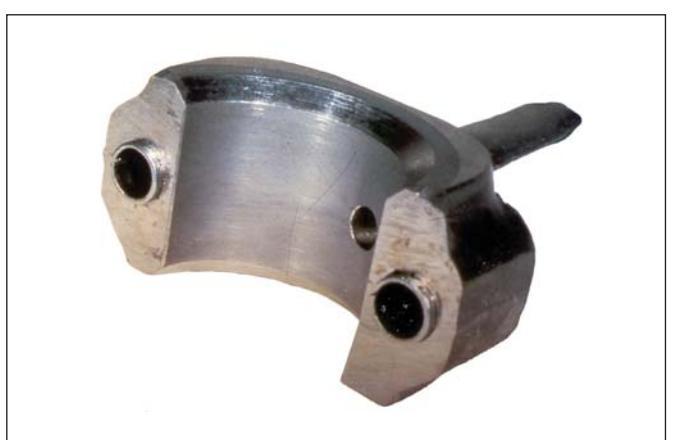
Figure 70.

**Figure 70** – This rod is from an engine that ran for 15 hours with dirt in the crankcase. The original surface finish has been worn off leaving a dull, satin appearance.

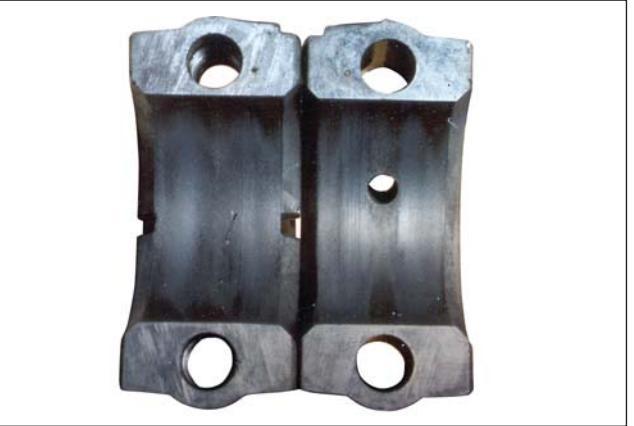
**Figure 71** – If there is a heavy concentration of dirt, or the particles are large and abrasive (honing grit), you may see a "dirt" trail around the center of the bearing surface. The dirt entering through the oil hole gets pounded into the surface of the aluminum, leaving a trail around the bearing, in line with the hole.

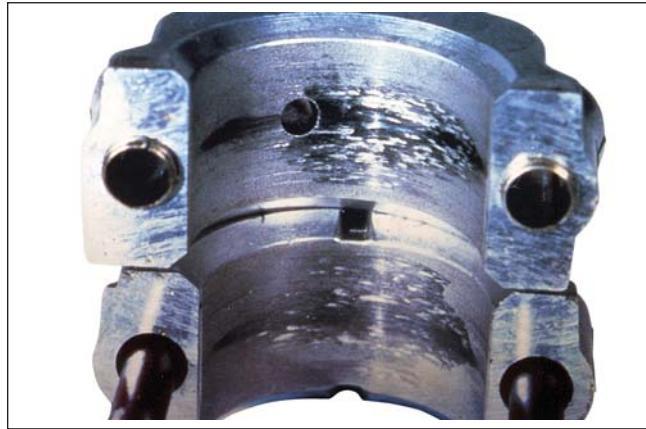
Figure 73.

**Figure 73** – This rod came from another engine that was not cleaned properly prior to rebuilding. After only 6 hours of running, the crankpin was worn .008 in. undersize. The rod had started pounding because of the excessive running clearance, causing the aluminum to begin smearing. The customer became alarmed when the engine started knocking and losing speed. Within one more hour of running, a total seizure would have occurred.

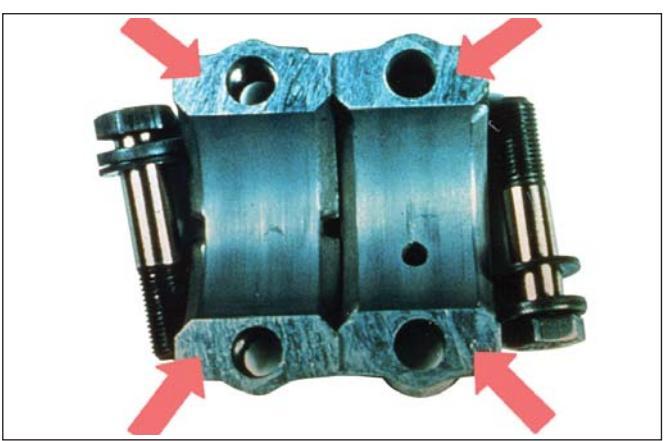
Figure 74.

**Figure 74** – The mating surfaces of the connecting rod are the third area that should be inspected.

The machining marks that you see here are normal. They are made by the saw blade when the rod is out.

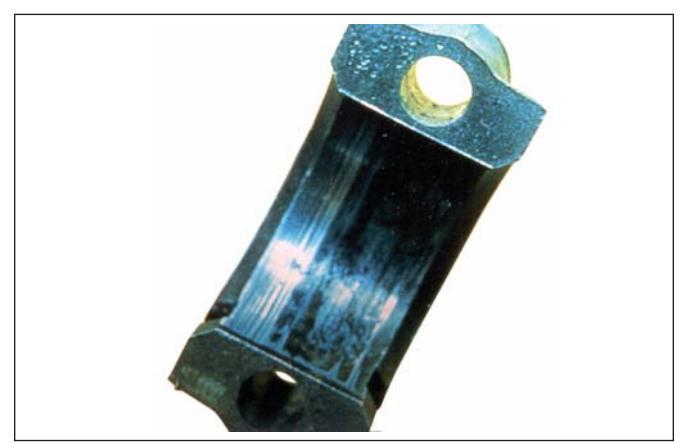
**Figure 75** – Here you cannot see any of the saw blade markings. Instead the mating surface has a hammered or peened appearance. The rod bolts were not tightened properly and the peening results from the two sections of the rod pounding together as the bolts backed out.

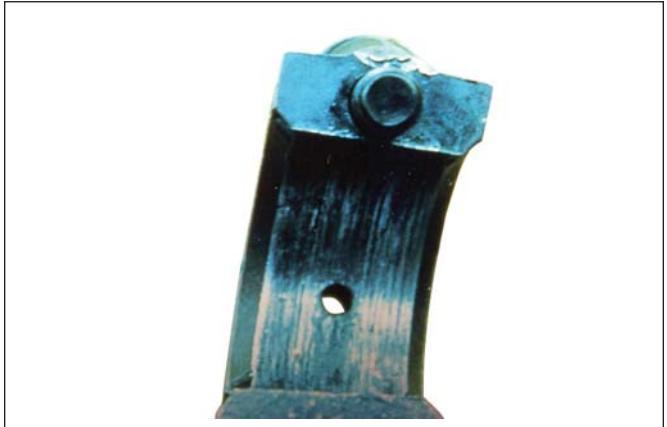
Figure 76.

Figure 76 – Here is another example of

undertightening. In this case, the bolts were just loose enough for the rod sections to work against each other, but not loose enough for them to hammer. The result is a dull gray finish on the mating surface known as "fretting." If magnified, this "fretting" would look like the "peening" you saw in the last slide. This condition will not be seen on Posi-Lock rods.

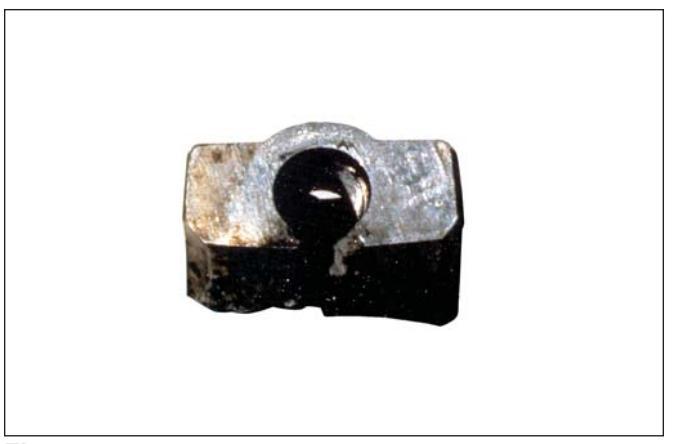
**Figure 77** – This piece has just a small peened area near the outer edge of the mating surface. The looseness here resulted from the high temperatures generated by the seizure. The bolts had been tightened properly and only began to yield when the rod started to seize. This type of peening is secondary. The cause of the failure was insufficient lubrication.

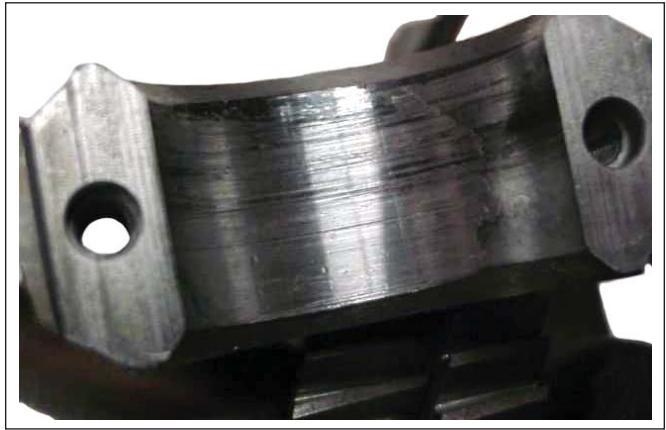
Figure 78.

**Figure 78** – This rod cap shows signs of scoring and aluminum smearing. If you look closely it has a double layer of aluminum on the right hand side. This engine was started with no oil; it seized and was freed up. It was restarted and shortly after it seized again because the aluminum transfer from the first seizure left insufficient running clearance. The lesson here is make sure there is oil in the engine before starting.

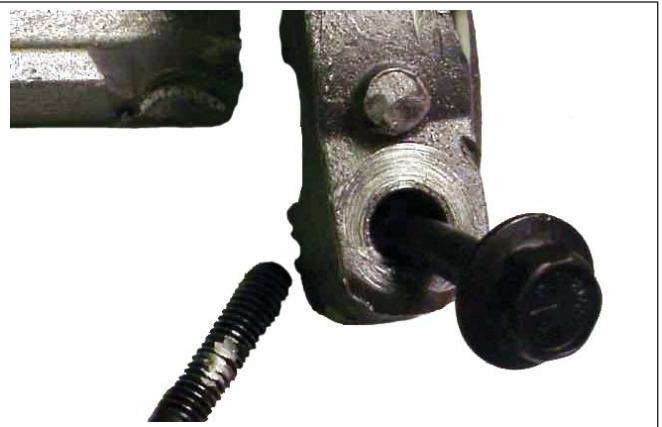
**Figure 79** – This is a shot of a rod bolt that was loose. This came early within its life cycle. Notice the elongation of the hole where the bolt comes through. You can also notice where the bolt wore a groove into the rod cap.

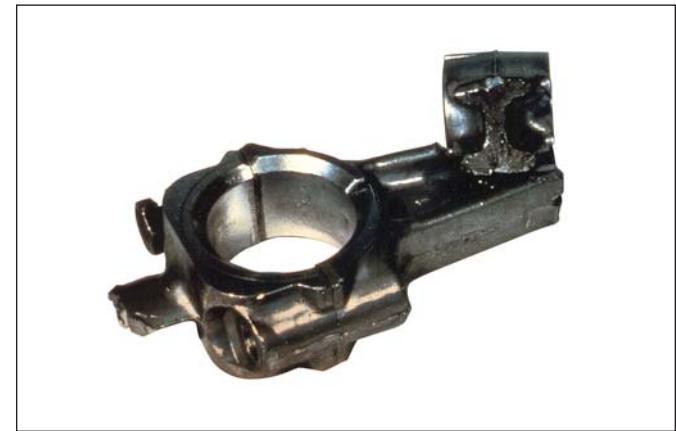
Figure 81.

**Figure 81** – This connecting rod broke in the beam, but has no other visible damage and did not seize. When we look at the break surface, there is no sign of fatigue or a casting defect, just a tensile break of a good casting. This failure was caused by engine overspeed.

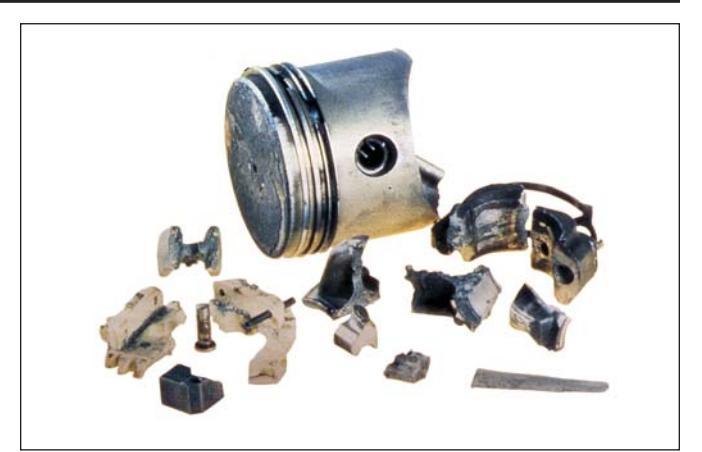
Figure 82.

**Figure 82** – Our first example includes a broken connecting rod and a broken governor gear. The rod bearing surface looks like it ran without oil. Notice, however, that the dipper is broken, and not discolored. The dipper broke first and caused the rod to seize. But the real culprit here is the governor gear. One of the roll pins backed out and the flyweight separated from the gear, breaking the gear in the process. The flyweight dropped into the oil pan and knocked the dipper off the rod.

If we had looked at only the rod bearing, we may have concluded that the engine was run without oil, and we would have been dead wrong.

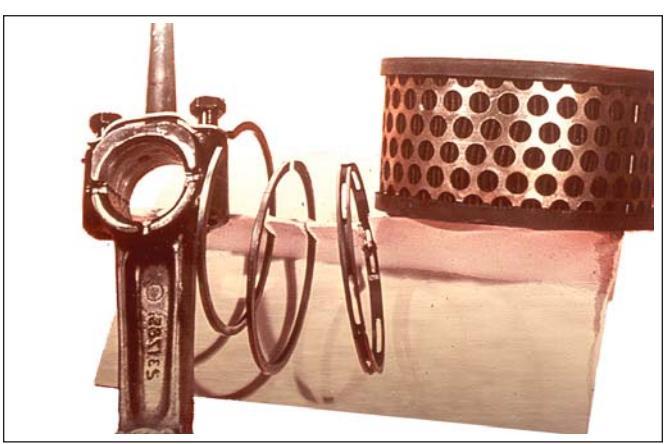
**Figure 83** – A high percentage of small engine failures result from customer neglect. Here you can see the dirty air cleaner, considerable wear on the piston rings, and traces of dirty, burned oil on the connecting rod. There is a color change line on the dipper, but it was only about 3/8 inch from the tip, so the oil level was well below the "low" mark on the dipstick at the time of failure.

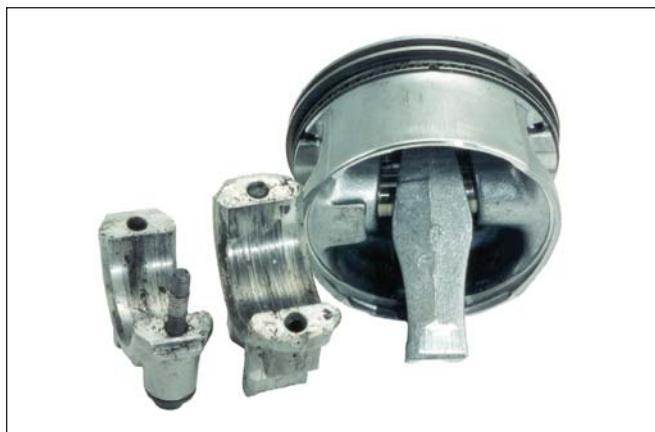
Figure 84.

**Figure 84** – This rod shows signs of aluminum transfer with burned oil deposits. The rod seized from inadequate lubrication. As it locked up on the crankshaft, the turning force of the flywheel and crankshaft caused the connecting rod to snap in the beam, and tried to pull the rod apart at the fastener joint. The aluminum thread transferred to the rod bolt is a secondary occurrence and not a loose rod bolt.

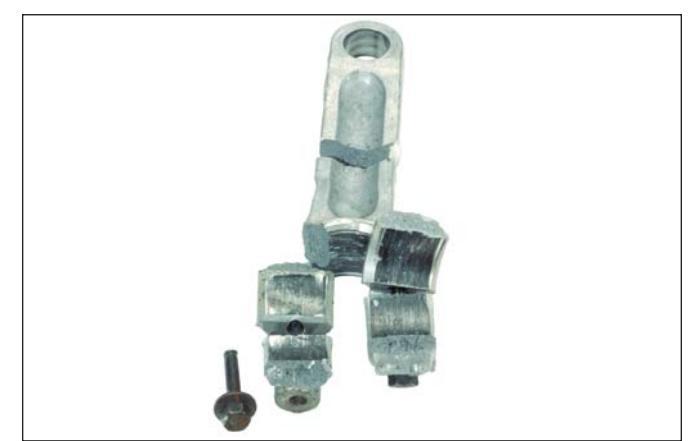
Figure 86.

**Figure 86** – This connecting rod shows multiple breaks. The break in the middle of the beam was a secondary break; in other words, it occurred after the rod seized to the crankshaft. The bearing surface indicates that the initial seizure was from insufficient lubrication.

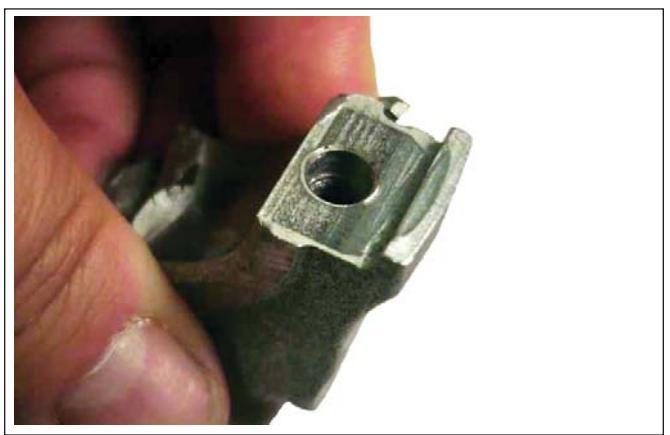
Figure 87.

**Figure 87** – Sometimes you may only have a small amount of evidence to look at to make a determination as to what happened. This lower rod cap shows some peening and shifting. This could have been caused by a loose rod bolt. Again you have to look for other signs, and/or ask questions of the owner and/or of the engine itself. In this case the unit had plenty of lubrication. The failure occurred shortly after an overhaul by a service technician who forgot to torque the rod bolt to proper specifications.

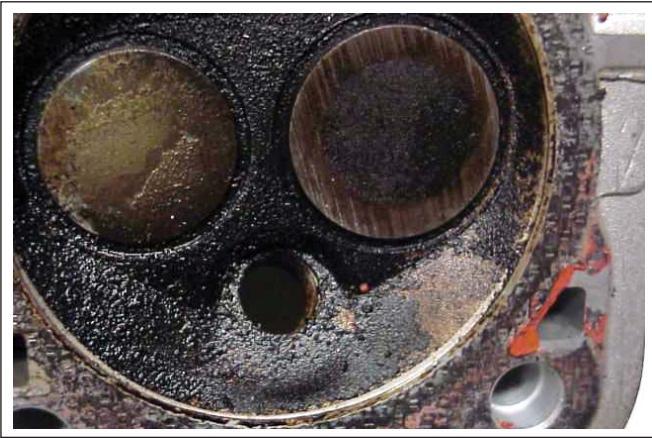
Figure 88.

**Figure 88** – This is a head assembly from a Command Engine. Notice the heavy carbon deposit on the face of the head and valves. The combustion deposits appear to be wet or shiny. This is an indication that excessive oil was entering the combustion chamber.

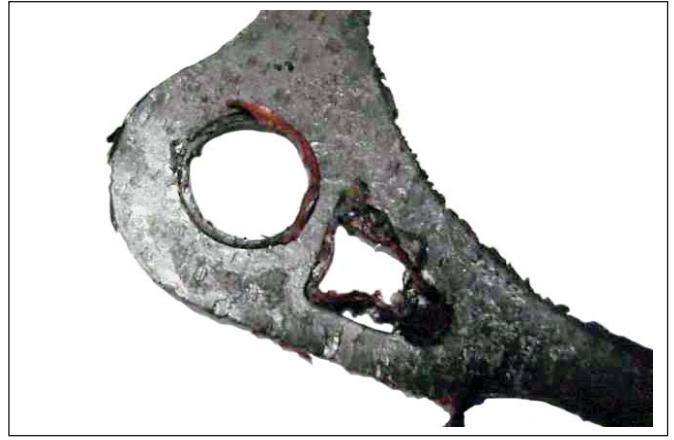
**Figure 89** – This is a close up of a Command head gasket. Notice the RTV sealant around the return passages. Someone wanted to get a positive seal between the head and block and applied RTV. This is not necessary if the surface areas are clean and dry as well as making sure there is no warpage. It is also good practice to check the recommended replacement data when it comes to the retaining fasteners.

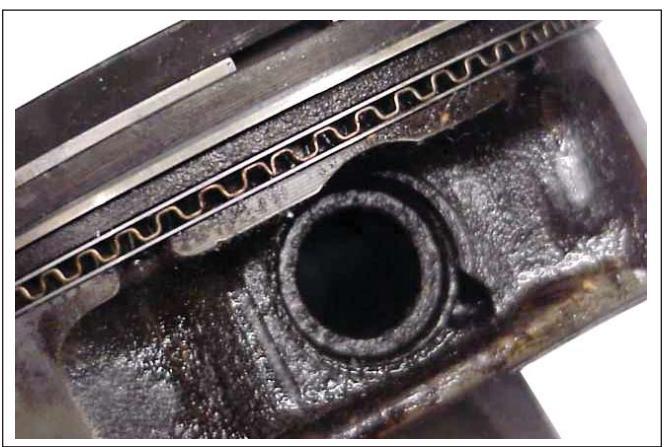
Figure 90.

**Figure 90** – Here is a close-up of the piston and wrist pin area. Notice the blackened and burnt deposits in the wrist pin area as well as the rest of the piston skirt. This can be caused by multiple factors. Some which would be poor oil quality, infrequent oil changes and/or overheating.

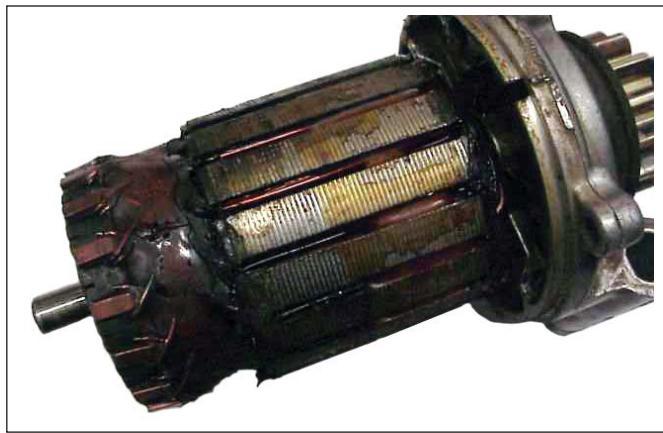
**Figure 91** – This is a typical starter motor winding burned up due to overheating. Again, your job as a technician is to determine what can cause this to occur. Was it due to overcranking and not allowing it to cool down? Was it do to parasitic loads? Improper voltage, etc.

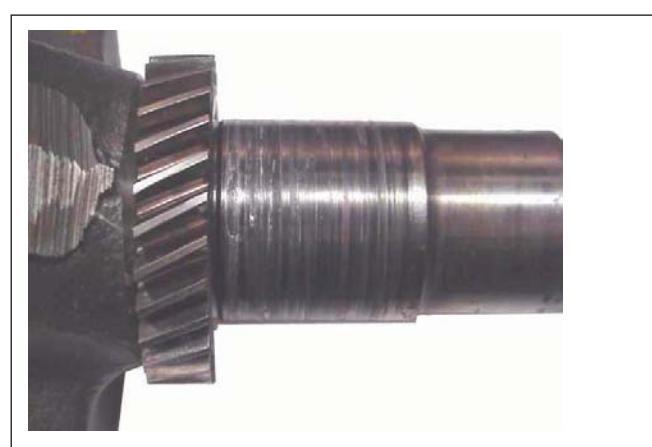
Figure 92.

**Figure 92 -** On the crankshafts look for signs of dirt wear, lack of lubrication and or side loading. Note condition of all bearing surfaces. In this case, notice the PTO bearing shows signs of severe scoring. This could indicate a lubrication or excessive side load problem. It could also be caused by a faulty electric clutch.

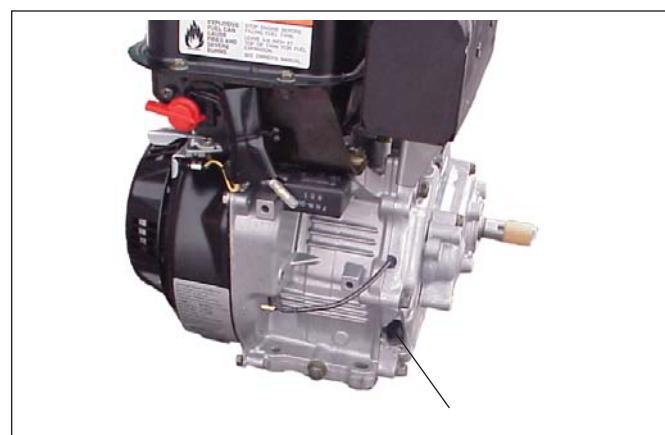
#### Figure 98.

Make a thorough preliminary examination to help determine the conditions under which the engine was operated and pick up any external signs of factors that may have contributed to the failure. In some cases, there will be very obvious indicators, but not always. This engine ran for over two hours, no load, with no oil in the crankcase, but there are no external indicators of that.

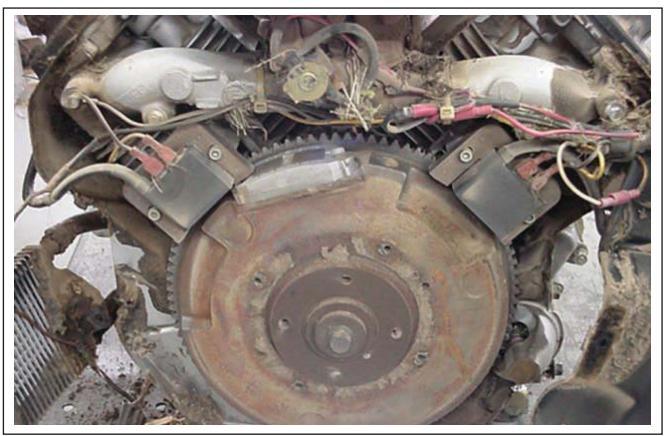
Figure 99.

- Carefully disassemble the engine and examine all of the components. Even though some parts weren't involved in the actual failure, they may still provide some indicators to assist you in reaching a correct decision. If you are fortunate the location of the failure is or will be obvious.
- Weigh all of the evidence against your experience as a professional small engine repairman. Your final decision should incorporate all of the evidence and provide a logical, sensible explanation for the failure which occurred. Running an engine out of gas doesn't cause a connecting rod failure, but running it out of oil probably will.
